# Truck Driver Electrocuted in North Carolina

FACE 87-37

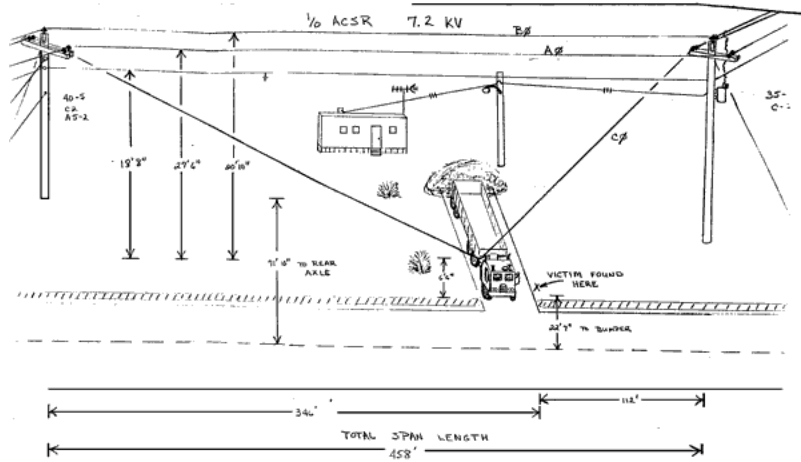
At dusk the driver informed the owner of the residence that he was about to spread the last load of the day since it was getting dark. The driver returned to the truck and raised the truck bed to dump the gravel. The driver then pulled the truck forward while at the same time lowering the bed. The bottom phase, which was 24 feet above ground, of a three-phase

7200 volt distribution system that ran perpendicular to the road caught under a tie-down railing that ran around the front and sides of the truck (see [Figure 1](#)

). This contact energized the truck. The owner of the residence stated that the tires on the truck began to explode. It is assumed that the driver exited the cab of the truck to see what was wrong and as his foot touched the ground he provided a “path to ground” from the electrically energized truck and was electrocuted.

**Recommendation #2: Workers should perform a job site survey prior to the performance of a given task.**

**Discussion:** Overhead power lines are an ever-present hazard in residential areas. NIOSH research indicates that one hundred thirty-five occupational fatalities occurred from 1980 to 1984 that were dumptruck related. Of these, approximately seven percent were electrocutions due to the bed of a dumptruck contacting overhead power lines (NIOSH unpublished data, 1987). Prior to the performance of a given task workers should perform a job site survey, which would identify any safety hazards present at a given job site. Workers would then be aware of the hazards they might encounter at a given job site. Additionally, in this instance the gravel was being dumped at dusk which would have made the power line very difficult if not impossible to see. If proper vision cannot be maintained by the driver in the truck someone should be posted outside the truck to be on the lookout for hazards.
