# Two Workers Electrocuted in Tennessee

FACE 86-39

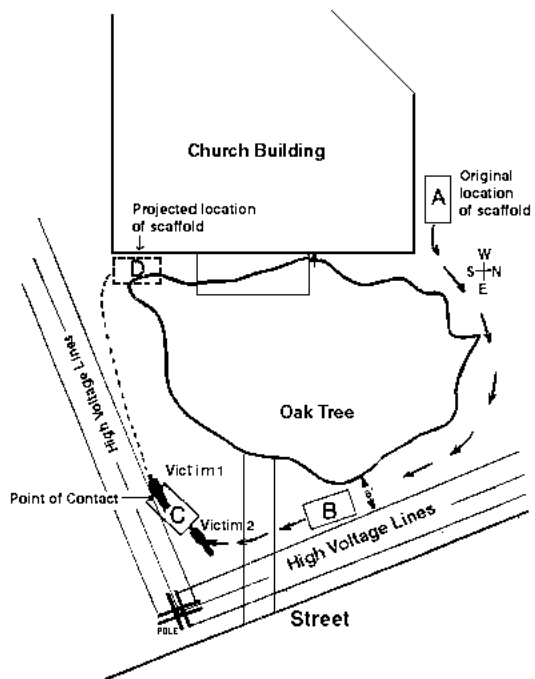
Figure.

The workers moved the scaffold in an easterly direction (see [Figure](#), Position A), then turned to a southerly direction, circling around a tree which was close to the building. They passed near or under a 12,000 volt line which was approximately 30 feet in elevation (Position B). They continued circling the tree, rotating the scaffold and pushing it towards the East face of the building. The power line changed direction at the pole and the elevation of the line dropped about five feet to approximately 25 feet. The scaffold contacted one phase of the 12,000 volt line (Position C), completing a path to ground (7200 volts phase-to-ground) through the two men and electrocuting them. The ground fault relay of the power company, set at 1750 amps, did not open the circuit breaker. This probably occurred because the casters were made of rubber and the current through the two victims did not exceed 1750 amps. The line was not de-energized until representatives of the power company came and physically removed the jumpers which ran from the North/South lines to the East/West lines.
