# 19-Year-Old Laborer Electrocuted in Kentucky

FACE 87-15

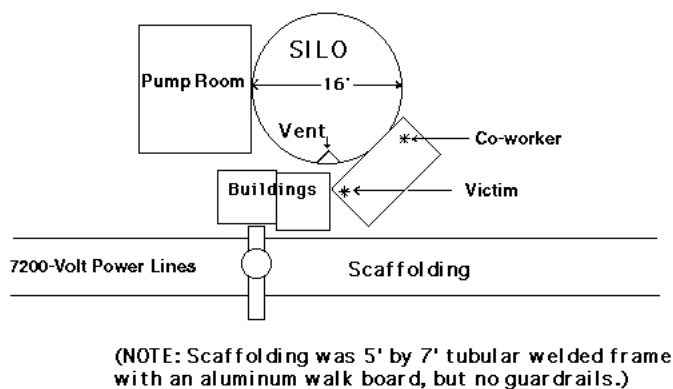
Figure. Top View of Fatality Site

the scaffolding above the employees required them to paint through the openings of the support lumbers of the scaffolding. A 7200 volt power line was located six to eight feet behind the workers and approximately 23 feet above the ground. (See [Figure](#).)

**Recommendation #1: The employer should not erect scaffolds within ten feet of electrical power lines. Electrically conductive tools should not be used where they may come into contact with electrical power lines.**
