# 23-Year-Old Lineman Electrocuted in North Carolina

FACE 86-20

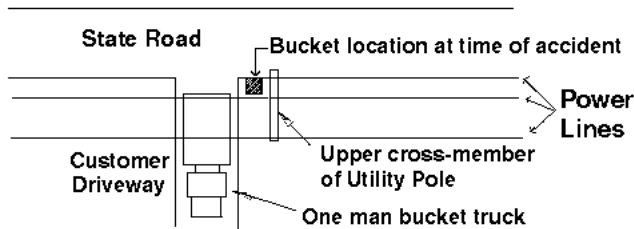
Diagram A. Location Sketch

The two-person crew (the victim and a supervising lineman) returned to the location where they had worked earlier in the week. They were to remove and replace a capacitor bank from a utility pole located in a flat rural area. (See [Diagram A](#) .) The upper cross member supported three 7200 volt conductors and each conductor had attached to it a lightning arrester. (See [Diagram B](#) .) The crew's specific task on the day of the accident was to splice a #16 wire cable into a LB 90° connection box which was attached to the upper cross member of the utility pole. The purpose of the splice was to bring electricity from the conductor to a service meter attached to the pole five feet above the ground.

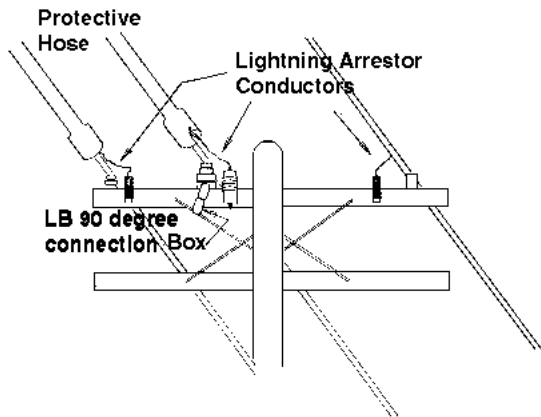
Diagram B. Upper Cross-member of Utility Pole

The supervising lineman on the ground did not witness the accident. However, the physical evidence suggests the victim was holding the #16 wire cable with his left hand when his right hand came in contact with the lightning arrester conductor. The lightning arrester conductor was located within 11 inches of the LB 90° connection box. The victim cried out when his hand came in contact with the lightning arrester conductor. The lineman on the ground looked up and saw the victim slumped in the bucket; he then ran to the truck and radioed for assistance.

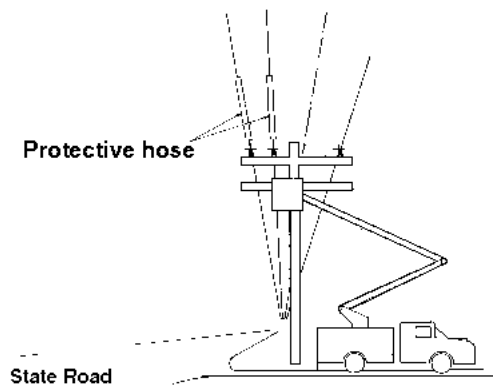
Diagram C. Location of the Aerial Bucket

At 8:45 a.m. the victim positioned himself in a one-person articulated, truck-mounted aerial bucket 25 feet above the ground and slightly below the upper cross member of the utility pole. (See [Diagram C](#) .) Protective insulating hoses were placed over two of the primary conductors; however, the lightning arrester conductors attached to the primary conductors prevented the hoses from slipping all the way to the cross member on the utility pole. The victim did not use any boots, blankets, or other insulating material to cover the lightning arrester conductors or other live conductors. The victim's insulated rubber gloves were in the tool tray located on the floor of the bucket. Immediately before the accident, the victim was in the process of splicing the 3-conductor #16 wire cable into the LB 90° connection box. The victim's splicing knife was found on the floor of the bucket.

**Recommendation #1: When working with electricity, workers should wear appropriate protective equipment and use insulating boots, blankets, and hoses where appropriate.**

**Discussion:** At the time of the accident the victim was not wearing rubber gloves which were provided by the employer. The victim did not cover all exposed electrical parts with blankets, boots, or covers as is required by the company's safety manual. The victim should have been required to follow the safe job procedure as stated in the company's safety manual. If the victim had worn protective clothing and covered energized parts, the risk of an electrocution would have been greatly reduced.
