# 20-Year-Old Bricklayer Electrocuted in Maryland

FACE 87-19

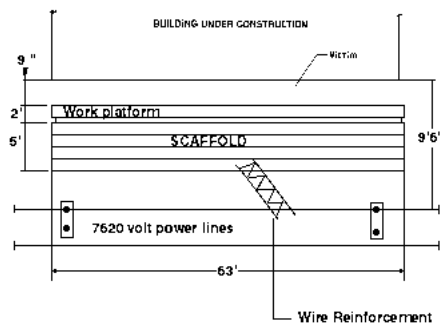
**Figure 1.** Top View of Fatality Site

main part of the scaffold. The scaffold was located between a 7620 volt power line and the building under construction (see [Figure 1](#)). The horizontal distance from the power line to the edge of the scaffold was 21 inches. The height of the power line from ground level was 27 ½ feet.

At the time of the accident, a laborer was walking along the top section of the scaffold carrying a piece of wire reinforcement (10 feet long and 8 inches wide). The wire reinforcement touched the 7620 volt line. The laborer, who was wearing leather gloves at the time, received a shock and dropped the wire reinforcement. The reinforcement fell across the 7620 volt line and the metal rail of the scaffold, energizing the entire scaffold. A bricklayer (the victim) was standing on the work platform, but was in contact with the main scaffold. This contact provided a path to ground and the bricklayer was electrocuted. Burn marks on the victim's hands and left leg above the knee indicate that he was touching the frame of the main scaffold with his hands while his knee touched the frame of the work platform section. The wire reinforcement eventually fell from the 7620 volt line, de-energizing the scaffold.

### **Recommendation #1: The employer should not erect scaffolds within ten feet of energized electrical power lines.**

Discussion: Although there are no Federal regulations concerning working a specified distance from energized power lines, several states have requirements concerning this activity. Erection of the scaffold within 21 inches of the power line was inherently dangerous and should not have been permitted.
