Laborer Electrocuted in Virginia

FACE 87-61

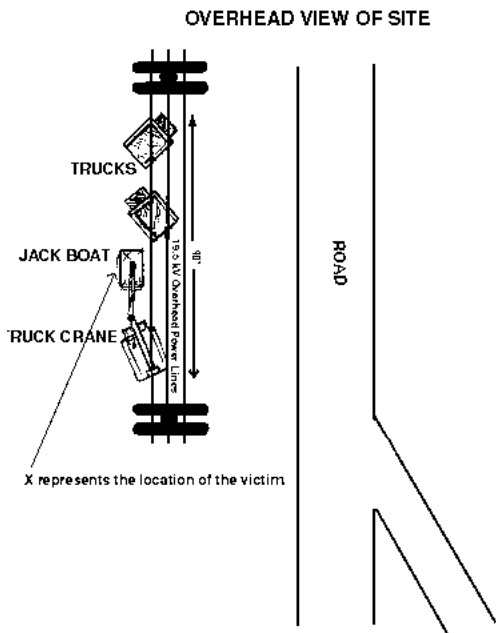
The weather on the day of the accident was clear and hot. The temperature was approximately 95 degrees Fahrenheit. Two trucks and the truck crane were at the site (see [figure](#)). The two trucks were positioned for loading under the power lines. The truck crane was operating close to the power lines in order to pick up a "jack boat" made of plate steel. The victim (location X) was a truck driver, but was also working as a "hook-on man" helping the crane operator load the scrap metal, which was a common practice for this company.

As the victim stood on the “jack boat” holding the cable hook, the boom cable of the crane contacted a 19,900 volt overhead power line. The victim provided a path to ground for the current and was electrocuted. The power line burned and separated, falling onto the trucks and starting a fire. Both the emergency medical service (EMS) and the fire department were called, but the victim was pronounced dead at the scene.
