21-Year-Old Technician Electrocuted in Indiana

FACE 86-14

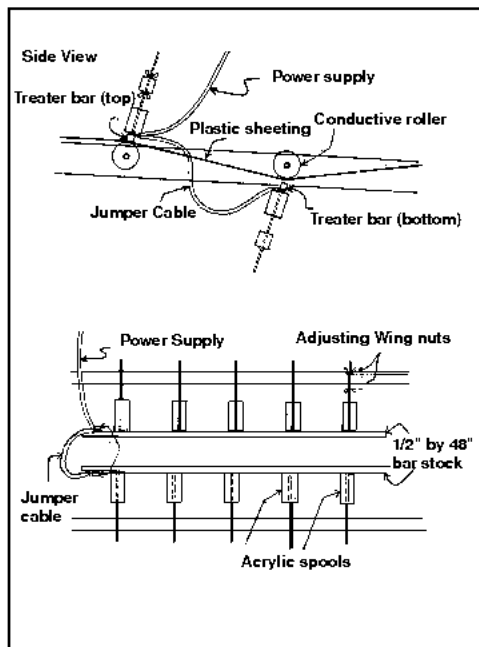
Figure. Corona Treatment of Polyurethane Sheets

On February 16, 1986, the victim (a 21-year-old male, plastic extrusion machine operator) worked the third shift (midnight to eight a.m.). The victim's machine was equipped to provide a corona treatment to plastic sheeting. Without this treatment it is not possible to print on the plastic sheet. The corona treatment is accomplished by charging a steel treater bar with a D.C. current. A grounded conductive roller is located near to the treater bar, so that a corona is established between the roller and the bar. The plastic sheet is passed through this corona. This treatment does not visibly change the sheet's appearance. Two treater bars (one above and one below the sheet) are used in this process. Each treater bar has height adjustment screws so that a gap of .055 inch can be maintained between the bar and the surface being treated. (See attached [figure](#) .) The plastic treater is designed to operate at 9600 Hz. This is accomplished by converting the three-phase input to DC and inverting the DC to a high frequency sinusoidal output. This high frequency output is then fed to the high voltage transformer (10 kV) and stepped up to a level sufficient to initiate and maintain an adequate corona for the process.

The victim operated the machine without incident until 7:45 a.m. at which time the corona treater was de-energized while a maintenance man installed a bonding strap from the machine to a nearby electrical panelboard. To make the connection safely, the maintenance man de-energized the transformer that supplied power to the treater bars. However, the extrusion machine remained energized. As a result, the plastic sheet was being extruded from the machine, but the sheets were not receiving the corona treatment. After the maintenance man connected the bonding strap, the victim re-activated the transformer. While standing on a metal step on the operator's side of the machine, the victim touched the treater wire/cable or the treater bar with his right hand and came into contact with a potential 10 kVDC, 9600 Hz source of electricity.

Discussion: The treater wire from the transformer to the upper treater bar and the jumper from the upper treater bar to the lower treater bar were insulated, but were not enclosed in 4" grounded aluminum conduit with acrylic supports inside the conduit (as required by the manufacturer). Additionally, the treater wire was not certified by the wire manufacturer for this application. The upper and lower treater bars should be partially enclosed to prevent personnel from coming in contact with the high voltage. A commonly used practice is to enclose the bars in a 3" PVC tube with the ends capped. (The requirement to enclose the treater bar was addressed at the time of the FACE field evaluation.) The employer did not have an owner's manual for the equipment and the equipment was not installed in accordance with the manufacturer's specifications.

Recommendation #1: Insulated conductors supplying power to this equipment should be enclosed in accordance with the manufacturer's recommendations to assure proper protection for anyone working near these conductors.
