# 34-Year-Old Maintenance Worker Electrocuted in Ohio

FACE 86-35

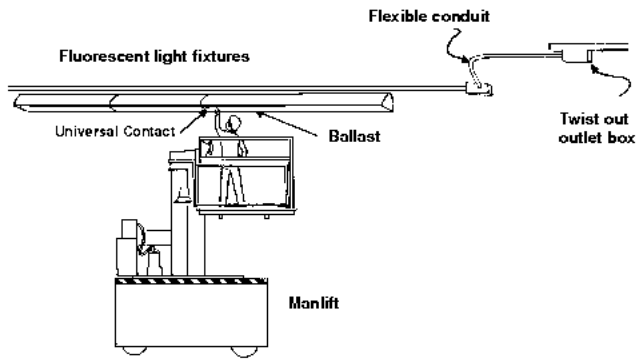
As the victim entered the factory at approximately 11:00 p.m. he noticed an overhead fluorescent light was out. Since he was the only maintenance worker on the third shift, it was his responsibility to replace the ballast and fluorescent tubes. This was considered a routine task for the victim. After returning from the maintenance shop with new tubes and a ballast, he obtained a manlift to elevate himself 12 feet above the floor to a height where he could comfortably work on the light fixture. (See [figure](#).) He removed the old tubes, metal shade, and a line fuse from the black wire which he assumed was the hot wire. The victim did not de-energize the conductor to the fluorescent lights. This could have been easily accomplished by disconnecting the twist out outlet box attached to the universal lighting duct or by removing the universal contact which was located beneath the metal fixture and which helps support the light fixture. He then cut all eight wires which were connected to the old ballast and started to strip insulation from the white wire. Apparently while holding the white wire in his left hand, he braced his left index finger against the metal structure supporting the light fixture. Holding the wire strippers in his right hand, the victim began to strip the insulation from the conductor. As he was stripping the insulation his metal wire stripper made contact with the hot conductor at the same time his left hand was braced against the metal structure. The victim received an electrical shock from the 277 volts which serviced the light fixture.

Figure. Worker Replacing Ballast from Manlift Platform

**Recommendation #1: Employees who work with electrical conductors should de-energize the conductors and take appropriate action to ensure the conductors can not be accidentally re-energized.**

**Recommendation #2: Correct electrical polarity should be maintained throughout the electrical service area.**
