# 28-Year-Old Truck Driver Electrocuted in Georgia

FACE 86-17

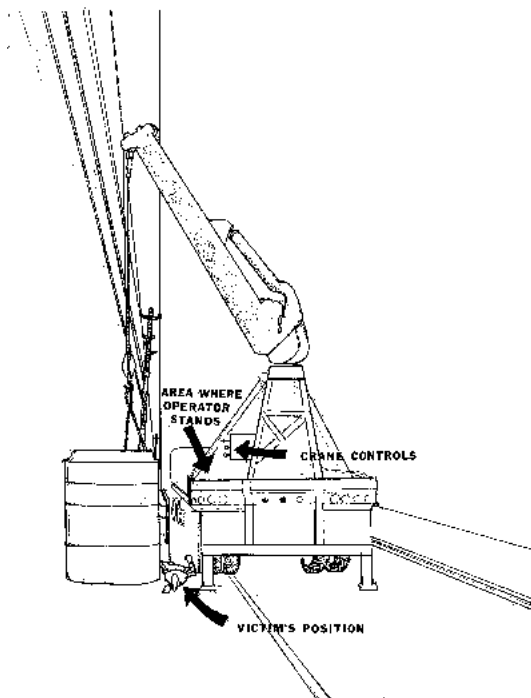
**Figure 1.** Accident Scene

The victim worked as a truck driver delivering precast concrete products. This job involves driving a truck to delivery sites and unloading the concrete products. Unloading is done using a hydraulic crane that is mounted on the rear of the trailer. The boom of this crane can extend approximately 28 feet vertically. The precast concrete is unloaded using a chain hooked to a metal bolt on the concrete manhole assemblies and to the cable of the crane boom. The crane is operated using the controls as shown in [Figure 1](#)

. The operator usually stands on the bed of the truck to operate the controls. The victim

At approximately 9:30 a.m. the victim unloaded two concrete manhole assemblies and was in the process of unloading the third when the accident occurred. The third manhole assembly was between the two that had already been unloaded. The first two assemblies were farther away from the truck and farther under the powerline than the third one. The third assembly was on the ground with the chains used to unload the product disconnected, but “welded” to the metal bolt used to connect the chain to the manhole assembly. The victim was found lying between the manhole assemblies and the truck and was in contact with one of the concrete manhole assemblies. The police report states that his elbow was burned into the concrete. The crane cable (approximately ten inches below the tip of the boom) was in contact with a 7200 volt powerline, located twenty-five feet ten inches above the ground. The powerline had to be de-energized and grounded by the local electric service utility before emergency care could be administered to the victim, who was pronounced dead at the accident site.

Since the accident was unwitnessed, the exact circumstances are unknown. Reviewing the known facts of this accident raises the question of why the victim had not made contact with the overhead powerline while unloading the first two manhole assemblies, since they were farther under the powerline and there did not appear to be enough room between the truck and the powerline to have unloaded the manhole assemblies. It appears likely that the truck was moved between the unloading of the first two assemblies and the third one. After moving the truck to unload the third assembly, the victim lowered the assembly to the ground. With the weight of the load removed, the boom may have drifted into the overhead powerline. If this occurred while the victim was holding onto the chain, the victim would have provided a path to ground and he could have been thrown onto the ground between the manhole assemblies and the truck. Electrical energy continued to flow through his body from his contact with the manhole assembly, since the chain attached to the boom was in contact with the manhole assembly.

**Recommendation #3: Loading, unloading, and storage sites should be chosen to avoid possible contact with overhead powerlines.**

**Discussion:** Loading, unloading, and storage sites away from overhead powerlines decreases the chance of inadvertent contact between crane booms and these lines. The need for safe storage sites is particularly true at construction sites and at areas used for permanent storage areas. The owner of the company instructed the victim to unload at an area away from the overhead lines. Had the victim followed these instructions, this fatality would not have occurred.
