Tractor-Trailer Repairman Dies while Welding Interior Wall of a Tanker in Indiana

FACE 8750

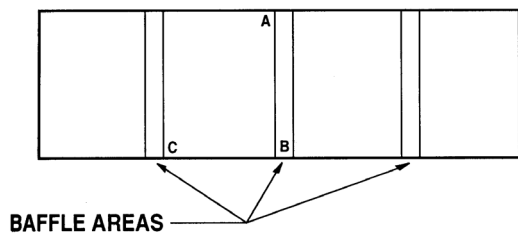
Figure 1 (87-50). Lateral view of the tanker-trailer in which fatality occurred.

The tanker compartments were steam cleaned for 1 to 1-1/2 hours to remove trapped chemicals and vapors from the tanker. The chemical in this instance was lacquer-thinner. Drain plugs were opened the entire time steaming was conducted to allow proper drainage of the compartments and baffles. Opening the drain holes is a standard safety procedure for the company when doing tanker repairs. The victim and his assistant left the tanker to do other tasks while the steam cleaning progressed. Because of this, they were not aware that the drain hole in the second baffle area had clogged (See B, Figure 1).

After air-blowing the baffle, the victim and assistant entered the tanker compartment to do pre-treatment work to the leak (See A, Figure 1) before welding. The assistant remarked about the "strong fumes" in the compartment; however, the victim decided to continue the repair operations. When the pre-treatment was completed, the victim instructed the assistant to leave the compartment, pass in the welding equipment and to stay on top of the tanker to attach the lids to the other compartments. Upon leaving the compartment, the assistant again mentioned the "strong fumes." The written company safety policy required that an explosion meter was to be used at this point. The explosion meter was available and was in working condition. However, the victim did not follow the safety policy and requested the assistant to pass in the welding equipment. After passing in the equipment, the assistant began replacing the compartment lids as instructed. An explosion, which apparently occurred as the victim began welding the leak, broke the weld of the compartment wall along approximately six feet of the seam line.

The assistant was the first to reach the compartment and saw the victim against the compartment wall opposite the leak (See C, Figure 1). The owner of the company immediately notified the local fire department and emergency medical service. The fire department responded within three to five minutes. An ambulance responded after ten to twelve minutes, by which time the victim had been removed from the tanker by co-workers. The emergency medical team began CPR at the scene and continued CPR while enroute to the hospital. The victim was rushed to a nearby hospital, approximately ten minutes away, where he was pronounced dead by the attending physician. The time between the incident and arrival at the hospital was approximately thirty minutes.

- A. Location of leak.
- B. Baffle area with clogged drain.
- C. Location of victim after explosion.

Recommendation #1: The employer should initiate a comprehensive enforcement and safety review program for confined space entry procedures.

Recommendation #2: The employer should expand confined space policies to address hazards due to oxygen deficient, flammable/explosive, or toxic environments.

Discussion: This incident emphasizes the need to address all of the potential hazards in confined spaces. Locating the clogged baffle drain before entering the tanker compartment allowed the baffle to be drained of trapped chemicals. However, if the clogged drain had not been located, the concentration of chemical vapors in the tanker compartment may have been sufficient to place both the victim and the assistant in an oxygen deficient or toxic environment. The need to inform employees about the hazards of confined spaces in all respects should be a priority of the employer. Information concerning confined space entry procedures is available from various NIOSH documents including:
