29-Year-Old Mechanic Electrocuted in Indiana

FACE 86-29

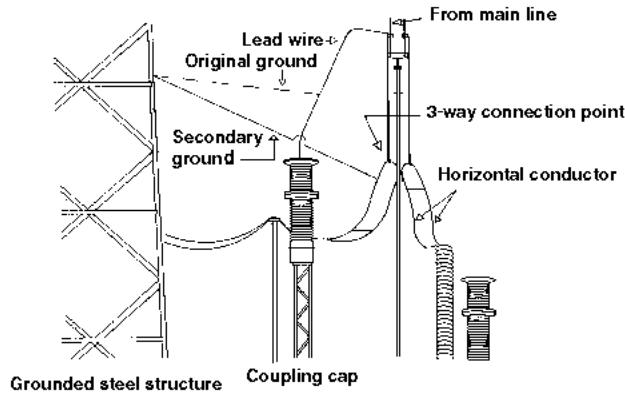
Figure 1.

On Wednesday morning May 7, 1986, a crew consisting of a foreman, lead class "A" mechanic, and another class "A" mechanic (victim) was assigned to perform maintenance at one of the company's substations. The maintenance was to include the replacement of a three-way connector. The grounding of the conductors and corresponding switches and breakers was put in place prior to the maintenance on the three-way connector. The foreman, after having discussed and established working procedures with the maintenance crew, moved approximately 150 feet away from the accident site to perform other activities. While preparing to remove the bolts and plates at the three-way connector the lead mechanic and victim were situated in the bucket of an aerial truck approximately 20 feet off the ground. For reasons unknown and without consulting the foreman, the crew moved a ground wire from the original grounded position (lead wire of the coupling cap to a grounded steel structure) to a secondary grounded position (horizontal conductor secured at the three-way connection point, to the grounded steel structure) (see [Figure 1](#)

). After repositioning the grounding wire to the secondary position the victim began removal of the bolts from the three-way connector. As the bolts were removed, the horizontal conductor with the grounding wire attached separated from the three-way connector; the victim momentarily contacted the grounded horizontal conductor with his left hand and the energized three-way connector with the right hand. This contact created a path-to-ground and the victim was electrocuted.
