Four Members of a Maintenance Crew Electrocuted in California at a Major Naval Installation

FACE 87-12

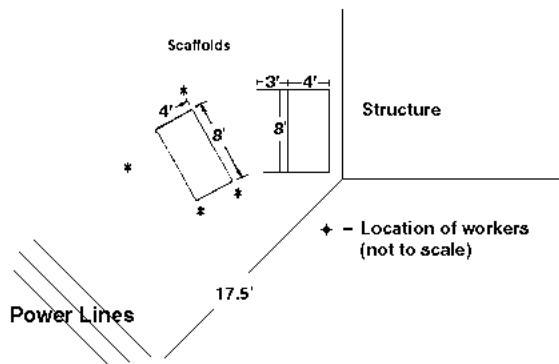
Figure. Top View of Accident Site

The crew (a crew chief and four painters) was painting a three story structure that housed offices for base personnel. The crew was using tubular welded frame scaffolding, approximately 4 feet wide by 8 feet long. The scaffold was five tiers high (approximately 28.5 feet) and was mounted on five-inch rubber-clad, aluminum wheels. The crew had completed painting the left side of the office building and was preparing to paint the front of the building. Although time was allocated on the work order to dismantle and rebuild the scaffold, the crew began to push the five-tier high scaffold to the front of the structure. A three-phase 12,000 volt power line was located 27.5 feet above the ground and 17.5 feet away from the left front corner of the building (See [Figure](#)).

A second scaffold was located at the left front corner of the structure. This three-tier high scaffold was also constructed from tubular welded frame scaffolding. However, the base dimensions were increased an additional three feet because the outriggers were extended. The crew had to maneuver the five-tier scaffold between the extended outriggers of the second scaffold and the 12,000 volt power line to reach the front of the building. Naval personnel estimated that less than four feet of clearance existed between the 12,000 volt power line and the five-tier scaffolding.

As the crew was maneuvering the five-tier scaffold around the extended outriggers of the second scaffold, the five-tier scaffold contacted the 12,000 volt power line. The four painters remained in contact with the scaffold while the crew chief received a severe electrical shock and was knocked backwards away from the scaffold. As naval personnel and civilians tried to approach the victims they received electrical shocks through their feet from the current running through the scaffolding to ground. The crew chief was able to grasp a board held by a rescuer and was pulled to safety. He was flown by helicopter to a local hospital where he was listed in critical condition. Rescuers tried to separate the victims from the scaffold, but were unable to do so until the power lines were de-energized.

Recommendation #3: Safe working distances should be maintained between scaffolding and power lines.

Discussion: California OSHA regulations require that six feet of clearance be maintained between power lines and scaffolding. Although California OSHA does not have jurisdiction in the case, it is smart and safe work practice to maintain at least a six foot distance as clearance. Additionally, when scaffolding is being moved in the vicinity of power lines a person should be appointed to constantly monitor the clearance between the power lines and the scaffolding.
