# 36-Year-Old Laborer Electrocuted In North Carolina

FACE 87-02

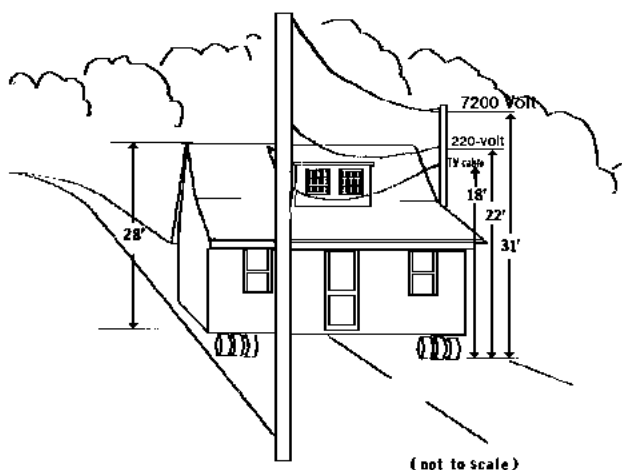
Figure 1.

On October 7, 1986, a house mounted on large truck dollies was being moved down a highway to a new location. The victim and another co-worker were standing on the roof of the house to ensure that the house could clear all overhead lines. At the time of the accident, the house was passing under three overhead lines: a cable TV line (18 feet above the

road); an energized 220 volt, insulated line (22 feet above the road); and an energized 7200 volt, uninsulated line (31 foot above the road). (See [Figure 1.](#)) The peak of the roof was 28 feet above the road surface. The power company was preparing to de-energize a 220 volt, uninsulated line at the next intersection. The power company was not de-energizing low voltage (220 volts or less), insulated lines and did not de-energize the 7200 volt line at the time of the incident. Representatives of the power company told the workers which lines were energized and the workers acknowledged that they were aware of the energized lines. The co-worker was wearing rubber gloves, but the victim was not wearing any personal protective equipment. The house moving company had borrowed a hot stick from the telephone company, but were not using it at the time of the incident. This was the sixth house moved down this roadway during this particular house moving job. The five previous houses were moved without incident utilizing the same procedure. According to representatives of the power company, the 7200 volt line was energized on all five previous occasions.

After the 220 volt line had cleared the roof, the victim grabbed the cable TV line with both hands and stood up to walk the line over the top of the house. While doing this, the back of his neck came into contact with the 7200 volt line and he was electrocuted. The victim and the cable TV line provided a path to ground for the 220 volt line. The co-worker did not come into contact with the line.

**Recommendation #2: All electrical lines should have been de-energized.**

**Discussion:** All electrical lines should have been de-energized by the power company prior to the house being moved under the lines. The power company was on the scene de-energizing some of the lines, but not all of them. The victim would not have been electrocuted had this 7200 volt line been de-energized.
