# Apprentice Sheet Metal Worker Electrocuted in Tennessee

FACE 87-04

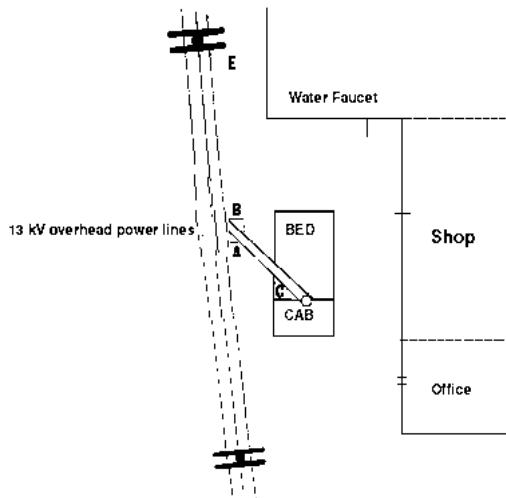
**Sketch.** Plan View of the Accident Scene

A powered scaffold, in need of repair, was being unloaded outside the shop door when the accident occurred (see [Sketch](#)). The outriggers of the truck were down. The crane operator ("C" on sketch) and another employee ("D" on sketch) were standing on the truck bed; the victim ("A" on sketch) and his co-worker ("B" on sketch) were standing on the ground guiding the power lift which was being unloaded. The ground where the victim stood was still damp from the runoff which resulted from washing the truck. The ground where his co-worker stood was at a slightly higher elevation and was dry.

A fifth employee ("E" on sketch) walking towards the truck, with a better view of the situation, warned them that they were too close to the overhead power line. Suddenly, a "ball of fire" appeared to engulf the hoist cable. The victim and his co-worker were held by the current for a few seconds; then both were released and fell to the ground as the hoist cable and power line separated.

**Discussion:** OSHA standard 1910.180(j)(1)(i) requires that a minimum clearance of ten feet be maintained between parts of truck cranes or loads and energized electrical power lines rated 50,000 volts or less, unless insulating barriers are erected. The truck was placed between the power lines and the company building, which were approximately 25 feet apart. The lift was then unloaded on the power line side of the truck (see sketch), which made compliance with the OSHA standard virtually impossible.

- A represents the location of the victim.
- B represents the location of the injured co-worker.
- C represents the location of the crane operator.
- D represents the location of an employee standing on the truck's bed
- E represents the location of an employee walking towards the truck crane, who warned of proximity to the power lines.

**Recommendation #1: Employers should enforce existing regulations concerning crane operations in the vicinity of overhead powerlines.**

**Recommendation #5: A safety observer with no other duties should monitor the work when there is even the remotest chance of contact with overhead power lines.**

**Discussion:** While there seems to have been no attempt made to maintain the required clearance, one may question whether the distance between a vertical hoist cable and horizontal power line can always be determined accurately from the operator's position. The fact that another employee ("E" on sketch) warned of proximity to the power line immediately before the accident suggests that a safety observer could have helped prevent this fatality.
