Utility Company Employee Electrocuted in California While Drilling Under a Road

FACE 85-42

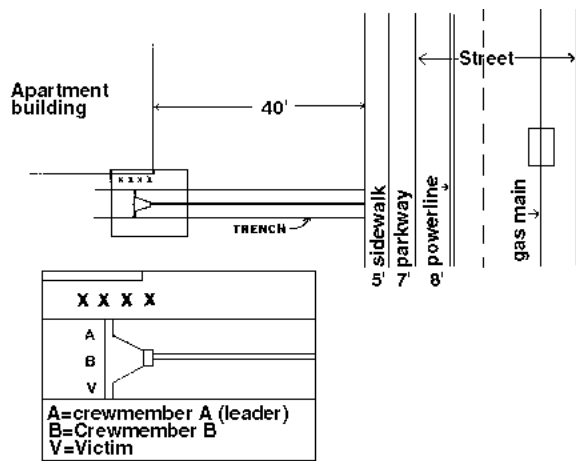
Figure 1. Construction Area of Facility

A service line was to be installed to connect an apartment building to the main (which is located under the street). See [figure 1](#)

. The area had been previously inspected by the crew leader. Telephone and street light electrical utilities were excavated and identified in the parkway. Power to the apartment was supplied by above ground lines. A non-profit organization that is responsible to alert utilities when excavation may affect their equipment had been notified. The local telephone company had marked their lines in response to this notification; however, the underground electric lines had not been marked by the local municipality. The municipality does not routinely mark their underground electric lines.

Partial excavation of the site had been completed by the gas company so that the procedure to bore under the street could take place. A trench had been excavated from the apartment building to the sidewalk. One hole had been dug in the parkway to expose telephone and street light service lines. Another hole had been dug in the street to expose the gas main. Although the crew had the equipment and training to electronically identify other underground metal structures, this was not done because the crew questions the reliability of the equipment currently being used.

Excavation of the site done during the post-accident investigation revealed a four inch thick concrete conduit approximately twenty-six inches below the street surface. The concrete was chipped near the top edge (presumably from the first attempt to bore under the street) and another damaged area was noted on a lateral of the conduit (presumably from the second attempt). A hole was found on the lateral side of the conduit where the drill bit pierced the cement and came into contact with the power line. The line was located prior to excavation using the underground metal locating device present on all underground service trucks. (It should be noted that a similar incident occurred in 1983 involving a 110 volt line. No serious injuries occurred.)

Recommendation #1: A thorough survey of the job site should be made prior to any excavation or drilling procedures. This should include locating all underground utilities.

Discussion: An organization exists that provides information to all service utilities that excavation is to occur which may involve their equipment. No excavation or drilling procedures should be initiated unless all utilities have marked their service lines. In addition, the underground metal locating device should be used prior to any excavation or drilling procedure to verify that a clear path exists and that all utilities have been identified. A metal locating device that is easier to operate and that more reliably differentiates underground service lines from miscellaneous metallic substances may improve its acceptability among the crew.

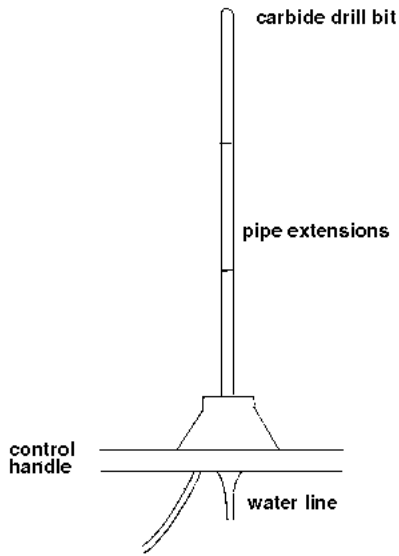
Figure 2. Schematic of Bore Motor

The crew was attempting to bore under the sidewalk and under the street to install a service line. The equipment used to bore this hole was an air driven, water-lubricated, low RPM drill with a carbide bit (see [figure 2](#)

). Pipe extensions are added as required. This equipment is usually operated by two crew members, but is occasionally handled by three when difficulty is encountered. Three attempts to bore a hole under the street were made with the fatality occurring on the third attempt. The first attempt resulted in the drill bit coming up through the street approximately two feet from the hole that exposed the gas main. The second attempt was not successful because resistance was met and the drill could not be advanced. All three crewmen were pushing on the machine during the third attempt because excessive resistance was encountered. A 4160 volt power line, encased in four inches of concrete, was contacted at approximately 2:10 p.m. resulting in one fatality and one serious injury. The third crewman felt a shock in his hands and released the equipment. The crew leader tried to release the equipment and fell to the ground unconscious. He suffered third degree burns on his hands and shoulders. The victim went into convulsions and slumped over the equipment. The victim had burn marks on both hands and the front of his right thigh and was pronounced dead at a local hospital after resuscitation efforts failed.

Recommendation #2: Drilling procedure instructions should be amended to include excavation and exposure of all service utility lines and to excavate and expose all points of resistance.

Discussion: This particular incident involved three attempts. The second attempt was unsuccessful because resistance was met. The third attempt involved three men pushing on the machine. If the point of resistance had been excavated and exposed, the electrical conduit would have been identified. The gas company has implemented this recommendation.
