# 52-Year-Old Electrical Technician Electrocuted in Indiana

FACE 86-41

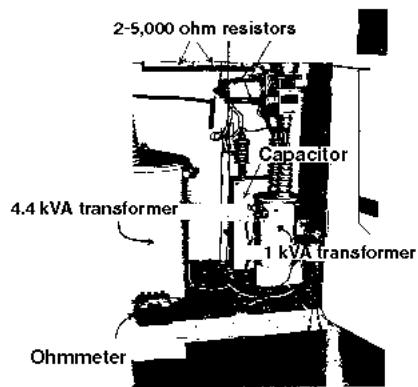
On July 21, 1986, a 52-year-old electrical technician was electrocuted while testing circuits in a metal cabinet housing power transmission and distribution equipment (see [Figure](#)).

While checking out the unit, the victim determined that the rectifiers in the control circuit were shorted. Both rectifiers were replaced and the victim continued to follow the testing procedure check list. At approximately 1:30 p.m. the victim was at the point in the test where he was to measure the resistance of the two 5000 ohm resistors with an ohmmeter. Apparently he reached into the cabinet with his left hand and attempted to remove one of the resistors. When he touched the resistor his body provided a path to ground and he was electrocuted. The victim fell to the concrete floor.

Discussion: The current design of these cabinets does not include (1) a power ON indication for the cabinet, (2) interlock of the access to the cabinet, (3) adequate insulation of the conductors inside the cabinet to safeguard against accidental contact, or (4) appropriate warning signs. Design considerations similar to the above should be incorporated into these cabinets. For instance a power ON indicator could be installed in a conspicuous location, as near as possible to the service entrance of the metal cabinet. The indicator would serve as a reminder that electrical energy is being fed into the cabinet. The victim had repaired many similar pieces of equipment previously and he was considered an experienced electrical technician. The indicator may have alerted him to the fact that the cabinet was energized.

**Figure.** Cabinet Containing Power Transmission and Distribution Equipment Involved in Fatality

**Recommendation #1: The testing procedure and the check list for this task should be re-evaluated. All unnecessary exposure to energized equipment should be eliminated or personal protective equipment should be identified.**

Discussion: The test procedure should be re-evaluated to identify any unnecessary exposure to energized equipment. Engineering controls should be used whenever possible to protect test personnel from inadvertent contact with energized equipment. One design modification that could be used to eliminate/minimize exposure to energized equipment would be the use of a dead-man control. During testing and repair, all electrical energy could be supplied to these cabinets through a dead-man control. This design would require the electrical technician to be away from the cabinet, so that he could not contact energized circuitry. Personal protective equipment should be used during those procedures that require test personnel to be in the cabinet while the equipment is energized.

**Recommendation #4: The design of power transmission and distribution equipment should incorporate safety considerations to protect workers who maintain, repair, and test these cabinets.**
