21-Year-Old Electrocuted While Moving Grain Auger in Indiana

FACE 86-22

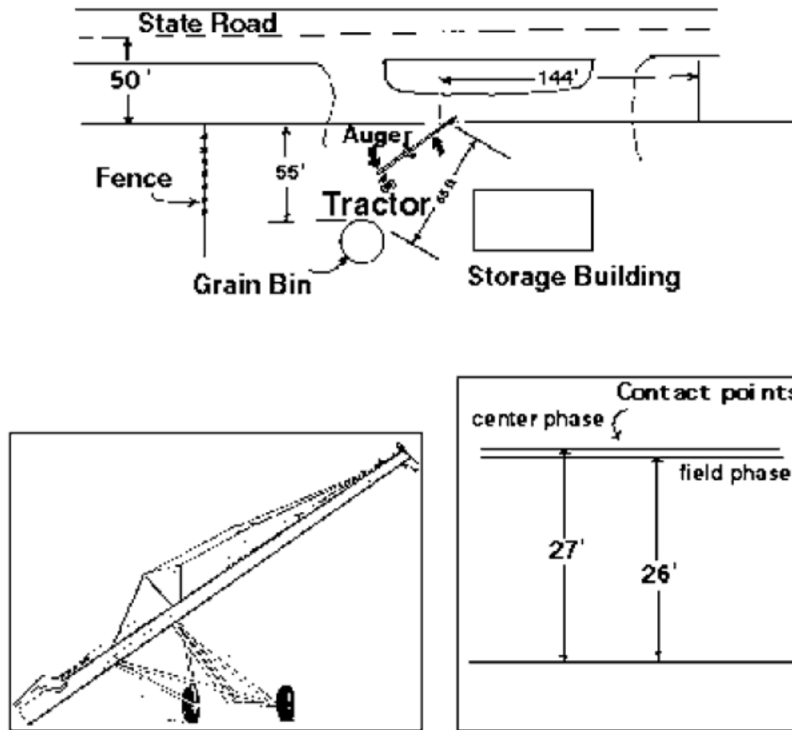
Figure. The Accident Scene

On April 7, 1986, two employees for a local grain company were attempting to move a grain auger when the accident occurred. One worker was using a tractor to pull the auger away from the grain storage bin while the other worker (the victim) was on the ground guiding the auger when it contacted two phases of a 12,470 volt distribution system (see [Figure 1](#)). The worker on the ground was electrocuted.

When the workmen arrived at the site (around 3:00 p.m.), the auger (61' long) was in the loading position (upright) against the grain bin. Both workmen had commented on the overhead power lines when they arrived at the site and were aware of the hazard while moving the auger. To unload the bin, it was necessary to pull the auger away from the grain bin, lower the auger, and turn the auger 180° so the lower end would be at the bottom of the bin. The workmen attempted to pull the auger back by hand but were unsuccessful. Attempts to lower the auger were also unsuccessful, since the auger had been in the upright position for some time and could not be lowered. The workers attached a chain between the tractor and the auger and started to pull the auger back away from the grain bin. The truck driver was operating the tractor, and the warehouseman was on the ground guiding the auger. The chain between the auger and tractor was adjusted and the workmen decided to turn the auger in the upright position. As the tractor pulled the auger back, the warehouseman guided the auger with both hands. The auger contacted two phases of a 12,400 volt distribution system, electrocuting the warehouseman on the ground. The driver on the tractor saw the man on the ground fall, he immediately jumped off of the tractor, and was shocked (briefly stunned) when he hit the ground. The truck driver then flagged down a passing vehicle and requested the driver call for help. The rescue squad arrived shortly thereafter, and the warehouseman was pronounced dead at the scene.

Discussion: Grain augers that are moved to different locations at the plant or off site work locations may present a safety hazard, especially when moved under power lines. Augers should be lowered to a safe transporting position before being moved from one location to another.

Recommendation #3: Employers should affix a safety warning sign to each auger that warns the user – LOWER BEFORE TRANSPORTING, AND LOOK UP FOR OVERHEAD POWER LINES.
