Crew Foreman Dies Due to Electric Arc from Power Line

FACE 85-04

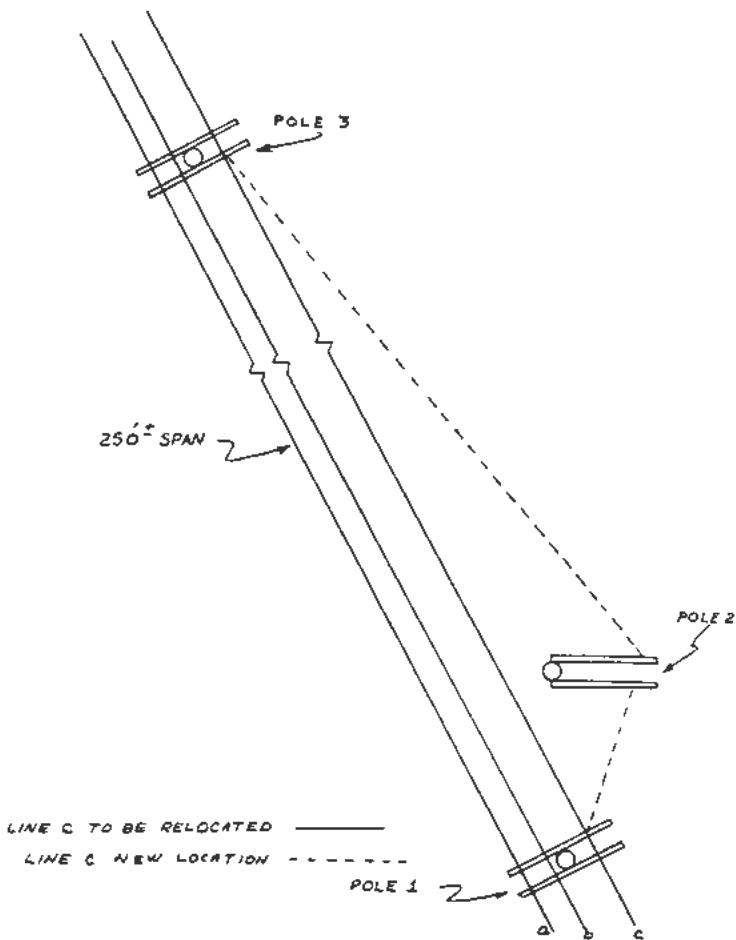
Figure.

The employer had contracted with a local utility company to relay some existing lines and add new wire to the system. On the day of the incident, the crew was in the process of performing this work. Refer to [figure](#) for layout of the incident work site. The existing span, which had to be moved, was between poles numbered 1 and 3. It consisted of three individual 7200 volt AC lines. These three lines had to be cut and moved to form spans 1 to 2 and 2 to 3. The crew had already moved two of the three lines to pole number 2. The victim was working from an aerial lift device while dead-ending the third span

conductor between poles number 1 to 2 (conductor C in [figure](#)). The conductor was attached to the cross arm by a wire grip and come-along. The dead-end of the conductor was to be attached to a dead-end insulator device. However, the conductor was too long for the span and could not be properly attached to the dead-end insulator device, because the wire grip was too close. In the process of correcting this condition, an electric arc occurred which caused the victim's clothing to catch fire. The crew lowered the aerial lift device to its lowest point and had to rig a hoist line to remove the victim to the ground. The victim was transported to a nearby hospital by rescue squad for emergency treatment and was later transferred to a specialized burn center where he expired the following day. The medical examiner's probable cause of death was identified as electrocution and severe burns.

It is concluded that the electric arc occurred while the victim was preparing to move the wire grip on the conductor so the span end could be attached to the dead-end device. The arc occurred as a result of either the victim moving the conductor causing the wire grip clevis to contact the unguarded guy wire or the victim was working between the conductor and guy wire and inadvertently came in contact with both at the same time.
