19-Year-Old Warehouseman Electrocuted by a 440 Volt Trolley Wire in Kentucky

FACE 85-06

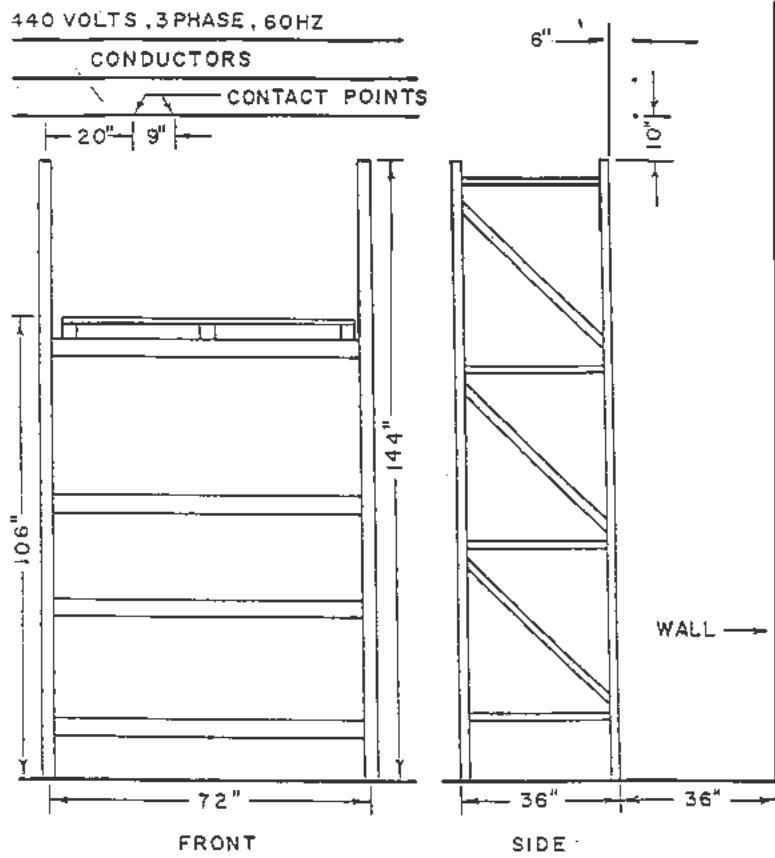
Figure 1.

The storage rack was located along the interior wall of the building beneath the overhead bridge crane track and runway conductors (see [figure](#)). As shown in the [figure](#), the 3-phase, 440 V conductors were within a few inches of the top of the rack. The pallet and rack arrangement was set up so that a forklift could be used to lift and lower a pallet down to ground level, then the overhead crane could be used to lift and carry the part to its destination. On the day of the accident, the forklift was out of propane fuel, thus necessitating the use of the crane to remove the part from the rack. This usage required a worker (the victim) to climb to the top of the rack, attach a chain to the mining auger (after the crane was moved into position) and attach the chain to the crane hook. At the time of the accident, the crane was being operated by the inventory control clerk.

Inspection of the area around the top pallet provided insight about how the accident might have occurred. The victim was in a squatting position facing towards the back of the plant. The victim was looking in the direction of the moving crane, while trying to maintain his balance on the uneven surfaces of the parts on which his feet rested. His right hand was holding a metal brace of the pallet rack. Finger impressions in the dust on the lower runway conductor showed that his left hand made contact with the lowest bare runway conductor. The path of current flow passed through the victim probably through the unpainted metal lip of the brace he held with his right hand.

The contributing factors leading to this electrocution include: a) proximity of the metal pallet rack to bare 440 V conductors; b) lack of visual danger signs in the vicinity of the bare conductors; c) deviation from the usual procedure of using a forklift to move items from the storage rack; and d) insufficient hazard recognition by the victim.

1. The pallet storage rack should be removed from the area of the runway conductors.
2. "Danger Voltage" signs should be placed in vicinity of exposed conductors.
3. Guarding should be installed in areas where close worker access to bare runway conductors is necessary.
4. The company should improve their safety training on hazard recognition and safe work practices.
