# Worker Electrocuted at Power Substation in Howesville, West Virginia

FACE 85-01

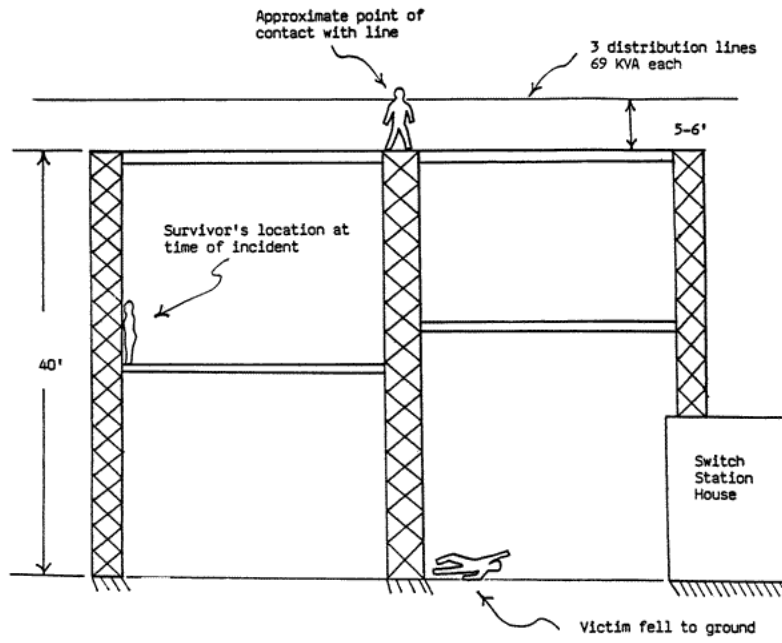
Figure.

The I towers were composed of columns, beams and joists which were bolted together at the connecting joints and also bolted at each column foundation base. (Refer to [Figure](#) for approximate configuration of the towers.) The towers were approximately 40' in height and were located directly beneath three distribution lines. These distribution lines were charged

with a potential of 69 KVA, each. The lines were approximately 6 feet above the tower.

Based upon available information, it is surmised that the victim climbed from the column onto the top tower beam. He did this so he could walk over to help his brother remove the remaining bolts from that column. As the victim raised up into a standing position he either came in contact with or in near proximity to (approximately 1 inch)<sup>1</sup> the live 69 KVA line which was directly above the beam. This permitted sufficient electrical current to flow through his body to electrocute him.

The tower was immediately under three high voltage power lines which had not been moved when the substation was deactivated. The close proximity of the energized power lines to the tower (51-61) presented a reasonably foreseeable risk of contact when dismantling the tower.
