Transportation Employee Dies from Electrical Injuries Resulting from Contact with Overhead Powerline

FACE 85-03

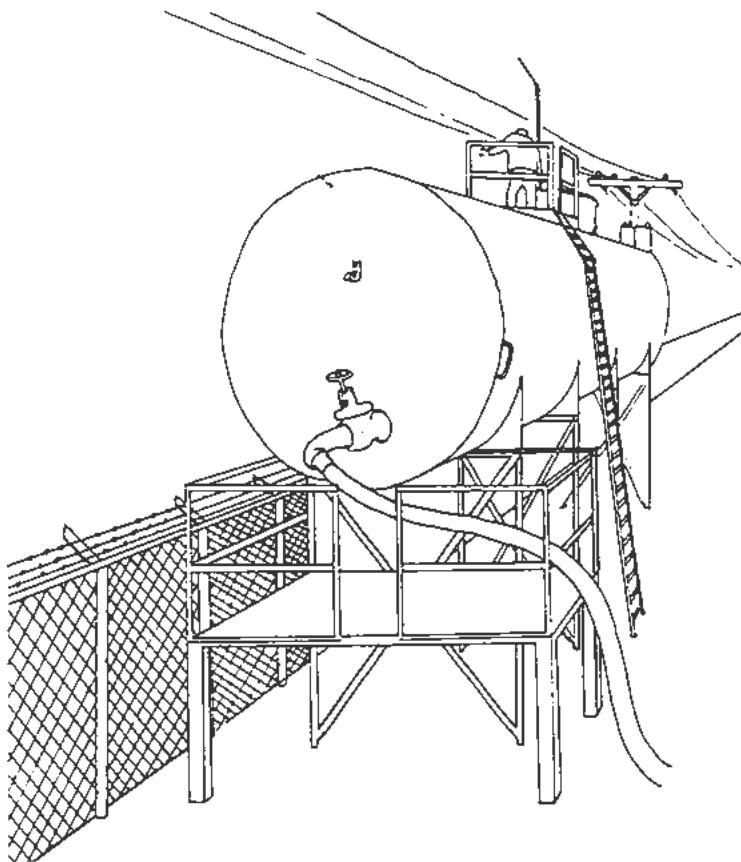
Figure. Configuration of Accident Site

The victim climbed to the top of the tank while the inmate worker stayed on the ground and watched. With his back against the platform railing such that he faced away from the powerline, he pulled the rod (measuring 12' 8" long) out of the tank. As the bottom end exited the tank, the top end apparently swung in a downward motion and the rod contacted the closest of the three overhead powerlines, which was approximately seven feet away.

The most probable path of the electrical current was from the rod to the victim's hands, through his body, out his knees and back, to the platform's ladder and then to ground. Various factors contributed to the occurrence of this fatal accident. Some of these factors are:

1. The location of the tank in close proximity to the proximal overhead powerline. The horizontal distance between the closest part of the work platform and the proximal powerline may have been as little as seven feet.

2. The elevation of tank. The tank was elevated in order to allow gravity to cause asphalt to flow out of the bottom of the tank. However, in cold weather, the viscosity of the asphalt increased such that use of an external pump was necessary to remove asphalt. The continuous availability of a pump circumvents the need for the tank being elevated so high. The work platform on top of the tank was approximately 18 feet off the ground. Given an approximate shoulder height of 51 for most workers, this elevation places a diagonal distance of approximately 7-9 feet between the powerline and worker. The length of the measuring rod was 12' 8".

After the accident, the highway maintenance engineer-supervisor had the tank moved approximately 33 feet from the powerlines. He stated that there were intentions to move the tank before the accident so that a berm could be placed around the tank, in order to contain any spillage. According to the supervisor, the fatal accident expedited the tank being moved but it was not the primary reason.
