The National Institute for Occupational Safety and Health (NIOSH)

Contract Worker Electrocuted While Repairing 13.2 KV Power Line in North Carolina

FACE 85-25

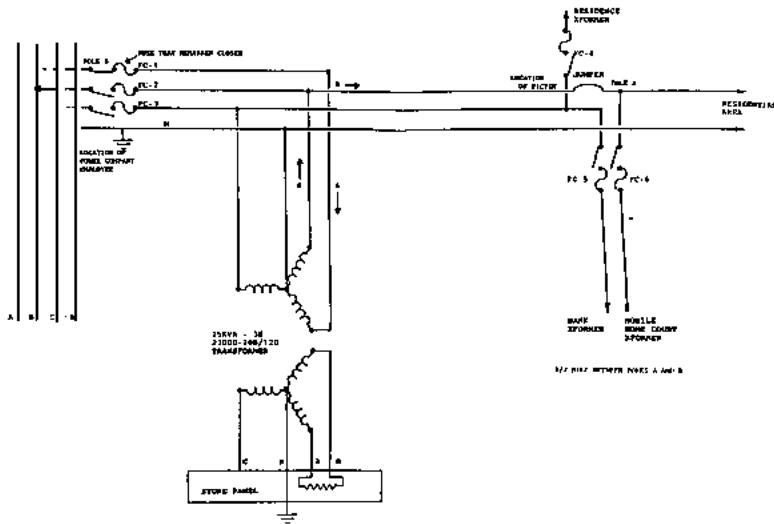
Drawing 1.

High winds and severe thunderstorms in this area on June 5, 1985, severely damaged overhead, high voltage power lines. At approximately 11:00 p.m., the line service supervisor of the local power company requested that an electrical construction company supply a crew to help repair the damage. A foreman and three crewmen were assigned this task. The crew arrived with an aerial bucket truck at the work site at approximately 4:00 a.m. on June 6, 1985. A power company official instructed the crew to replace, a pole insulator and a 13.2 kV power line, which had been "downed" by a fallen tree. In order to restore service to as many customers as possible, the power company had previously isolated the "downed" line by cutting the pole jumper on line B of pole A (see [drawing #1](#)). Service was then restored to all customers up to the pole jumper that had been cut.

The electrical flow and circuitry that resulted in the electrocution of the lineman is illustrated in drawing #1. When the power line and the insulator had been replaced, the victim, a first-class lineman with twenty years of experience, was instructed by the superintendent to open the last of three fused disconnects (FC-6) on pole A, where the jumper splice was to be made. (Two other fused disconnects (FC-4, FC-5) on pole A were opened by a power company worker before the crew arrived at the accident site.)

While the victim was opening the fused disconnects on pole A, a power company worker was replacing fuses (damaged during the storm) in two of the three fused disconnects (M-2, FC-3) on pole B. Pole B was located approximately one-half mile to the south of pole A. These three lines fed a bank of three transformers (illustrated by the windings in [drawing #1](#)) that supplied power to a general store. The superintendent then left his crew and traveled to pole B to inform the power company worker that preparations to make the jumper splice were complete, and the fused" disconnects (F-1, F-2, F-3) on pole B could be opened in order to de-energize the entire line. The power company worker then opened the fused disconnects (FC-2, FC-3) in lines B and C in which the fuses had been replaced. He did not open the fused disconnect (M-1) for line A. Voltage from line A then fed through the line transformer and the store's electrical system to line B, the line on which the splice was to be made. Although the exact voltage could not be determined, power company representatives estimated that the voltage on this line ranged from 4000 V to 7500 V. When informed that the line was de-energized, the superintendent contacted his foreman by truck radio and instructed him to make the splice, but to "buzz" (test) the line first to ensure that it was de-energized. Buzzing a line is a standard practice to test for the presence of high voltage in power lines; however, it could not detect the lower voltage level present in this line. The victim buzzed the line by touching it with pliers he held in his gloved hand. When the victim did not see an arc or hear a buzzing sound, he apparently removed his glove and began to splice the jumper wire. He inserted the supply side of the jumper wire into the splice tube and crimped it. When he grasped the load side of the jumper wire, he completed an electrical circuit between the supply and load sides of the jumper causing the current to pass through his arms and chest. A crewman heard the victim groan and saw his hard hat fall to the ground. The crewman lowered the aerial bucket using controls on the truck, removed the victim from the aerial bucket, and began to administer CPR. The foreman contacted the superintendent on the truck radio and told him to summon the rescue squad. The rescue squad arrived at approximately 4:30 a.m. and transported the victim to a local hospital, where he was pronounced dead on arrival. The splice was later completed by another crewman, after a power company worker de-energized the line by opening the third fused disconnect.

Recommendation #1: Employers should provide linemen with equipment and procedures to address all magnitudes of voltages to which they may be exposed.

Discussion: To "buzz" a power line to determine if high voltage is present is a standard procedure followed by linemen. However, the "buzz" method did not detect the lower voltages present. Procedures to perform a dual voltage check should be established. Once it is determined by the "buzz" method that high voltage is not present, a low voltage testing device (such as the glowing neon type or the light emitting diode type) should be used to determine if a lower range of voltage is present. The use of a low voltage testing device in this case may have prevented this accident and the establishment of procedures for a complete voltage check may prevent future accidents.

Recommendation #2: During training programs for linemen, employers should emphasize proper procedures for working with multiphase distribution systems and also the hazards associated with these systems.

Discussion: Training programs for linemen should include basic electrical theory sessions that address multiphase distribution systems including the identification, evaluation, and control of the hazards associated with these systems. Due to the possibility that any one phase can serve as the supply for the transformer, the only absolutely safe way to de-energize a three-phase system is to open the fused disconnects in all three phases. Only two of the three fused disconnects were opened in this case. The closed disconnect on the third phase allowed the other two phases to remain energized.
