REPORT#: 22KY096

REPORT DATE: 02/02/2023

Roofing Contractor Dies after Falling through Skylight

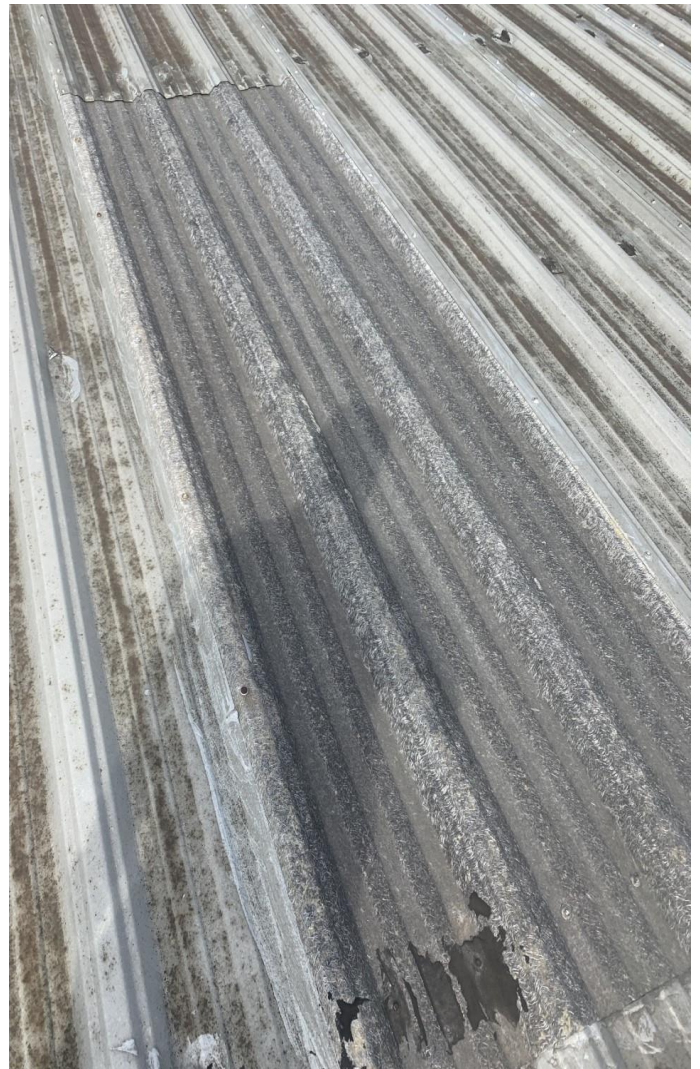
Photo 2. Photo showing 1 of 30 fiberglass skylights present on top of the building where the incident occurred (photo taken prior to incident).

Recommendation #2: Employers should guard skylights with railings or a skylight screen.

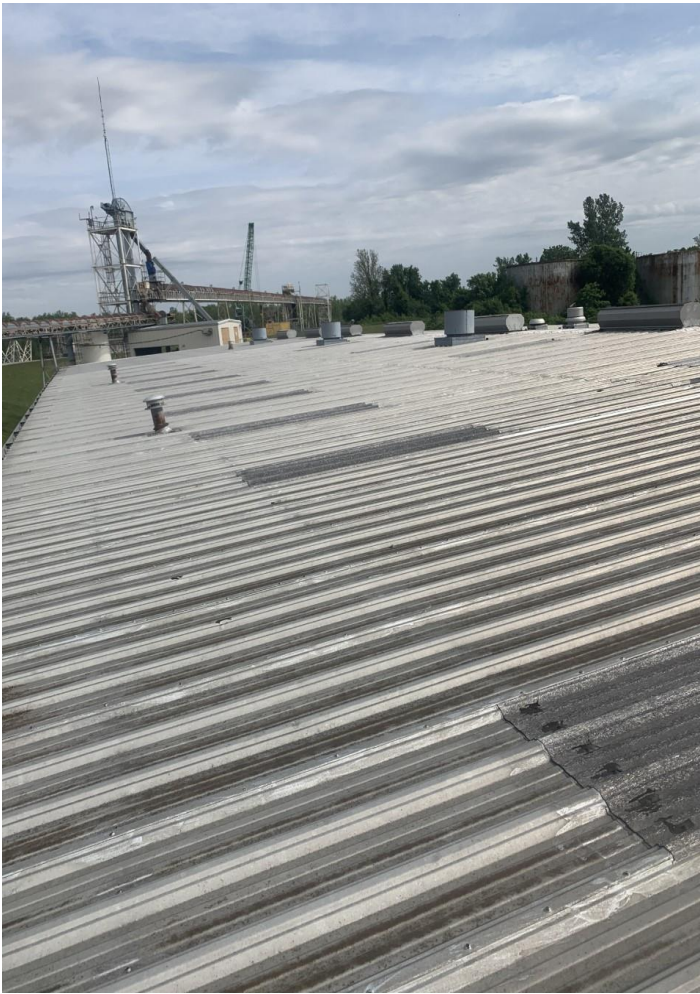
Photo 3. Photo showing fiberglass skylight arrangement and roof of the building where the incident occurred (photo taken prior to incident).

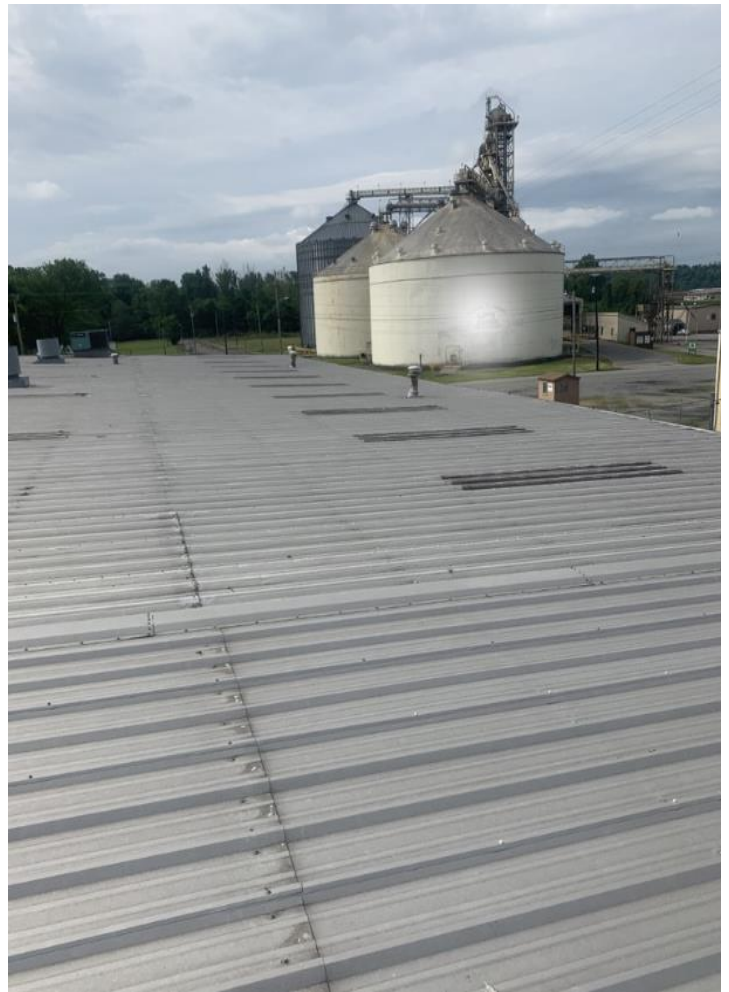
Photo 4. Photo showing fiberglass skylight arrangement and roof of the building where the incident occurred (photo taken prior to incident).

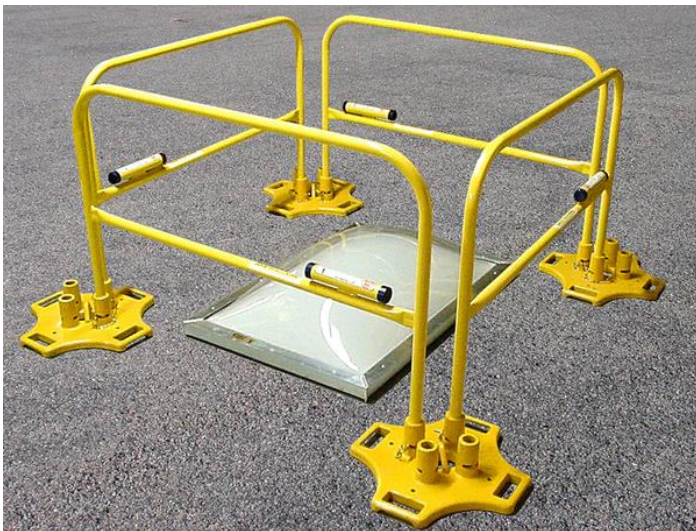
Photo 6. Photo depicting a skylight rail guarding system.⁶

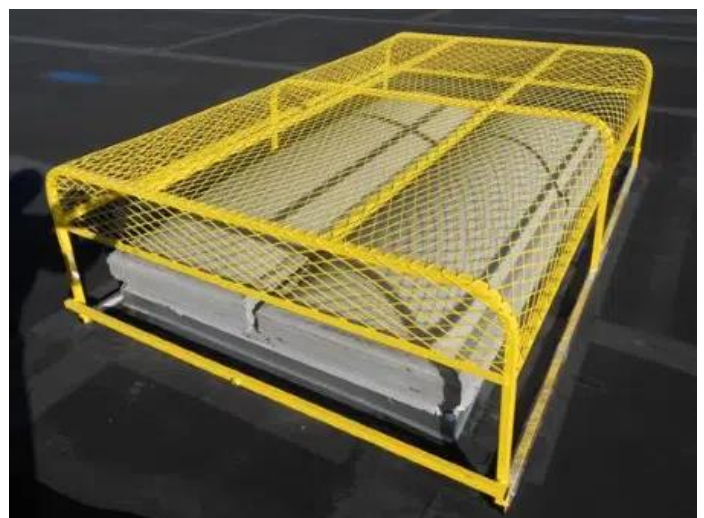
Photo 7. Photo depicting a skylight screen.⁷
