REPORT#: 22KY083

REPORT DATE: March 28, 2023

Equipment operator crushed by skid-steer attachment—Kentucky

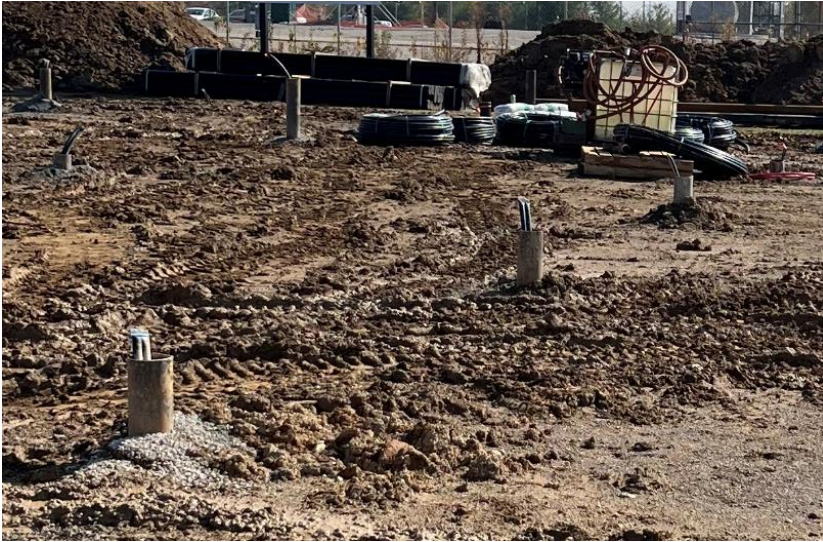
A geothermal system was being installed in a field adjacent to a larger construction project. The process involved drilling holes into the ground vertically, installing a pipe into each hole, and installing a water line into each open pipe. Pipes were then filled with gravel from a gravel bucket carried by a skid-steer. The work area, with several pipes filled with gravel, are shown in Photo 1.

Photo 1. Geothermal system pipes (Property of KY FACE)

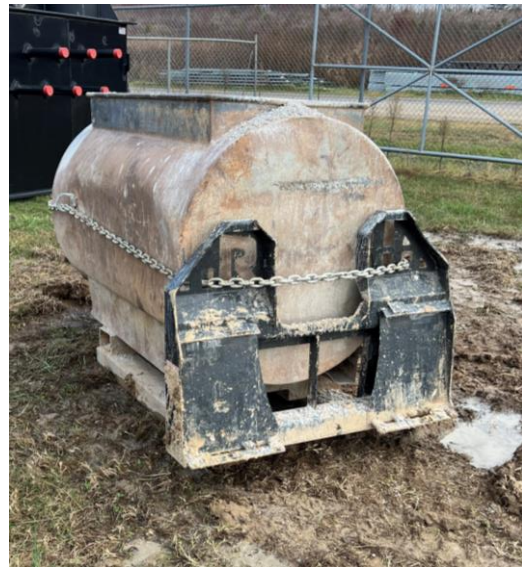
The gravel bucket involved in the incident was secured to a twin-fork attachment of the skid-steer through fork slots and chain was used to provide additional stability. Gravel buckets similar to those involved in the incident are shown in Photo 2, and a gravel bucket secured to a twin-forks attachment in a configuration similar to the one involved in the incident is shown in Photo 3. The combined weight of the attachment, bucket, and gravel involved in this incident are estimated to be 2,000 pounds [[EPA, 2016](#)].

Photo 3. Twin-forks attachment with gravel bucket (Property of KY FACE)

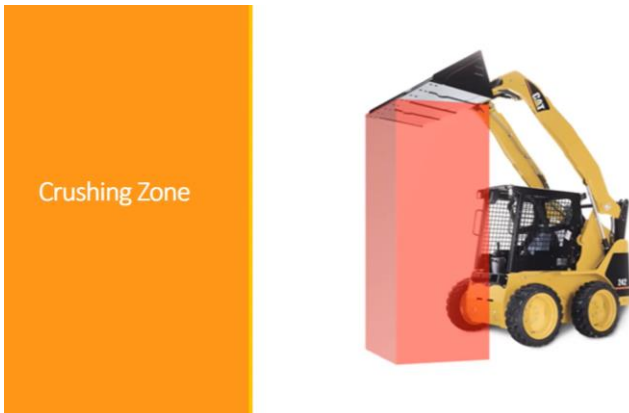
The operator was struck by the twin-forks attachment and bucket because he was located in the *crushing zone* when the twin-forks attachment separated from the lift arms. The crushing zone is illustrated in red in Diagram A.

Diagram A. Crushing Zone (KYSAFE [n.d.]. [Hazard Alert: Skid-Steer Loader video](#)).

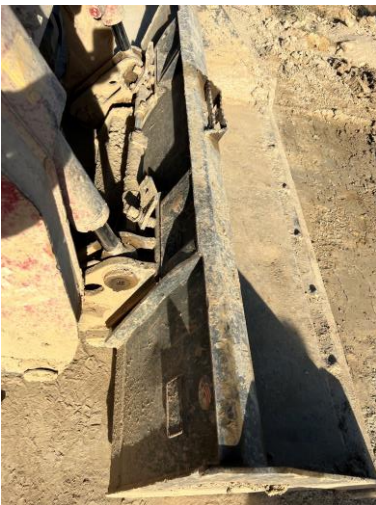
The skid-steer was designed to accept a variety of attachments. The twin-forks attachment involved in the incident secured to the skid-steer using a *quick hitch* built into the skid-steer's lift arms that inserted into slots on the twin-forks attachment. Once the quick hitch was inserted, two locking pins on the quick hitch were engaged to fully secure the attachment to the lift arms. A scoop attachment, which is attached to the lift arms in a similar fashion as the twin-fork attachment involved in the incident, is shown in Photo 6. The locking pins are detailed in Photos 7 and 8.

Photo 6. Skid-steer with scoop attachment (Courtesy of KY FACE).

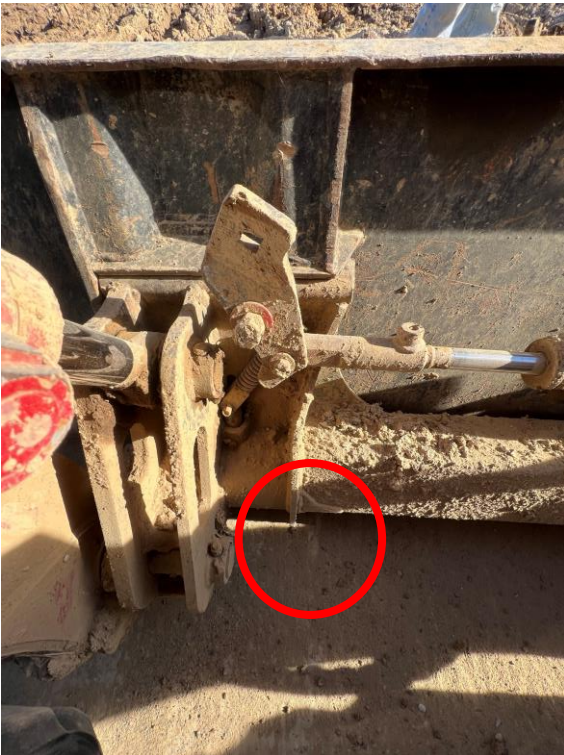
Photo 7. Skid-steer locking pin (Courtesy of KY FACE).

Employee interviews indicated that an equipment malfunction had likely occurred such that one or both of the two locking pins that secured the forks onto the arms of the skid-steer were not properly in place. Interviewees speculated that the presence of mud, rock, and other debris may have prevented the pin(s) from being securely locked into place. A visual inspection of the equipment, after coupling the attachment to the lift-arm, is necessary to ensure that the pins are properly secured in place.

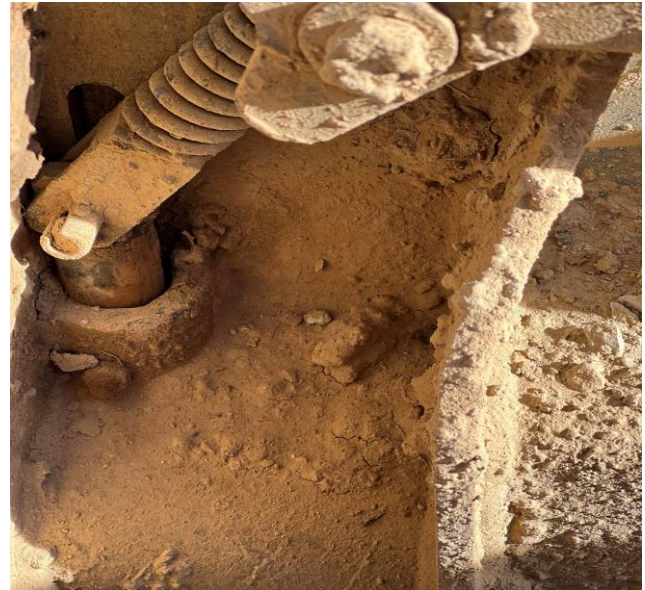
Photo 8. Detail of locking pin (Courtesy of KY FACE).
