REPORT DATE: March 15, 2023

REPORT#: 22CA002

Warehouse Worker Dies When Material Falling Off of Pallet Strikes Him — California

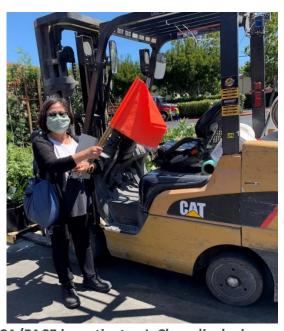
Exhibit 1. CA/FACE investigator J. Chan displaying spotter flags. in front of the CAT® forklift used in the incident. Photo by CA/FACE program.

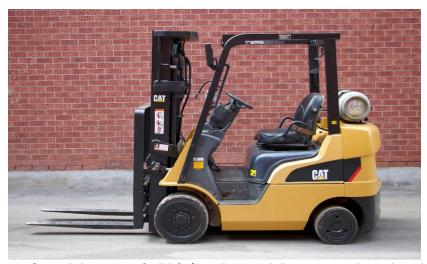
The primary piece of equipment involved with this incident was a CAT® model 2C6000 forklift (Exhibit 2). The forklift is a relatively small indoor/outdoor, liquid propane fueled forklift that has a lifting capacity of about 6000 pounds and weighs about 9,440 pounds. Safety features include overhead guards (to protect the driver from falling objects), side/rearview mirrors, a backup alarm, strobe lights and a loud, audible horn.

Exhibit 2. A CAT® model 2C6000 forklift (similar model, not actual used in the incident).

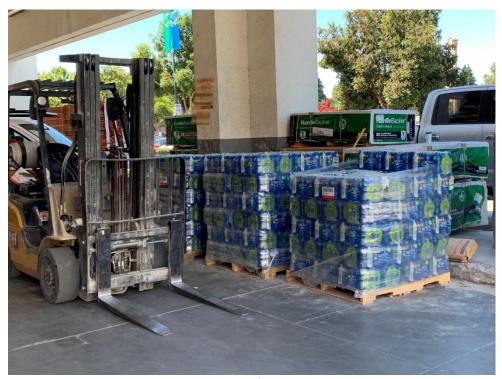
backwards slightly and causing it to tilt at a slight angle. The cased water on the top pallet further shifted against the shrink wrap, which gave way and dumped the entire pallet of cased water on the victim.

Exhibit 3. Incident location with CAT® forklift (similar model, not actual used in incident) and pallets of product identical to those that struck the victim. Photo by CA/FACE program.

In this incident, the forklift's forks were placed under the top pallet which created a tilted, unstable load. If a method had been used to manually break down the unbalanced/unstable pallet, this death could have been prevented.

Recommendation #5: Employers with retail warehouse operations should include a method for correcting (manually breaking down and restacking merchandise on) unstable or unbalanced pallets in their Standard Operating Procedures (SOP).
