**REPORT#:** 21CA004

**REPORT DATE:** January 5, 2022

## Construction Laborer Died When Struck by an Excavator Bucket that Detached from a Quick Coupler — California

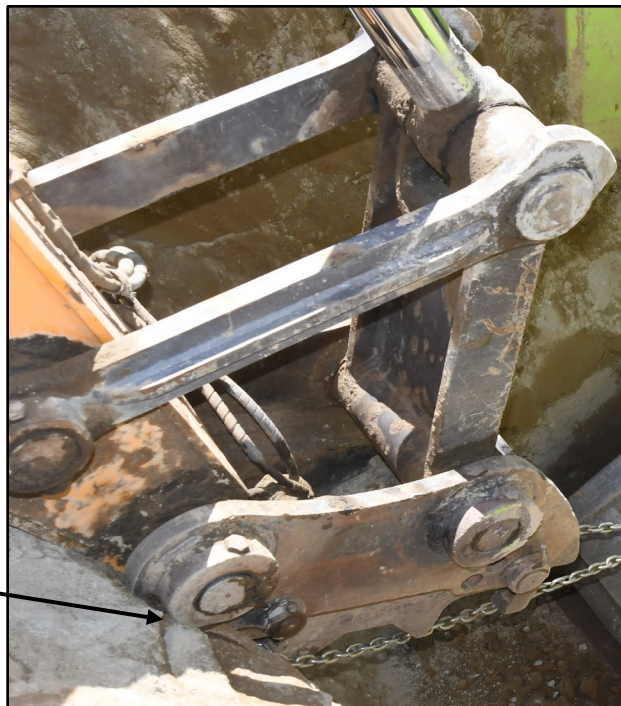
Quick coupler

*Exhibit 2. A close-up of the quick coupler in this incident. Photo courtesy of police department.*

Discussion: In this incident, the bucket released unexpectedly from the quick coupler when it was being lowered into the trench. It is unknown if the operator performed an inspection of the quick coupler prior to use. To prevent injuries or fatalities from excavators with quick coupler devices, employers should:

- Ensure that machine operators always perform [pre- and post-operation inspections](#) on the excavator
- Adhere to regular maintenance of the quick coupler device according to manufacturer guidelines
- Train workers in the proper use of quick couplers, including making visual inspections,

- proper procedures for engaging attachments, and methods for testing connections
- Prior to using an attachment, ensure the operator performs a connection test as specified by the manufacturer

- Ensure that the quick coupler is properly engaged by using approved safety checks, visual indicators, and/or warning devices. If required by the manufacturer, the safety locking pin must be in place prior to lifting the attachment off the ground

- Use only manufacturer-approved and compatible attachments
  - Install retrofit safety kits on older quick coupler devices or upgrade to newer quick couplers with built-in safety mechanisms. Human detection systems may also be available in some newer excavators to prevent contact with a worker who is within the swing radius

- Never operate an excavator that has signs of damaged components, malfunctioning controls, faulty safety features, or other problems

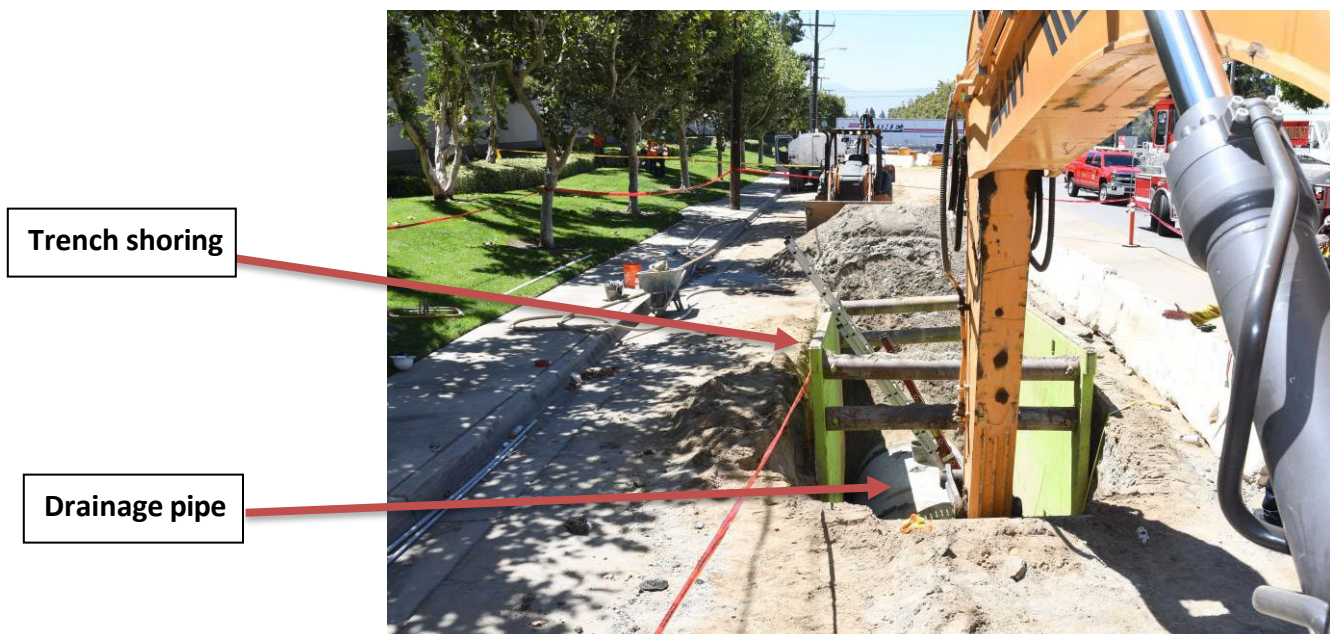
The incident scene was a residential street construction site in southern California (Exhibit 3). The company was installing an underground storm drainage system that expanded the existing system. The installation had been underway at this site for two weeks. The concrete lined drainage pipes were 8 feet long with a diameter of 60 inches. The trench was approximately 20 feet deep, and 5 feet wide. The length of the open trench was just enough to accommodate one piece of pipe at a time, and it was equipped with shoring to prevent the sides of the trench from caving in.

Exhibit 3. The Incident scene. Photo courtesy of police department

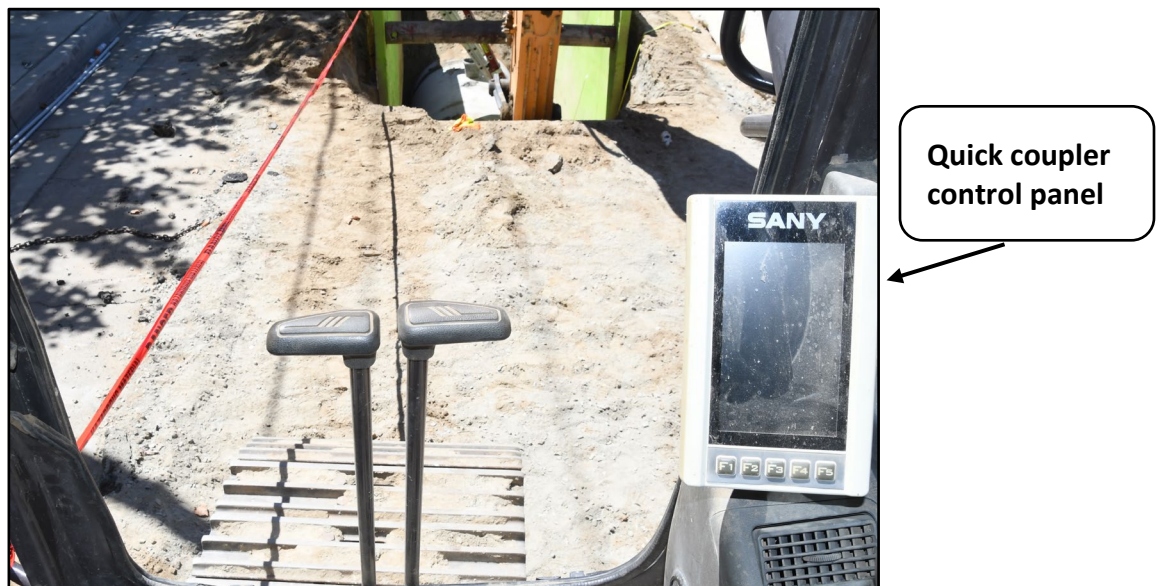
excavator operator where to position the boom before lowering the pipe into the trench. After the excavator operator dug a portion of the trench with the bucket, he swung the boom off to the side of the trench and pushed a button on a control panel (Exhibit 4) to disconnect the bucket that was attached to the quick coupler.

*Exhibit 4. The control panel used to operate the quick disconnect. Photo courtesy of police department.*

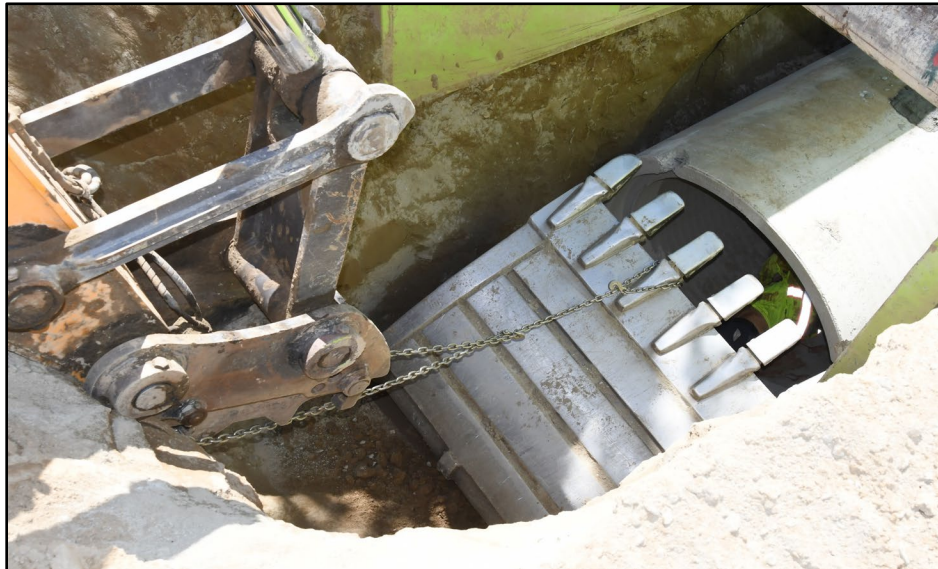
*Exhibit 5. View into the trench where the victim was standing and where the bucket detached from the quick coupler. Photo courtesy of police department.*

Discussion: In this incident, the victim was in the trench below the excavator boom swing radius when the bucket detached from the quick coupler. All heavy equipment poses serious, even potentially fatal, risks to operators and workers in the vicinity. If a load falls, either from improper attachment of a quick coupler device or a mechanical failure, death or serious injury can occur.

When employees are required to work in trenches deeper than five feet, a competent person is required by OSHA to be onsite to perform the necessary daily inspections of excavations, and the precautions that are necessary and required. A Job Hazard Analysis (JHA) can prevent work-related injuries or illnesses by eliminating or controlling identified hazards. It is a means to ensure that workers have the training, equipment, and supplies to do their jobs safely. On the day of the incident, the excavator operator was the competent person onsite. It is not known if the operator performed a JHA that day or held a tailgate safety meeting that morning with the crew to discuss and new hazards and/or to remind them of the safety precautions required during operation of the excavator. It is also not known if the victim or spotter had received specific training about working below an elevated load while the excavator was in operation. It is also unknown if the excavator operator or the spotter were aware that the victim was standing in the trench when the bucket was swung over the work area. If all the workers involved in the excavation and trenching had received task specific training, had a reliable communication system between the operator and ground crew to confirm and convey the location of the victim, this incident may have been prevented.

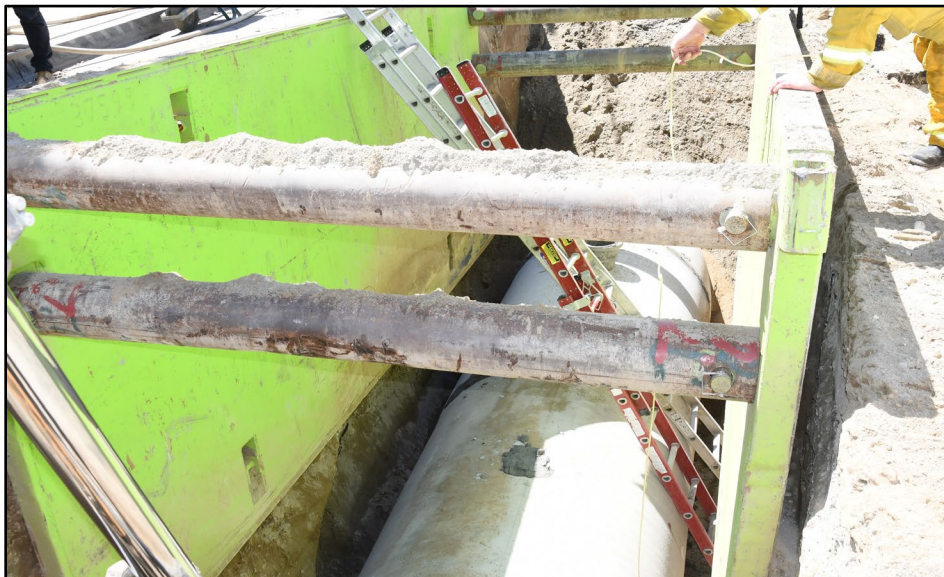
*Exhibit 5. The ladder the victim was going to use to exit the trench. Photo courtesy of police department.*
