REPORT#: 52-54-2023

REPORT DATE: February 6, 2023

Family Dairy Farm Worker Dies When Tractor Rolls Down Embankment

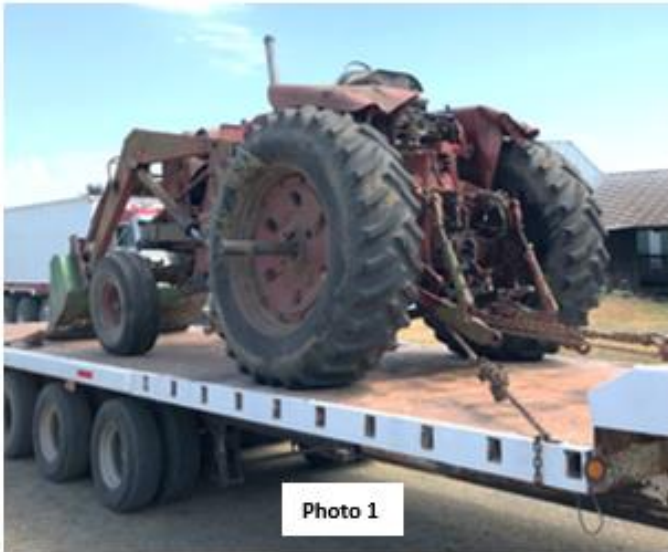
The incident involved this 1971 International Harvester 1066 open-cab row-crop tractor.

Photo 1: Tractor left rear side profile with 3-point hitch and fenders damaged by rollover.

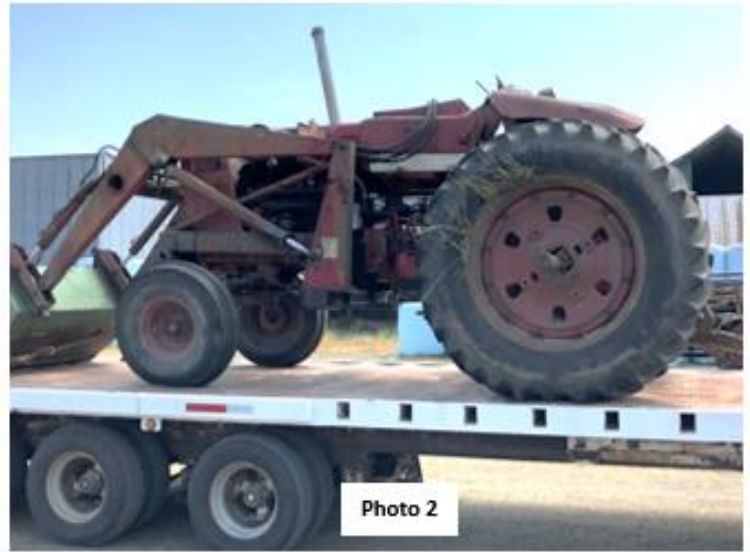
Photo 2: Tractor left front side profile.

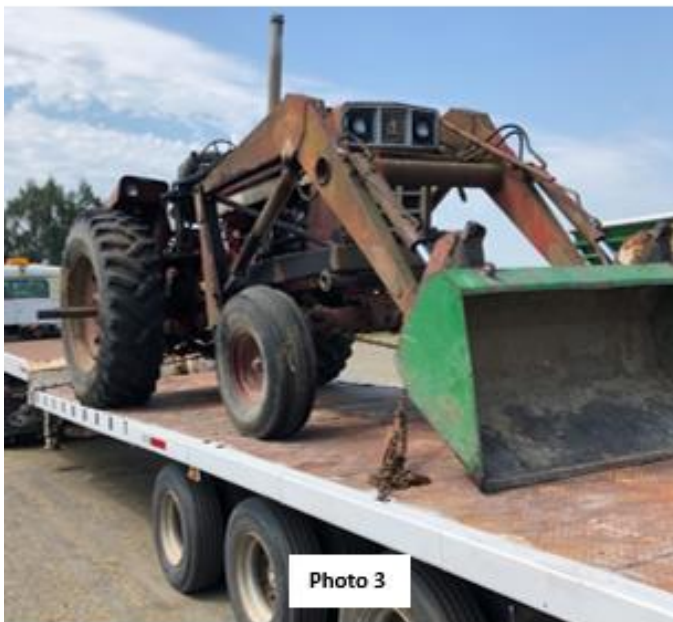
Photo 3: Tractor right side profile with Westendorf WL-42 front-end loader.

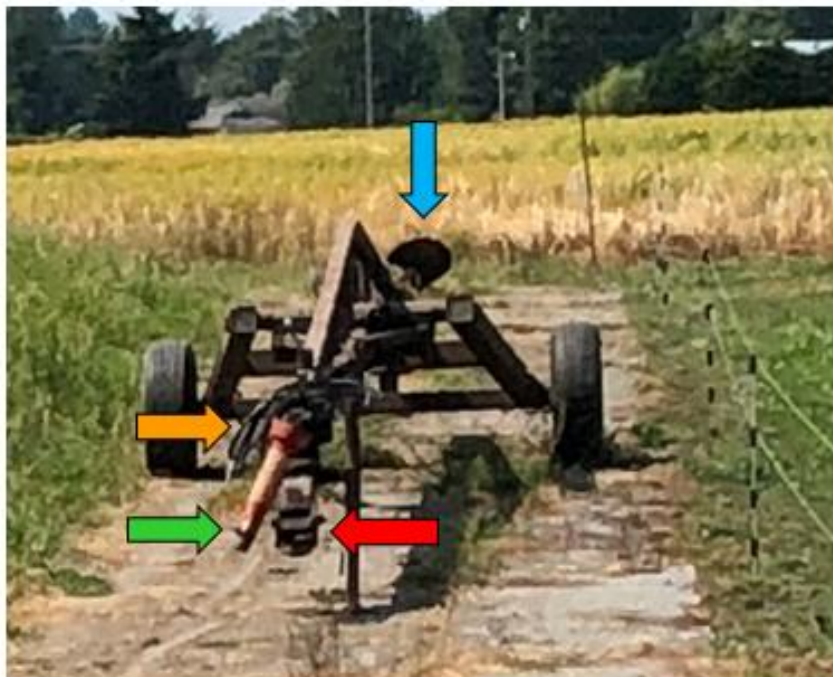
When the incident occurred, the tractor was towing a 25-plus-foot steel, single-axle manure lagoon pump trailer (Photo 4). The trailer was coupled to the tractor's drawbar. The trailer had an impeller at the end to agitate water and cow waste solids stored in the farm's manure pond. The homogenized mixture was pumped out of the pond as soil fertilizer through discharge pipes to an irrigation gun in nearby feed crop fields.

Photo 4: Manure pond pump trailer after incident. Red arrow shows tongue. Green arrow shows PTO shaft. Blue arrow shows pump impeller. Orange arrow shows hydraulic hoses.

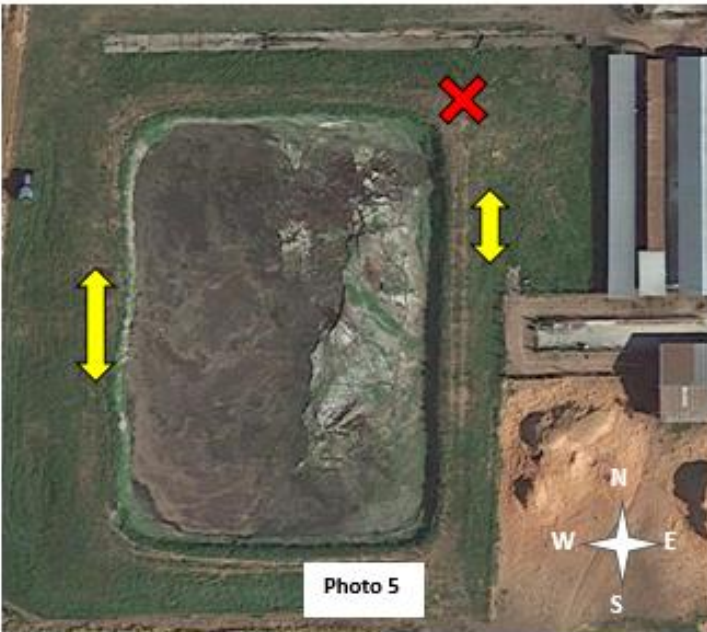
The incident happened at the northeast corner of the earthen embankment that surrounded the dairy farm’s manure pond, where cow waste solids were stored for future use as soil fertilizer. The rectangular pond was around 130 feet wide and 260 feet long. On the elevated crest of the embankment was a narrow, bumpy, rutted dirt track road (Photos 5-6). The embankment had a 25-degree outer slope covered with tall grass (Photo 7). A dirt road from an area of farm buildings extended west across the pond’s north side and ended near its northwest corner. The pond area was dark when the incident occurred, and the only light came from the tractor and farm buildings east of the pond.

Photo 5: Aerial view of the rectangular manure pond where incident occurred. Red X shows tractor rollover location. Yellow arrows indicate the uneven, rutted, dirt track road on the elevated crest of the pond’s earthen embankment. The pond area was dark, and the embankment road had no lighting system, hazard signs, or reflective markers. Photo courtesy of ESRI.

Recommendation #3: Improve tractor safety on embankments by inspecting and maintaining roads and slopes, installing lights, and marking edges of roads with visual cues, such as reflective driveway stakes.

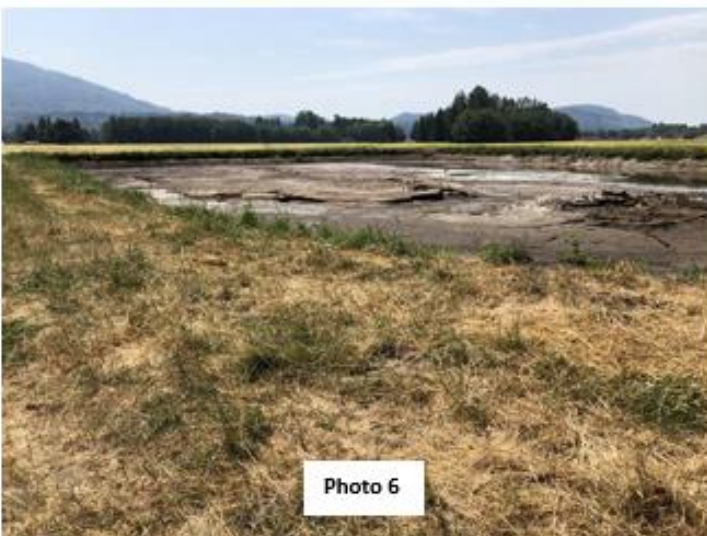
Photo 6: Southwest view of manure pond from crest of embankment.

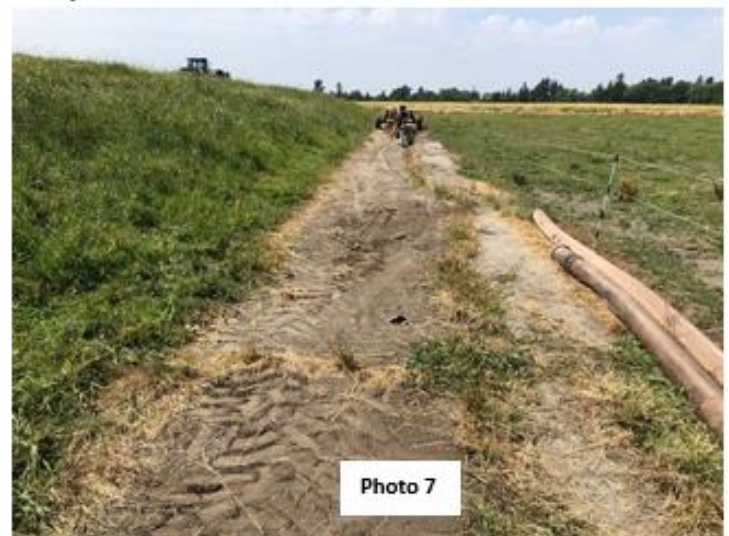
Photo 7: North side of embankment with 25-degree slope. Manure lagoon pump trailer and discharge pipes are visible in the road below the slope.

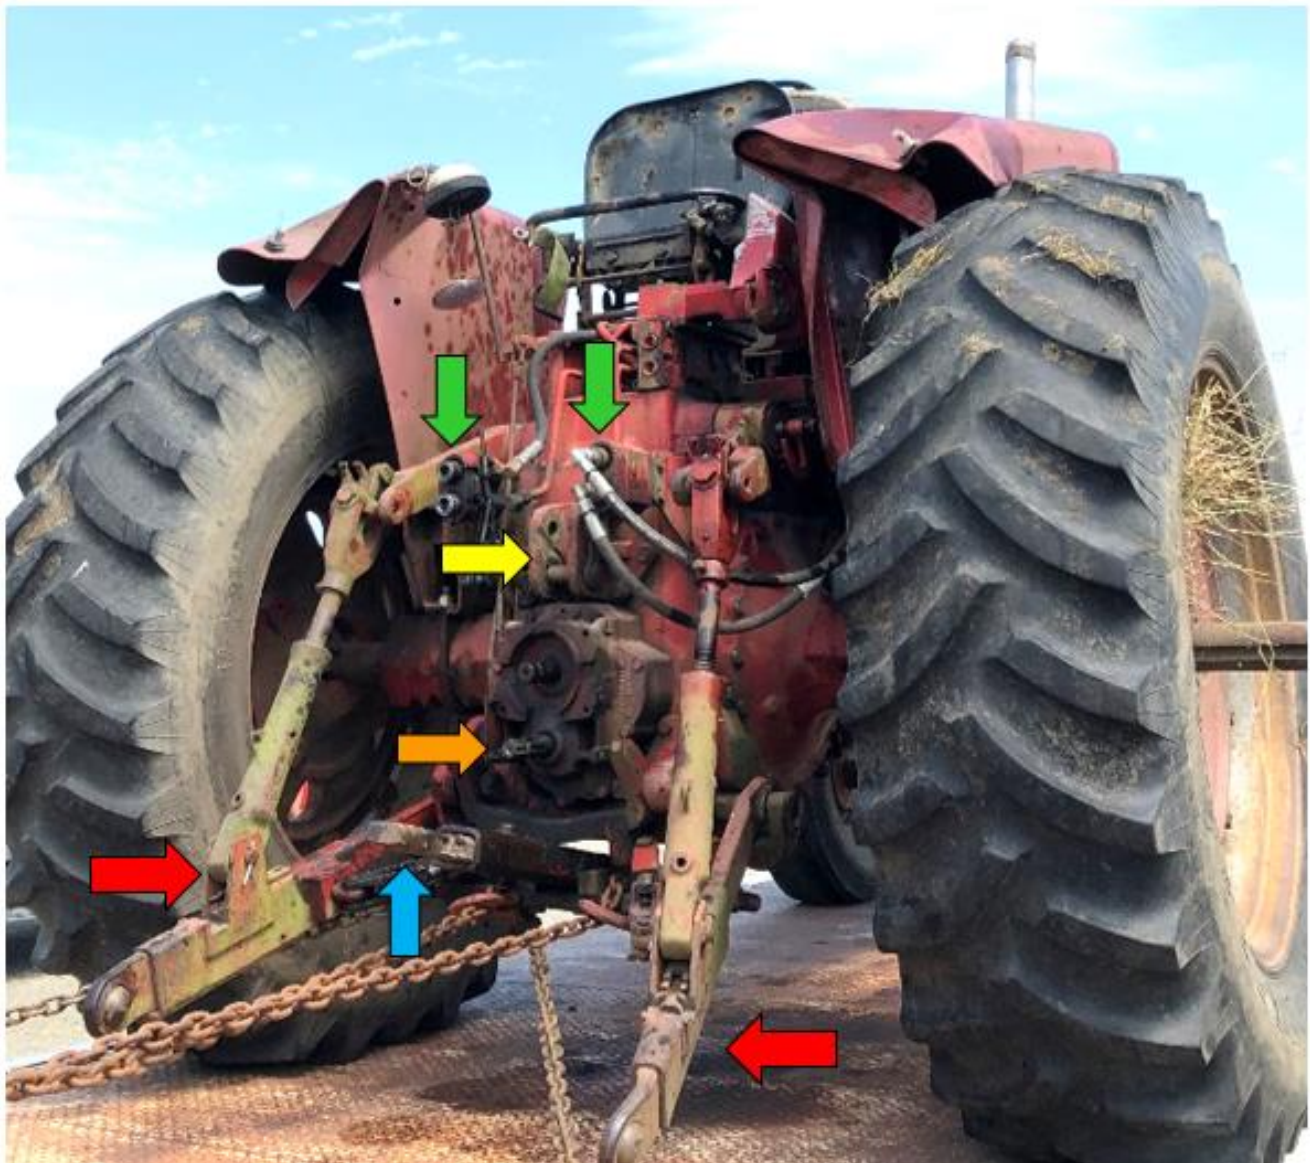
Photo 8: Image of rear of incident tractor. Red arrows point to 3-point hitch lower link arms. Yellow arrow shows hitch's top link arm bracket with arm removed. Blue arrow points to straight drawbar. Orange arrow points to PTO drive shaft. Green arrows indicate hydraulic fluid outlets where right side with hoses powered front-end loader and left side without hoses powered manure lagoon pump trailer.

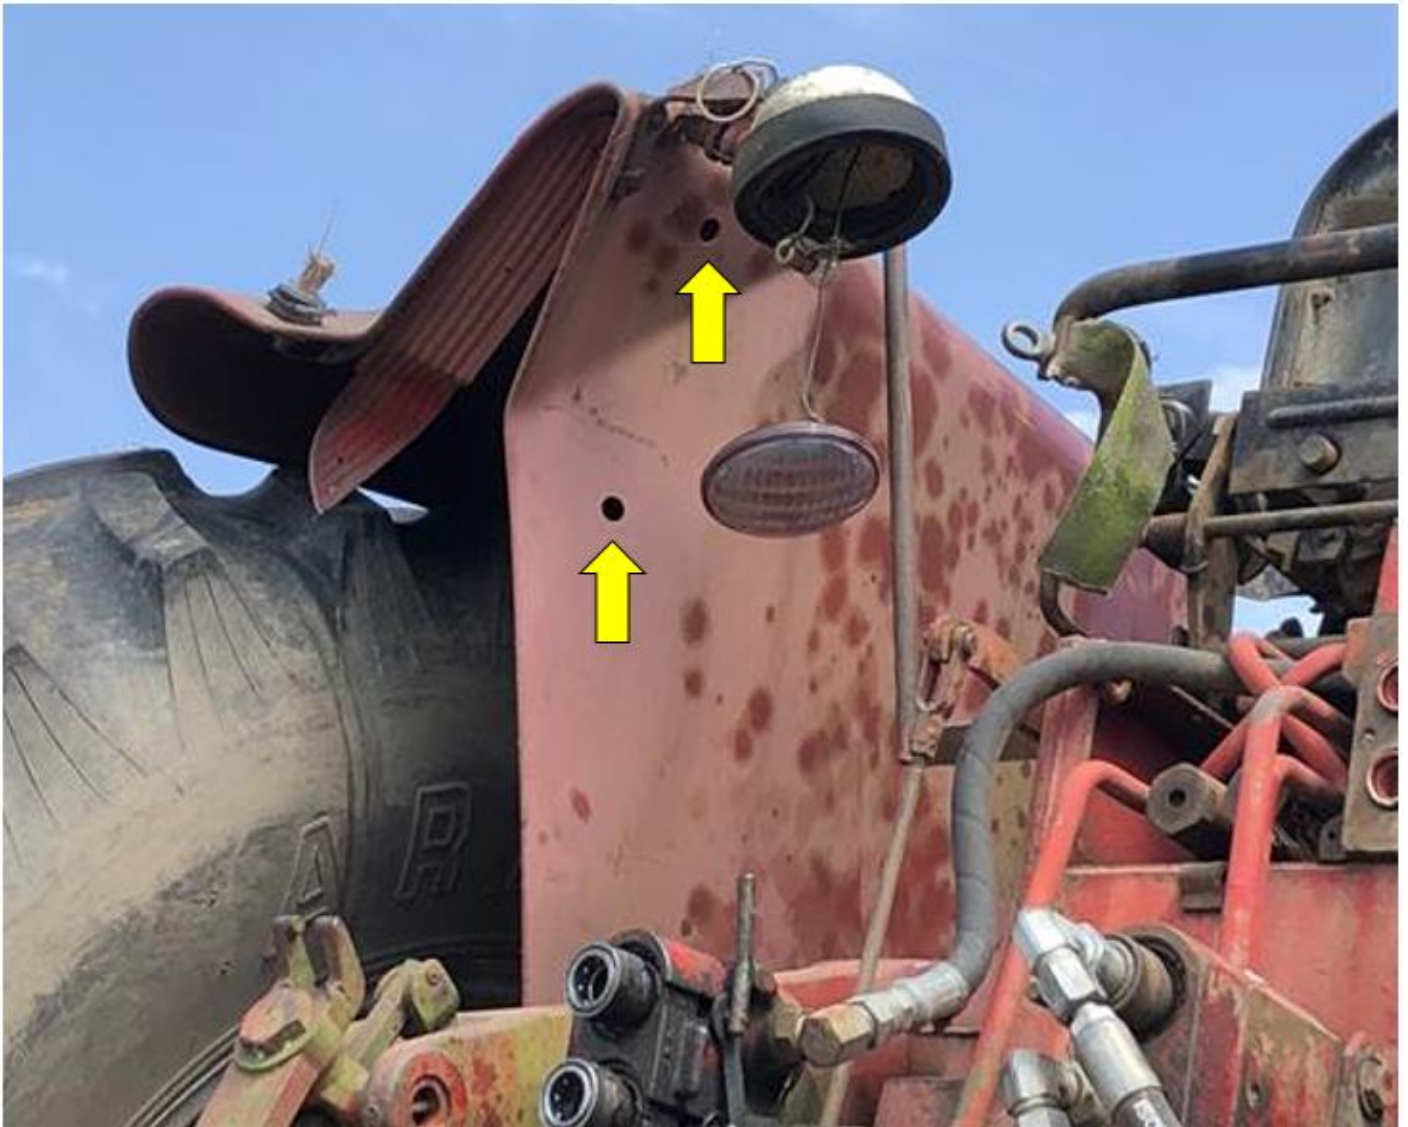
Investigators found the worker was operating the nearly 50-year-old tractor without ROPS and a seat belt installed. The employer purchased the tractor at an auction in 2019 as a training tractor for the deceased worker's son. He began using it two days earlier as a backup tractor when the employer's primary tractor had developed engine problems. It is unknown if the worker was trained to use the incident tractor though he expressed a dislike for it to relatives. The compliance safety and health officer (CSHO) was informed by farm machinery experts that when the 1971 tractor was sold new, ROPS or a ROPS-certified cab were optional from the manufacturer (Photo 9). At that time, standard equipment would have been an open-cab tractor without ROPS. Aftermarket certified ROPS and seatbelt were available to be purchased for the tractor.

Photo 9: Arrows point to manufacturer-made openings to accommodate ROPS installation on incident tractor. During ROPS installation, the fenders are removed, the ROPS is mounted to the axle housing, and the fenders are secured to the ROPS using the holes. Washington State agriculture workplace safety rules require ROPS for pre-1976 tractors that were built or sold with ROPS as an optional accessory; or according to the manufacturer, the tractor was designed to accommodate the addition of ROPS.

Recommendation #1: Install manufacturer-approved, certified ROPS and seat belts on tractors.
