REPORT#: 52-52-2022

REPORT DATE: 4/12/2022

Driver Crushed by Rollaway Woodchip Truck

SUMMARY

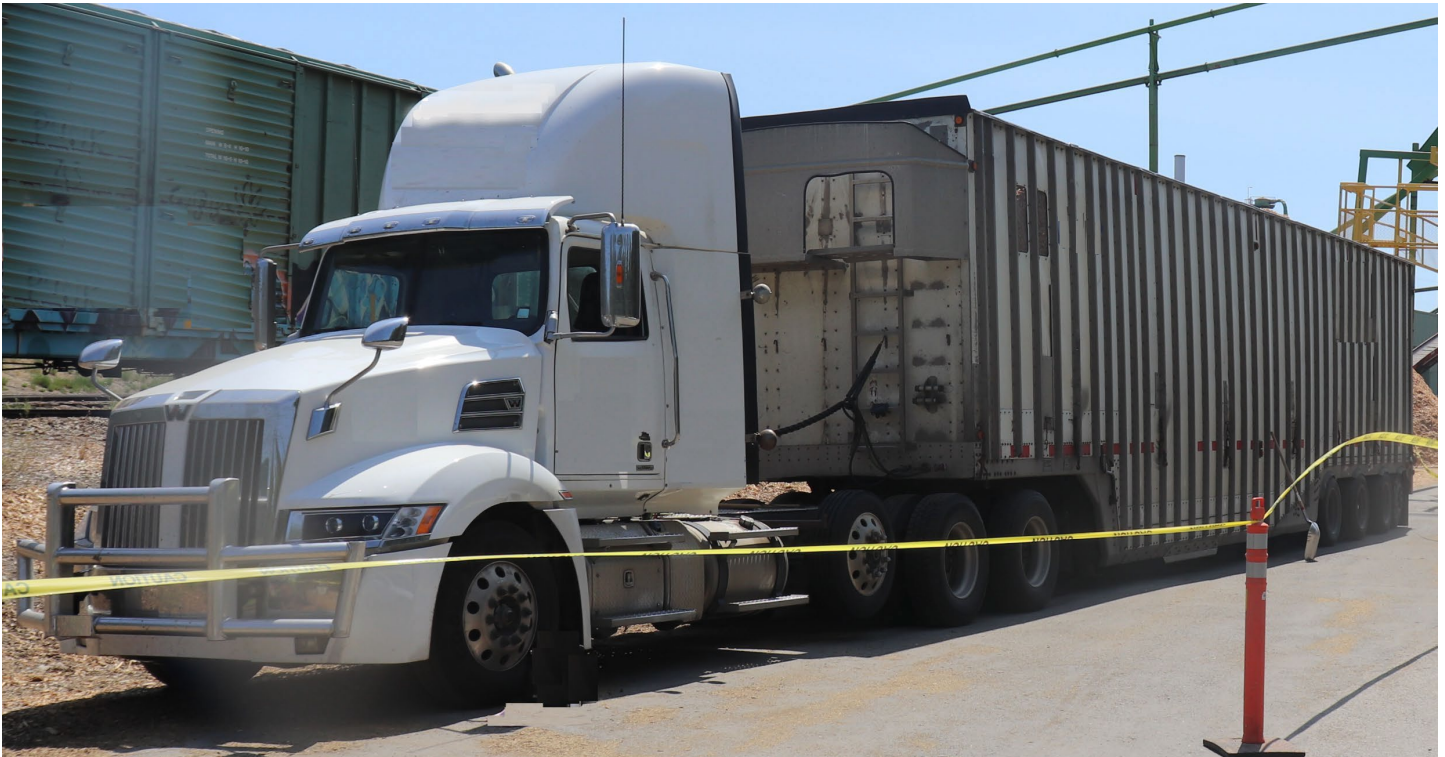
Photo 1: The fatally injured driver operated this 2016 Western Star semi-tractor with a 2004 TYCROP high-cube, quad-axle, possum belly Super B-train chip trailer.

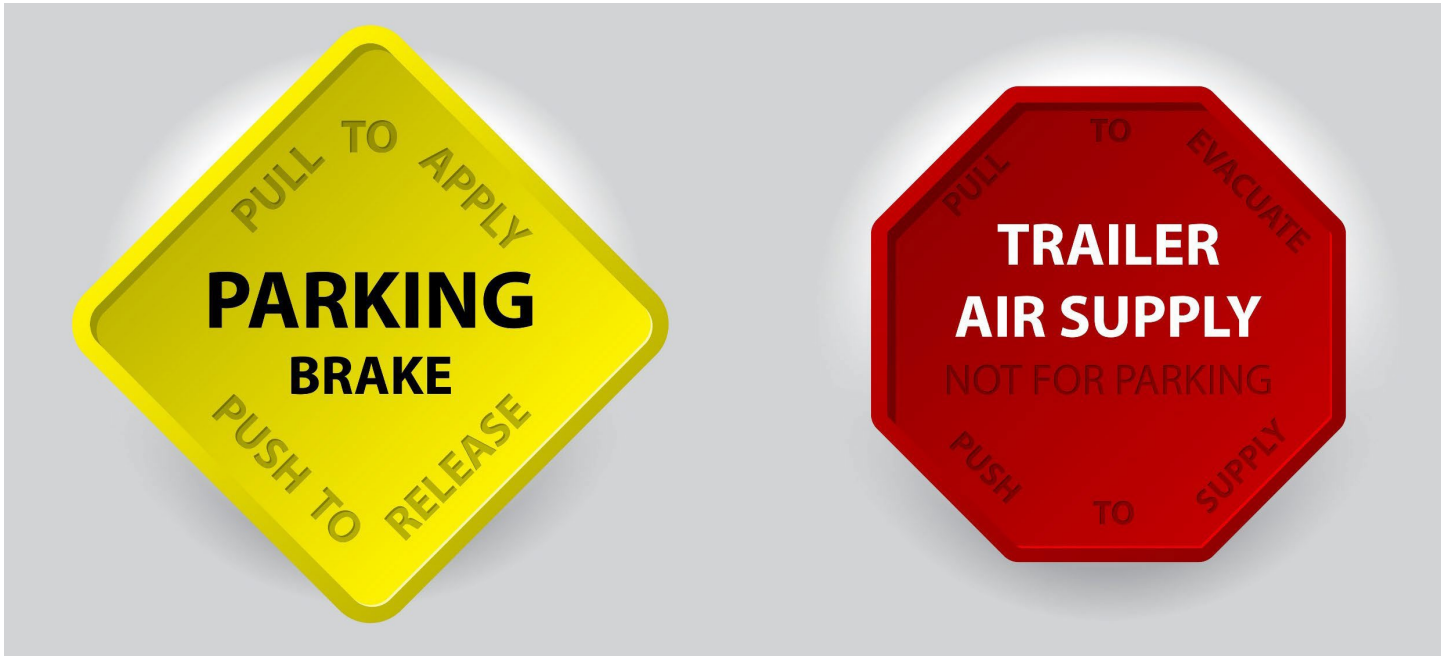
Photo 2: Industry standard push-pull air brake valve control knobs that are installed on semi-truck cab dashboards.

Recommendation #1: Employers should install electronic parking brake systems that automatically apply the parking brake when the driver has not set it before exiting the cab.

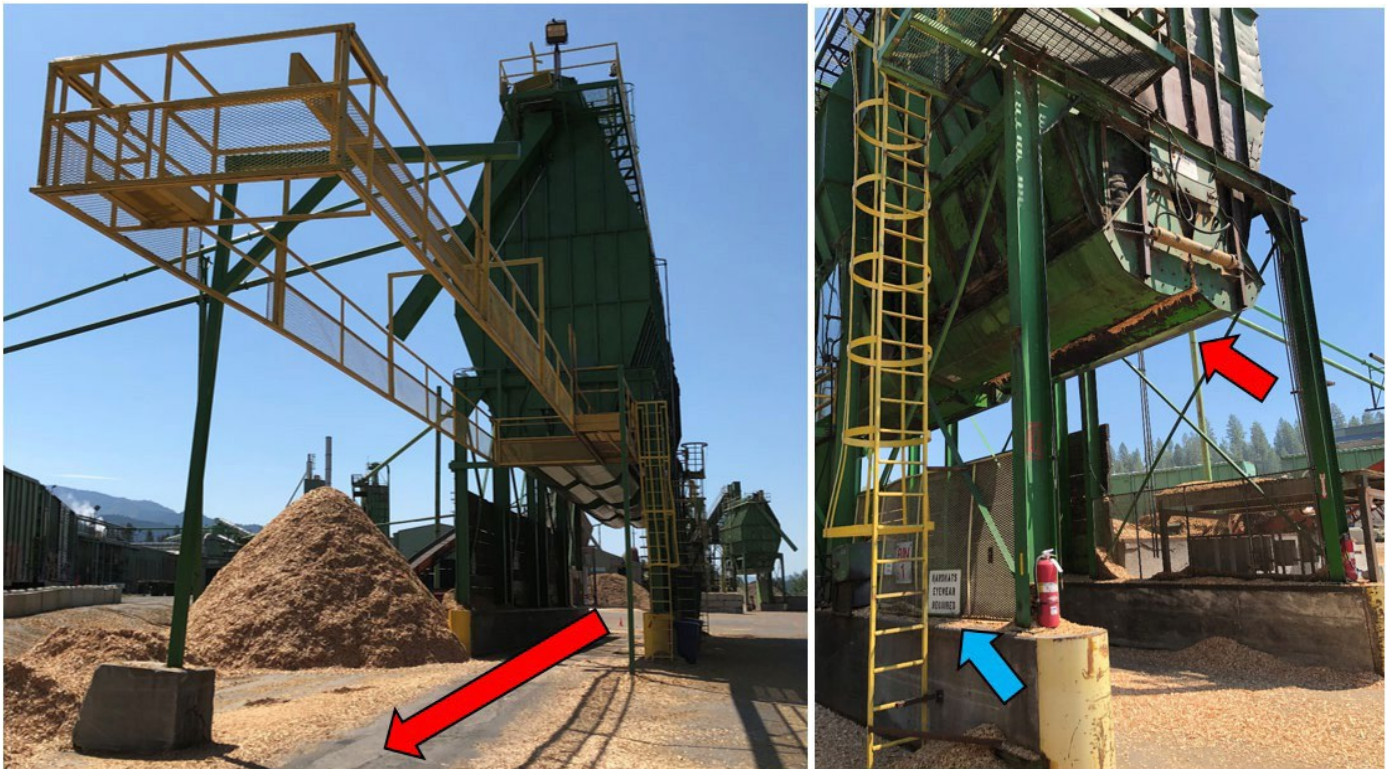
Photos 3 and 4: The left photo shows the fall protection tarping station extending north from the bulk woodchip storage bins. Arrow shows the path of chip truck travel on paved road under the bin entrance and loading area to the tarping station exit in foreground. Right photo shows entrance to bin loading area. Red arrow shows the bin’s clamshell gates that released woodchips into trailers. Blue arrow shows PPE requirement signage.

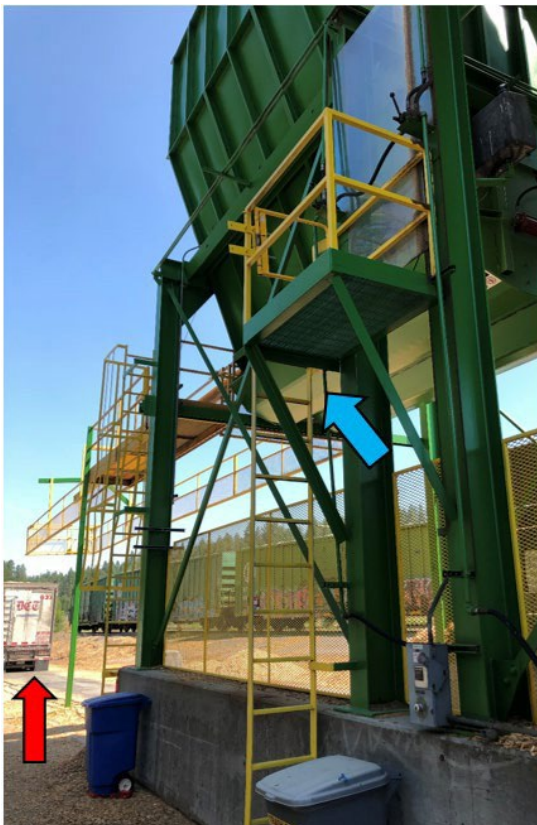
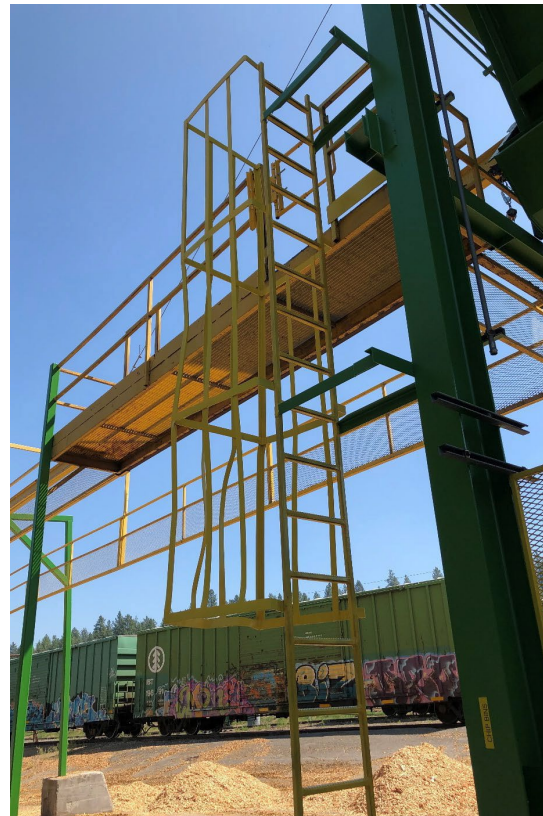
Photos 5 and 6: Top left photo shows tarping station extending north from bins toward exit. Red arrow shows rear of incident truck's trailer. Blue arrow shows bin hydraulic control platform with ladder. Top right photo shows caged ladder and first tarping platform that drivers used to access top rear of trailer.

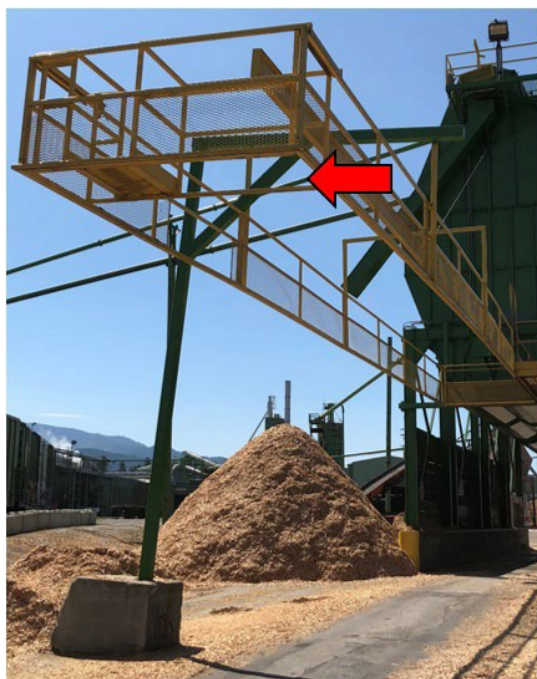
Photo 7: Arrow in bottom left photo shows second tarping platform and entrance that drivers accessed by climbing their front trailer ladders. Yellow guardrails around tarping station provided fall protection for truck drivers tarping on top of trailers.

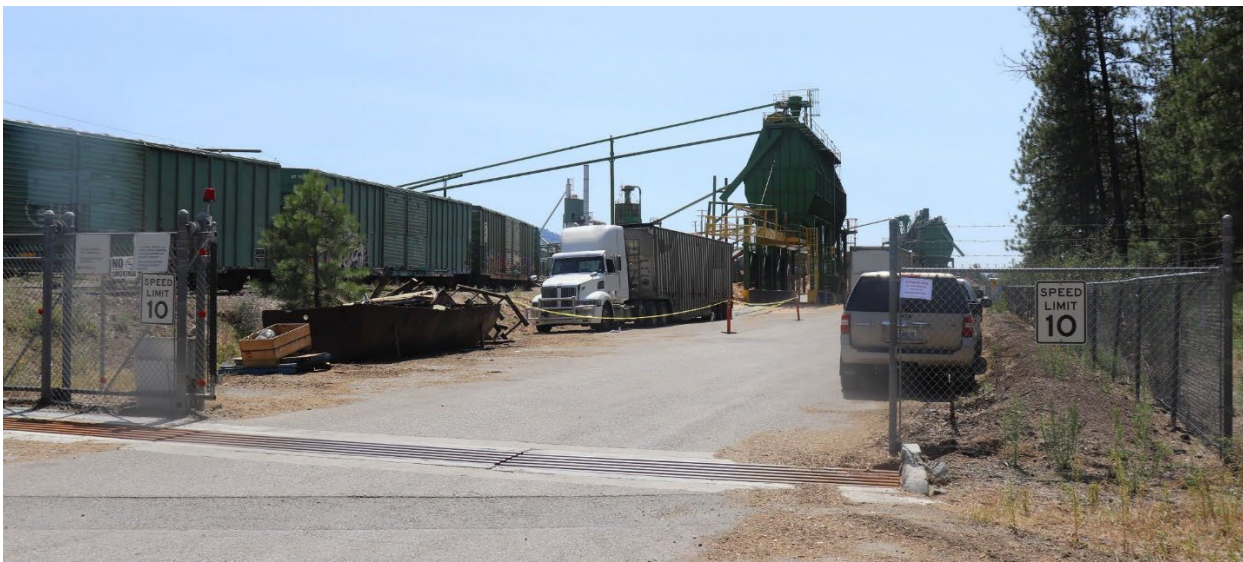
Photo 8: View looking south at road through sawmill entrance’s security gate. Incident truck is parked on left with the fall protection tarping station and bulk woodchip storage bins behind it

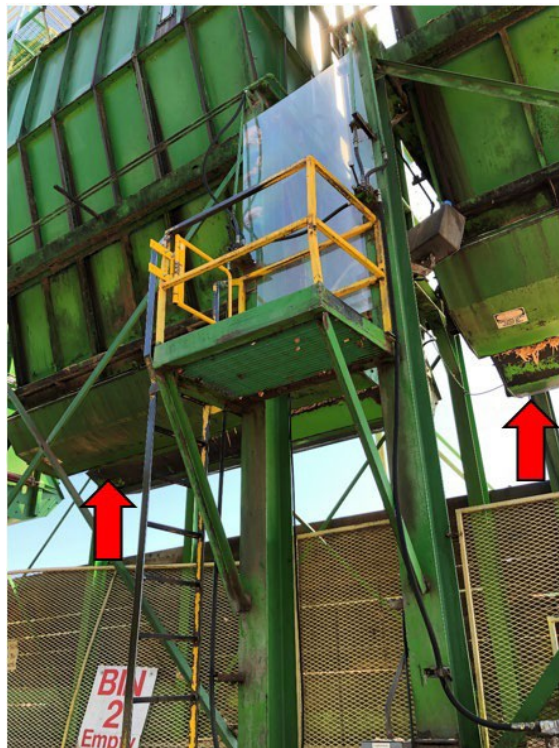
Photo 9: Bin control platform with ladder that truck drivers used to access hydraulic levers for bottom gates that released woodchips into the trailer. Arrows point to the gates.

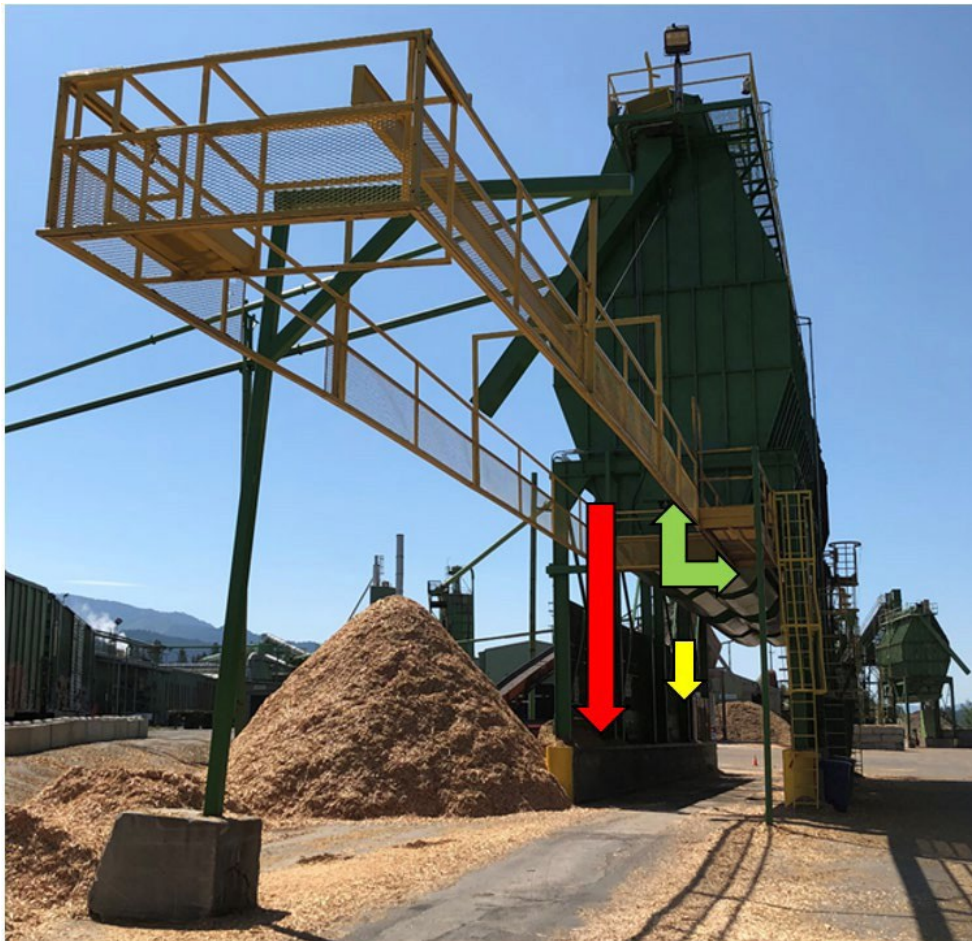
returned to his truck, drove it forward until the trailer was under the adjoining fall protection tarping station, and parked on the station's paved road, which had a 2% downgrade toward the exit. The second truck then pulled forward and parked the front of its trailer under the first bin. This left approximately 30 feet of space between the front of the second truck and back of the first truck now parked at the tarping station (Photo 10).

Photo 10: Red arrow shows where the back of the fatally injured driver's trailer was aligned under the back of the tarping station above. Green arrows show the ladder and platform that allowed the driver to access the rear top of his trailer. Yellow arrow shows where the front of the second truck's tractor was located under the bins when the incident occurred. Approximately 30 feet of space separated the trucks. The paved road under the tarping station had a 2% downgrade toward the exit in the foreground.

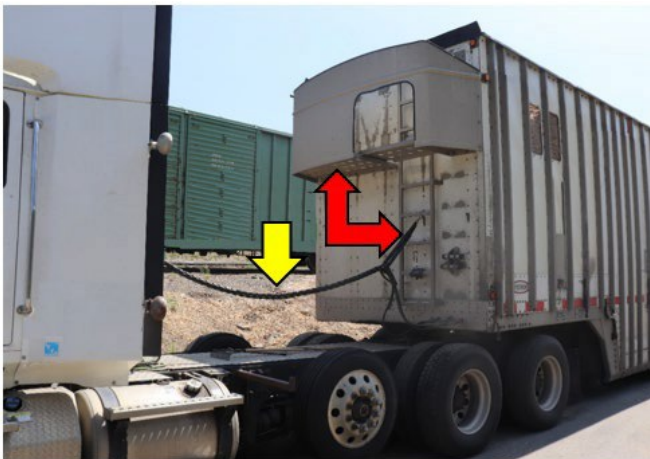
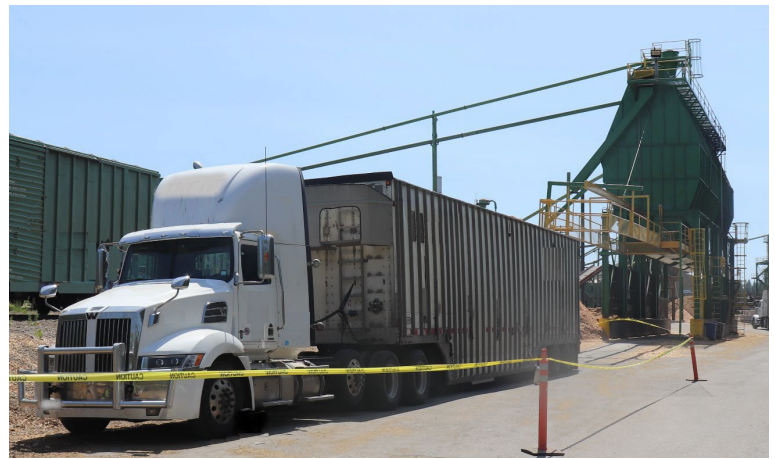
Photos 11 and 12: Red arrows in left photo show front trailer fall protection platform and ladder that driver ran toward while on top of the load at the back of the trailer when rollaway occurred. Yellow arrow shows the trailer's air and electrical supply lines suspended between the tractor to the trailer. Right photo shows truck's approximate stop location after it rolled away down the paved road's 2% grade.

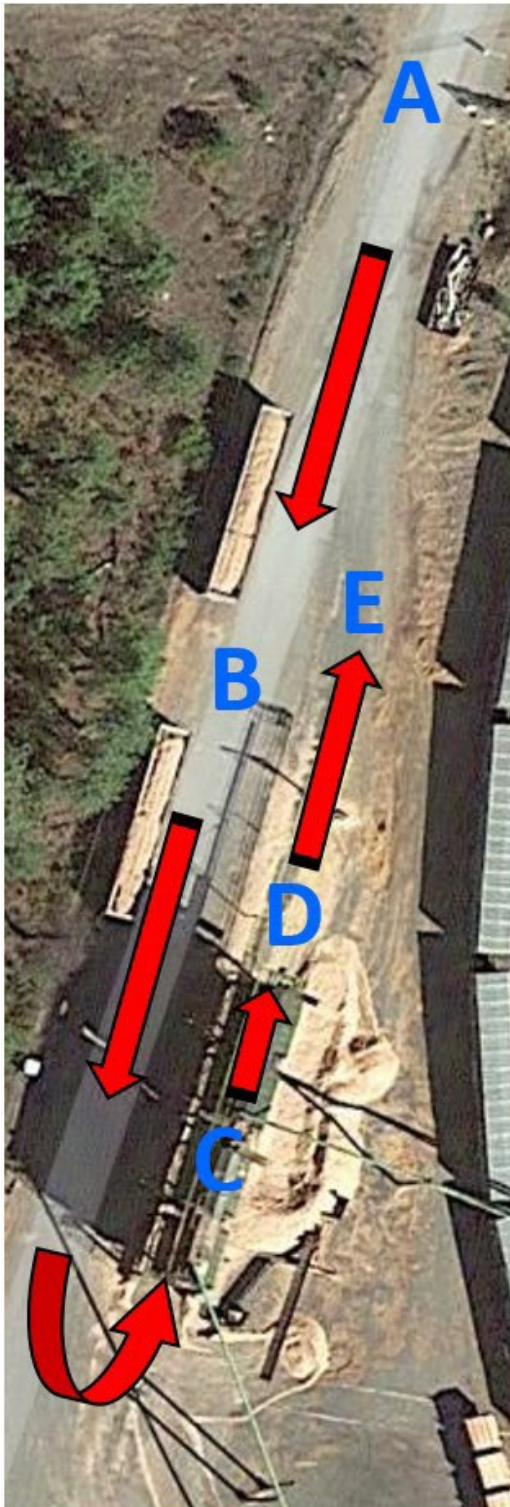
Diagram of incident scene. A) sawmill entrance gate, B) paved road, C) chip bin loading area where second truck parked, D) tarping station where first truck rolled away, E) location where rollaway truck crushed driver and stopped. Arrows show travel path of chip truck from sawmill entrance gate to chip bin and tarping station areas. Image courtesy of Google Maps.

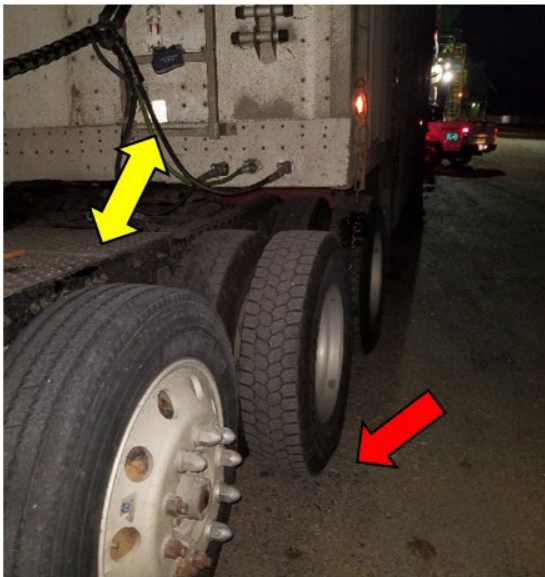
Photo 13: Red arrow in top left photo shows approximately where the driver's body was found crushed under the chip truck's left front drive wheels. Yellow arrows show base of front trailer ladder and walkway between cab and trailer that the driver attempted to access as his truck rolled.

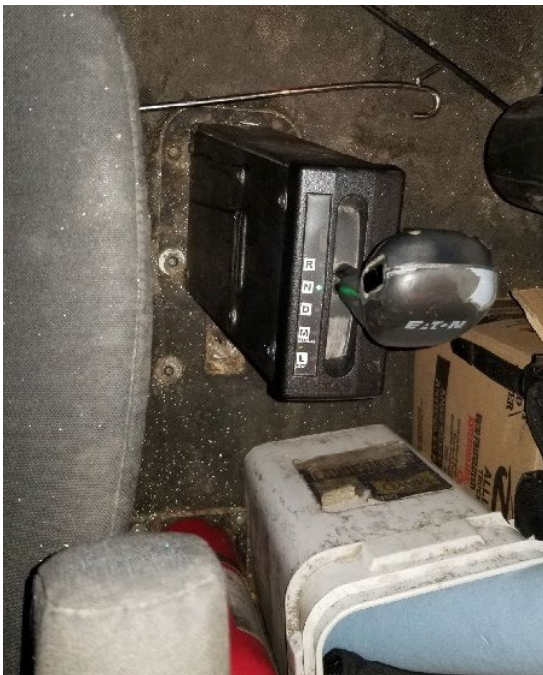
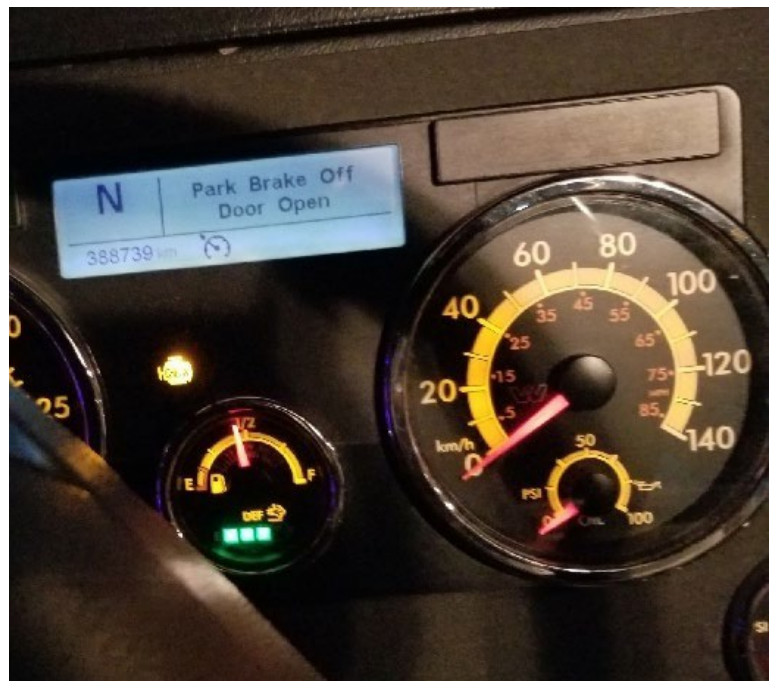
Investigators concluded the truck rolled away because when the driver exited his cab to use the fall protection tarping station, he left the truck's engine running with the transmission in neutral and parking brake released while parked on the road with the 2% downgrade (Photos 13-15). As is typical for semi-tractors, the truck's automatic transmission did not have a park position, which made it absolutely necessary to set the brake. The employer conducted a post-incident inspection that found no faults with the truck's air brake system. The driver's pre-trip vehicle inspection report from the day of the incident also indicated the truck was in safe operating order. Maintenance records showed that three months earlier, the incident truck passed a mandatory semi-annual safety inspection per requirements of BC's Commercial Vehicle Inspection Program (CVIP) [[B.C. Reg. 2021b](#)]. Around the same time, the brake pads and drums on the tractor's rear drive axle were replaced by a commercial truck maintenance shop in BC. An air brake system regulator was also replaced about two weeks before the incident.

Photos 14 and 15: Bottom left photo shows chip truck's transmission shifter set to "N" neutral after the crushed driver was found. The transmission did not have a "P" park position. Bottom right photo shows dashboard instrument panel indicator showing that the truck's transmission shifter was in "N" neutral and parking brake disengaged when the incident occurred.
