**REPORT#:** 2020OR010    **REPORT DATE:** December 7, 2020

## Forklift Operator Crushed by Full Pallet of Soft Drink Cans - Oregon

#### **Oregon Fatality Assessment and Control Evaluation Program**

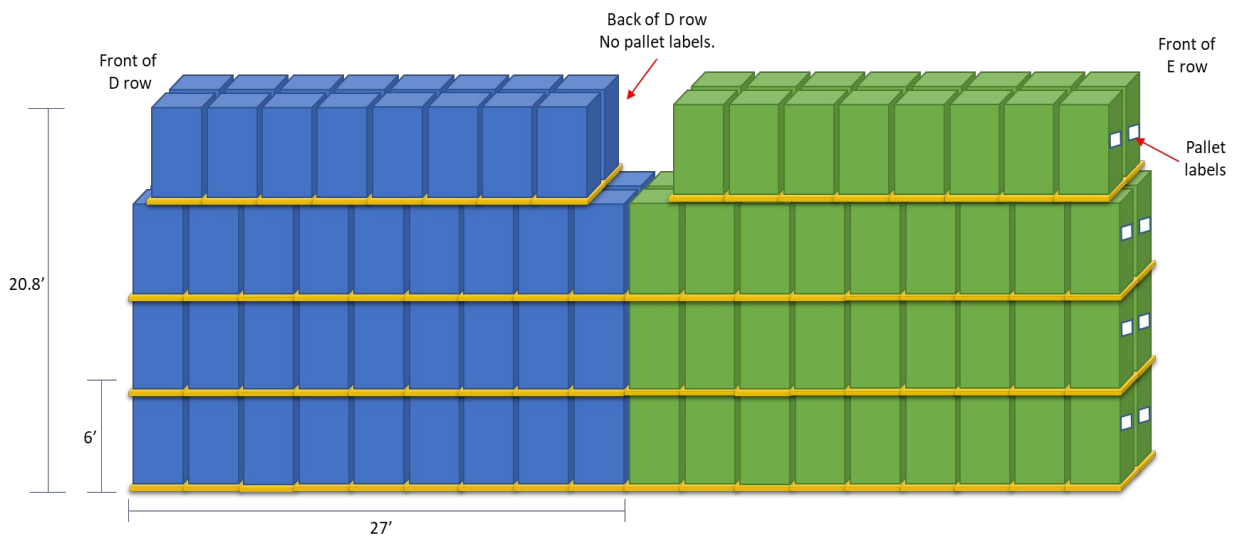
Product stored on the warehouse floor is placed there by the manufacturing forklift operators, who stack pallets 2 across, 4 layers high, and 9 pallets deep, except for the 4<sup>th</sup> layer, which is 8 pallets deep. Pallet rows are arranged back-to-back (*See Image 1 on following page*) so that pallet labels are on the front side of a pallet row.

**Image 1. Diagram of the back-to-back pallet row configuration utilized for product stored on warehouse floor.**

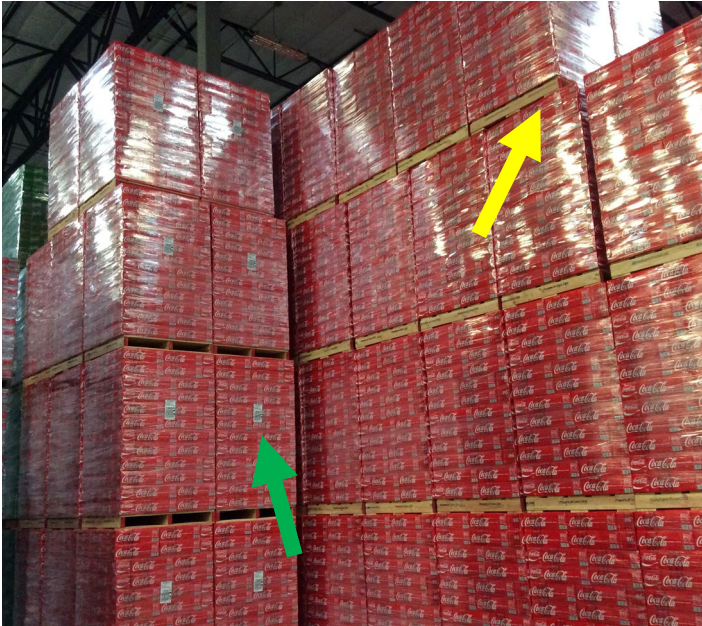
The 4<sup>th</sup> layer is offset from lower layers. The pallets of the 4<sup>th</sup> layer are placed so the front edge is offset behind the front edge of the 3<sup>rd</sup> layer (*See Image 2*). The last pallet at the back of the 4<sup>th</sup> layer last two pallets on the 3<sup>rd</sup> layer (*See Image 3*), which is why the 4<sup>th</sup> layer is only 8 pallets deep. This offset technique, combined with the weight of a pallet, stabilize the pallet row.

**Image 2. Front of pallet row. Note top (4th) pallet layer offset behind 3rd layer (yellow arrow). Also, note pallet labels with barcodes on shrink wrap, indicating this is the front of the pallet row (green arrow).**

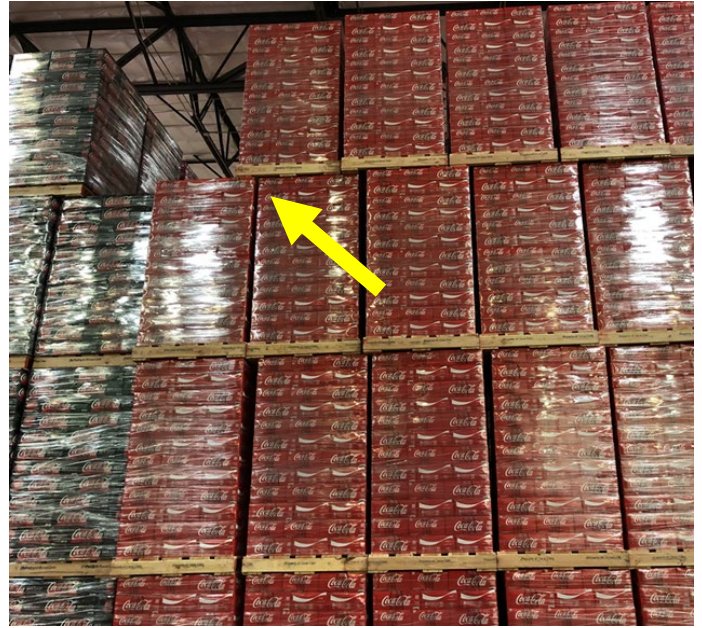
**Image 3. Back of pallet row. Note offset of top (4th) pallet layer overhangs rear edge of 3rd layer (yellow arrow). Also note back of pallet row abuts back of adjoining pallet row containing a different product.**

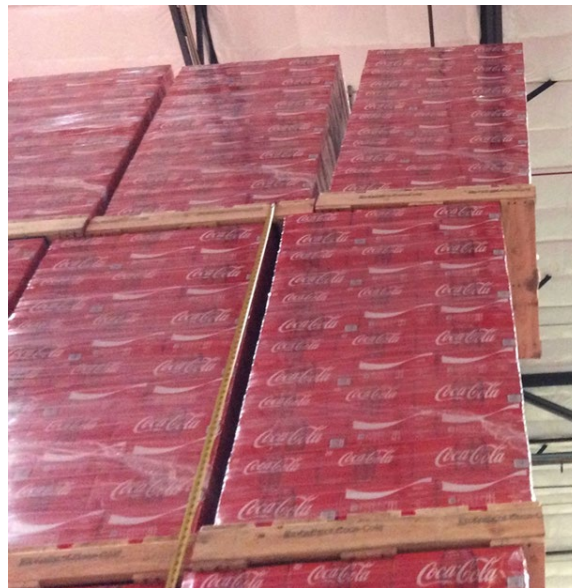
The incident occurred in the warehouse on a Friday, February 28<sup>th</sup>, 2020 at 4:27pm, approximately an hour into the beginning of swing shift. The decedent's task assignment that day was to retrieve palletized product from the floor and move it to the staging area for custom order fulfillment. The IMS directed the decedent to pull product from D1-116 pallet row and relocate it to the custom order fulfillment staging area. However, there was no product in the pallet row D1-116. For an unknown reason, the decedent pulled the 3<sup>rd</sup> layer from the back of adjoining E1-117 pallet row instead, and in doing so, 8 cases fell off of one of the pulled pallets. Because this was the back of the row, the decedent most likely did not see the 4<sup>th</sup> layer from his location inside the forklift. When the decedent lifted the 3<sup>rd</sup> layer and pulled it, it is likely this action dragged the 4<sup>th</sup> layer toward the edge, creating an even greater overhang (*See image 4*). Pulling the 3<sup>rd</sup> layer out from under the overhanging 4<sup>th</sup> layer is likely what caused the 8 cases to fall off of the 3<sup>rd</sup> layer pallet.

**Image 4. Side view of end of pallet row where incident occurred. Top (4<sup>th</sup>) pallet layer overhanging 3<sup>rd</sup> layer and leaning away from top pallet row. The pallet next to this leaning pallet was the one that fell on the decedent.**

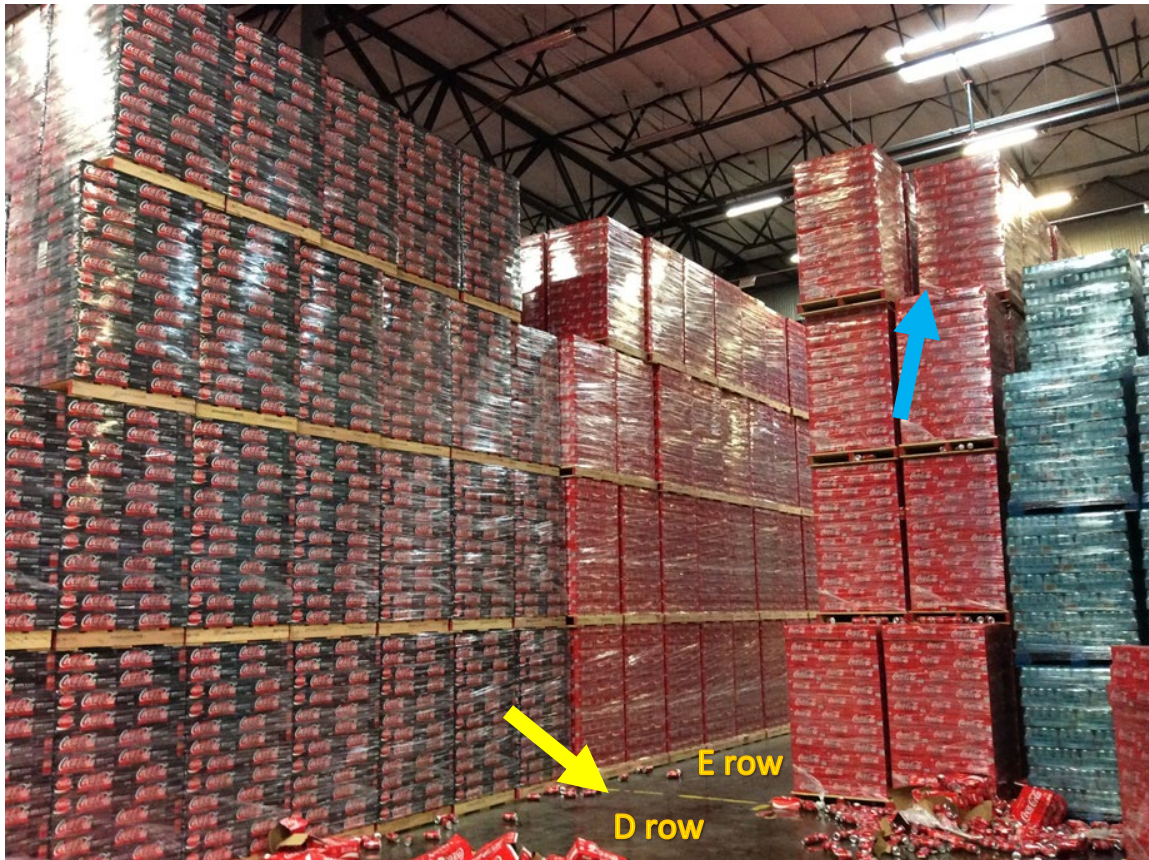
The decedent placed the 2 pallets pulled from the 3<sup>rd</sup> layer of E row on the floor near the pallet row, and pulled the 2<sup>nd</sup> layer from the back of E row, placing it on the floor near the pallet row as well. This was to ostensibly to reach some of the fallen cases from the 3<sup>rd</sup> layer pallet that were on the top of the 2<sup>nd</sup> layer. The decedent left the area to retrieve a containment pallet, a special pallet with a plastic grid on top and a solid trough on the bottom, designed to hold leaking product so it can be moved to the spillage/wastage area in the warehouse. The decedent returned to the back of E row with the containment pallet, shut off his forklift, walked to the back of E row and began picking up the spilled product. The 4<sup>th</sup> row pallets, destabilized when the decedent removed the lower layers (*See Image 4*), were now overhanging and tipping away from the E1-117 pallet row, toward the empty D1-116 pallet row. While the decedent was cleaning up the spilled product at the back of E1-117 pallet row, the pallet on the right side of the 4<sup>th</sup> row (*See Image 5*) fell down onto the decedent, striking him in the head and upper body, causing massive internal injuries.

**Image 5. Looking at front of D row and the back of E row. Note 1: The faded yellow line on the floor that marks the end of one pallet row and the beginning of another (yellow arrow). Note 2: The pallets at the end of E row do not have pallet labels on**

First, while there were visual cues that the decedent was located at the back of a pallet row (yellow line on floor, no pallet labels), there were no engineering controls to physically prevent a distracted employee from pulling product from the wrong side of a pallet row, and creating a serious, and in this case, fatal struck by hazard.

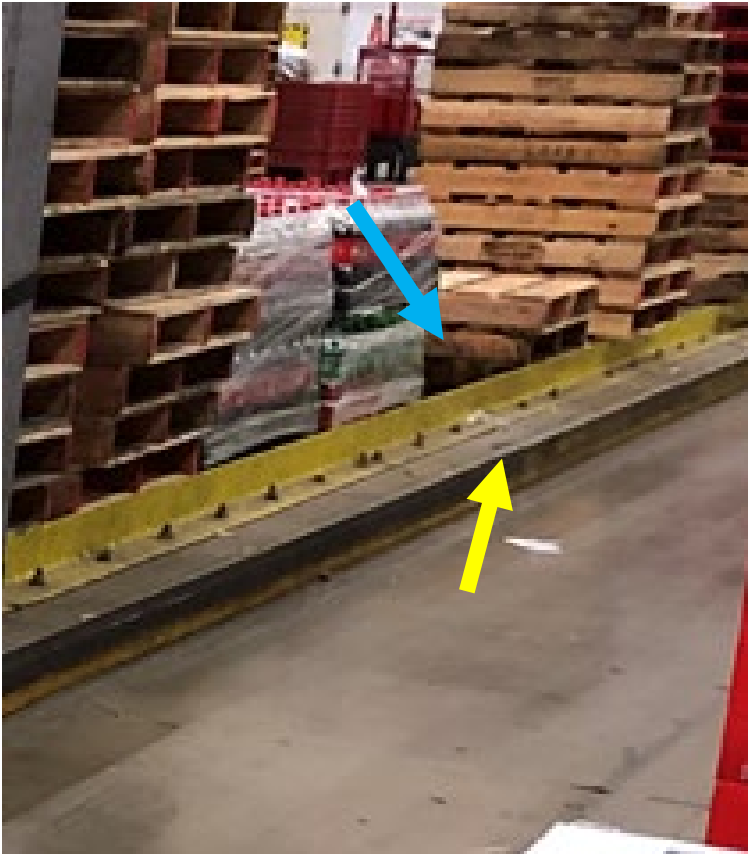
*Image 6. Metal rails installed into concrete floor at the warehouse. Yellow and blue arrows mark end of each row. Rails prevent pulling product from back of adjoining pallet row. Rails were not installed in the area of the warehouse where the incident*

**Recommendation #1:** Ensure warehouse layout and pallet stacking procedures incorporate sufficient engineering controls to prevent distracted employees from inadvertently destabilizing multi-layer pallet rows.

Discussion: The warehouse floor in the pallet row storage area was painted with a yellow line, delineating the end of a pallet row. In addition, metal rails had been installed into the concrete floor in some sections of the warehouse, to prevent material moving equipment from pulling products from the back of pallet rows (*See Image 6*). However, there were no rails installed in the section of the warehouse where in the incident occurred. A disadvantage of using floor mounted metal rails is that it doesn't prevent a distracted forklift operator from removing product from the 2<sup>nd</sup>, 3<sup>rd</sup> or 4<sup>th</sup> layer of the pallet row. A better solution would be to use a warehouse retractable curtain wall (*See image 7*), that is not only a visual cue, but also a physical barrier marking the end of the pallet rows. An internet search returned several brands of warehouse curtain walls available.

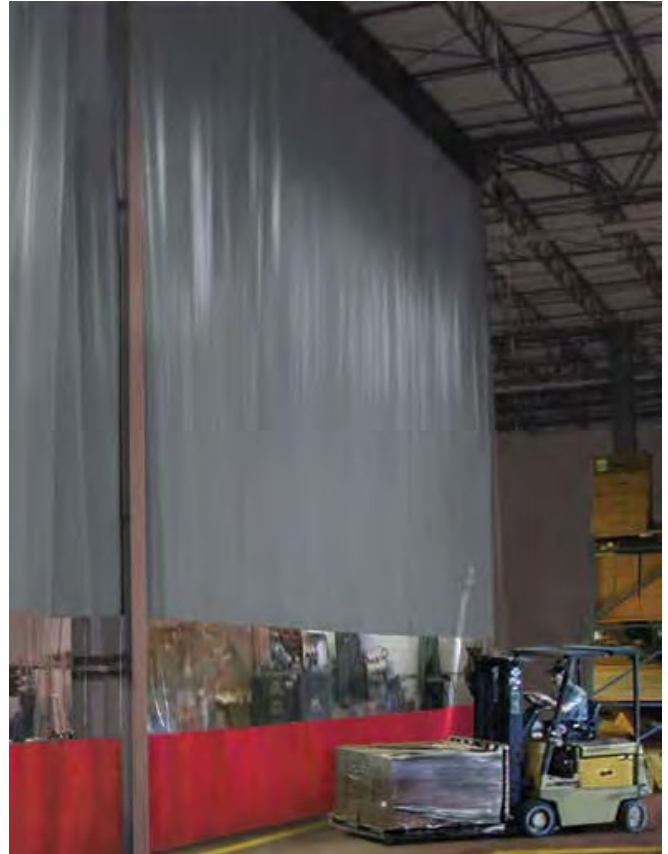
*Image 7. Example of a retractable warehouse curtain wall, that would create a physical barrier between pallet rows, while also allowing for visibility through curtain wall at pedestrian or forklift operator height. Photo credit: TMI, LLC warehouse part*
