FATALITY ASSESSMENT AND CONTROL EVALUATION PROGRAM (CA/FACE)

A pipefitter, working in a trench, died when he was struck by an excavator bucket that detached from a quick coupler

Case Report: 20CA002

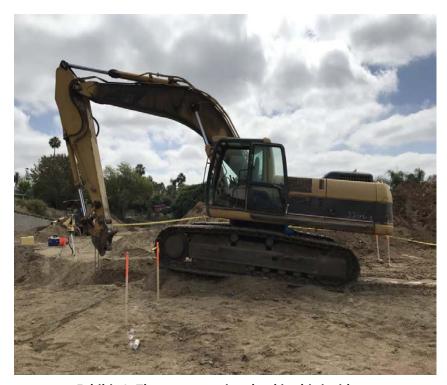
Exhibit 1. The excavator involved in this incident.

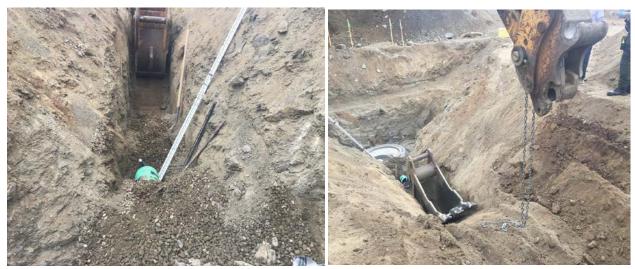
At the time of the incident, the excavator operator was digging an additional trench next to existing underground sewer pipes. The new trench was going to accommodate more pipes that would be tied into the current sewer system (Exhibits 2 & 3). The depth of the trench was approximately nine feet. The deepest four feet were straight-sloped and wide enough to accommodate the new polyvinyl chloride (PVC) sewer pipes (Exhibit 4). The victim was likely in the trench acting as a spotter to signal to the operator where to move the bucket so that it would not damage existing pipe already in the trench.

Exhibit 2 and 3. Alternate views of the trench.

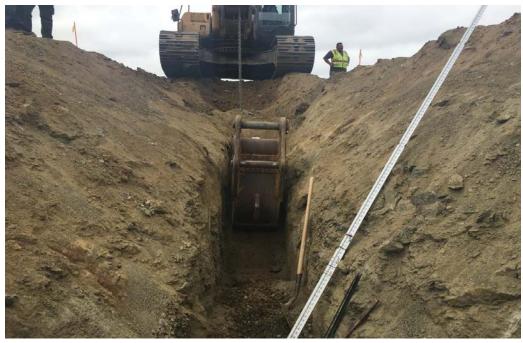
Exhibit 4. Slope and depth of the trench.
