**FATALITY ASSESSMENT AND CONTROL EVALUATION PROGRAM
(CA/FACE)**

A heavy equipment operator dies when he was struck by an excavator bucket that detached from a quick coupler

Case Report: 20CA001

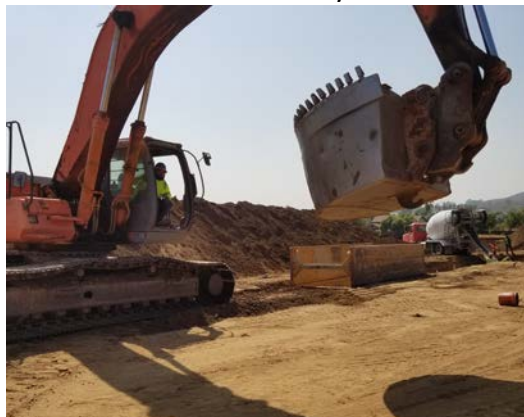
The machine involved in this incident was a Hitachi hydraulic excavator (Exhibit 1). Attached to

Exhibit 1. The excavator involved in the incident.

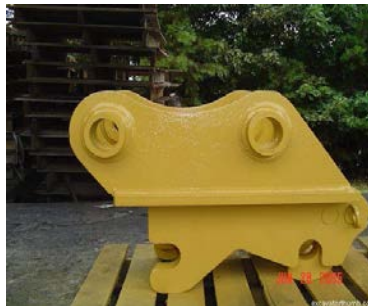
the end of the boom was a hydraulic device called a quick coupler. Quick couplers are made by various manufacturers and have several designs. They are installed at the outer end of booms by the pins that would normally be the mountings for the bucket or attachment (Exhibit 2). They facilitate the rapid exchange of working tools or buckets. The quick coupler involved in this incident was fully automatic. The distributor of the quick coupler was Steel Unlimited Inc. The coupler was hydraulically connected to a Geith hydraulic control panel in the excavator operator's cab (Exhibit 3). The control panel is designed to hydraulically lock the bucket to the quick coupler, and has an alarm to warn the operator when the mechanism malfunctions. The excavator operator typically confirms proper attachment of the bucket by raising the boom and testing the operation of the bucket prior to use.

Exhibit 2. A quick coupler similar to the one involved in this incident.

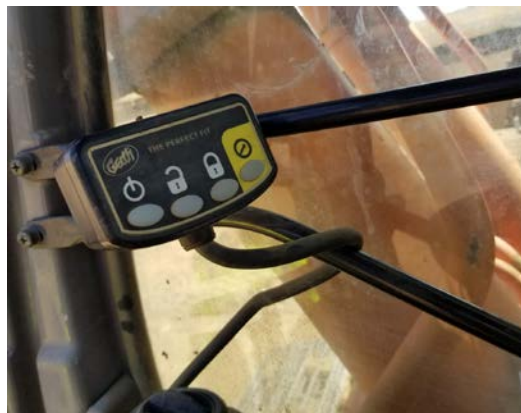
Exhibit 3. The automatic hydraulic quick coupler control panel.

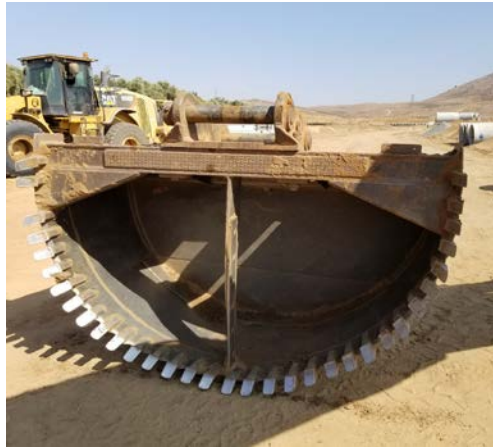
It is not known why the victim stopped the excavator boom and exited the cab. It is possible that the quick coupler locking mechanism did not fully engage and the victim was alerted by an

alarm on the control panel. The victim may have exited the cab to check on the bucket. The supervisor witnessed the victim approach the elevated bucket from underneath, and then the bucket detached, striking the victim (Exhibit 4). The decedent fell onto a small dirt berm at the edge of the trench. 911 was immediately called and the supervisor performed cardiopulmonary resuscitation (CPR) until emergency services arrived. The fire department provided advanced cardiac life support (ACLS) measures and transported the victim to the hospital where he was pronounced dead by the attending physician.

Exhibit 4. The bucket that disconnected from the coupling.

Recommendation #1: Always lower the bucket to the ground before exiting the cab.

Discussion: In this incident, the victim left the cab while the boom and bucket were still elevated. If operators become aware that the bucket is not operating properly, they should always lower the bucket to the ground before inspecting. If the bucket had been lowered to the ground, it would not have disconnected and fallen on the victim.

Recommendation #2: Never walk/traverse beneath an excavator boom swing radius or elevated load.

Discussion: In this incident, the victim exited the cab and walked underneath the elevated bucket. All heavy equipment poses serious—even potentially fatal—risks to operators and others working in the vicinity. The relatively quick and far-reaching motion of the boom and bucket on an excavator is a particular source of danger. Manufacturers of excavators advise that no one should

walk below an elevated load or work within the boom swing radius during operation. If the victim had not walked under the elevated load, he would not have been struck by the bucket.

Recommendation #3: Train hydraulic excavator operators in the proper procedures for engaging excavation attachments and incorporate these procedures into the company's safety and health program.

Discussion: In this incident, the victim had received OJT training on how to operate the excavator. There was no documentation that he received specific instruction on the operation of quick couplers. If the victim had received increased training on excavator operations, he may have had greater knowledge about how quick couplers function and the the proper safety procedures to follow. With additional training, the victim may have lowered the boom to the ground, thereby preventing this incident.
