REPORT#: 18MI105

REPORT DATE: 7/7/20

Construction Firm Owner Dies From Fall From 8-Foot Step Ladder Or Overhead Platform

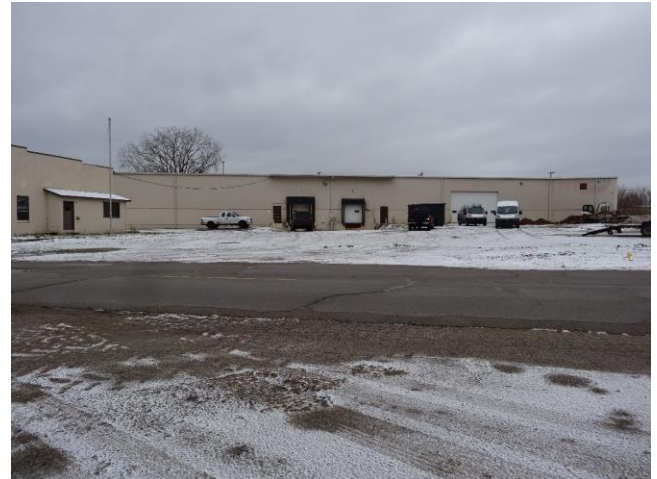
The incident scene was inside of a warehouse undergoing demolition/renovation (Photo 1). The decedent was working from either an 8-foot step ladder positioned on a level concrete floor or from an elevated platform. If working from the ladder, based on his height, he most likely was standing on the third rung from the top. The decedent was using a compressor-powered saw to cut away foam-covered plywood platform positioned between two trusses/floor joists.

Photo 1. Warehouse undergoing demolition/renovation

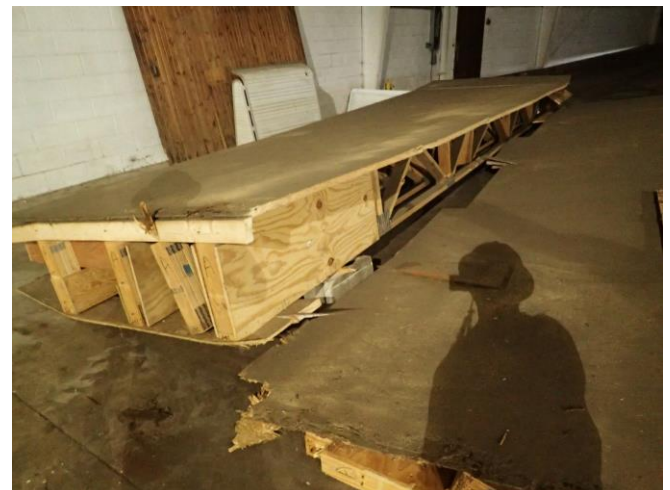
Photo 2. Example of truss/floor joists with foam-covered plywood that had previously been removed.

ultimately decided to use a Bobcat to lift them up and twist them away from their attachment points, and then use the Bobcat to move them outdoors (Photo 2).

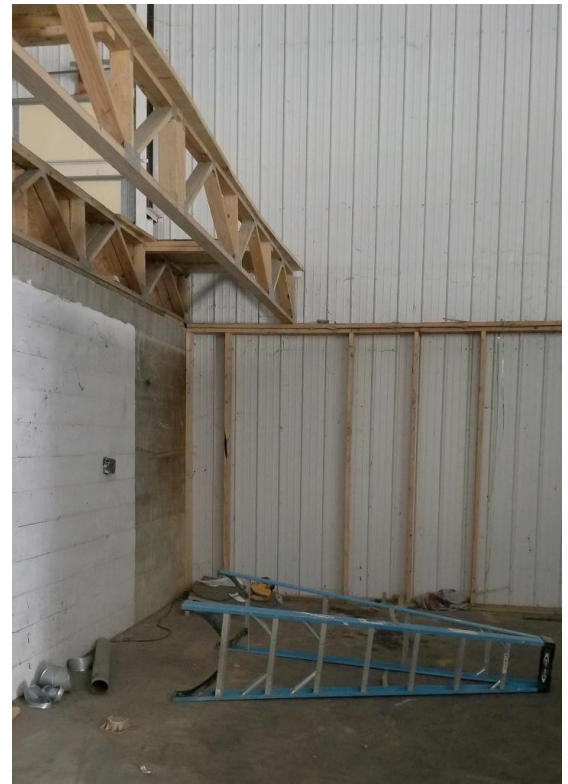
After the trusses were removed, the last truss (as described by the son as the most “dangerous” truss) required removal. The last two floor joists were associated with a 9-foot-high cement block wall (Photo 3). One of the two floor joists was positioned on the top of the cement block wall. They could not use the Bobcat to remove the truss because they did not want to damage the cement block wall.

The decedent’s fall occurred a few minutes after noon. His son was outside, working with the Bobcat as well as tearing the insulation-covered plywood floor from the previously-removed floor joists. He took a short break, and during this time, he heard the crash of the ladder and plywood hitting the floor, and then the compressor “go to idle” (the compressor idles when the saw is not in use). He ran to the source of the sound and found his father face down on the concrete floor. The ladder had tipped to the side. A piece of plywood was near his father, and the saw was laying on the plywood on the floor (Photo 3).

Photo 3. Incident scene showing ladder tipped to side, saw used at the time of the incident, and portion of elevated platform which fell.

The decedent selected a Type 1 (Heavy Duty) step ladder from which to work. The maximum weight the ladder was designed to carry was 250 pounds. The decedent weighed more than 250 pounds. Overloading a ladder can result in ladder instability. A safer ladder selection for the decedent would have been a Type 1A step ladder, which has a maximum carrying capacity of 300 pounds or a Type IAA (Extra Heavy Duty) ladder capable of supporting 375 pounds.

Discussion: Firms should try to minimize the use of ladders as a work platform. Working from ladders can pose a fall hazard; therefore, ladders should be used for accessing higher and lower levels. If the task to be performed requires the worker to push, pull, or pry, then the use of scaffolding or aerial work platforms rather than a ladder is strongly recommended. The use of a ladder inherently limits the possible work area of a worker to an arm's length on either side of the ladder. Safe ladder use requires a worker to maintain a three-point connection (two hands/one foot or two feet/one hand) and his/her shoulders within the side rails. If the decedent was working from the ladder, he had to work outside the ladder rails to cut the foam-covered plywood and would have had to use both hands to operate the saw.

Discussion: Proper ladder selection includes, not only ladder material, type of ladder, length/size of ladder, and the environment in which the ladder will be used, but also its duty rating. The duty rating is an indication of the maximum weight capacity the ladder can safely carry. The ladder user should determine the total amount of weight the ladder will be supporting, including the user's weight, weight of clothing and any protective equipment, weight of the tools and supplies, and the weight of any items stored on the ladder.
