REPORT#: 18MI072

INCIDENT HIGHLIGHTS

Field Manager Struck by Vehicle in Active Roadway While Taking Depth Measurement

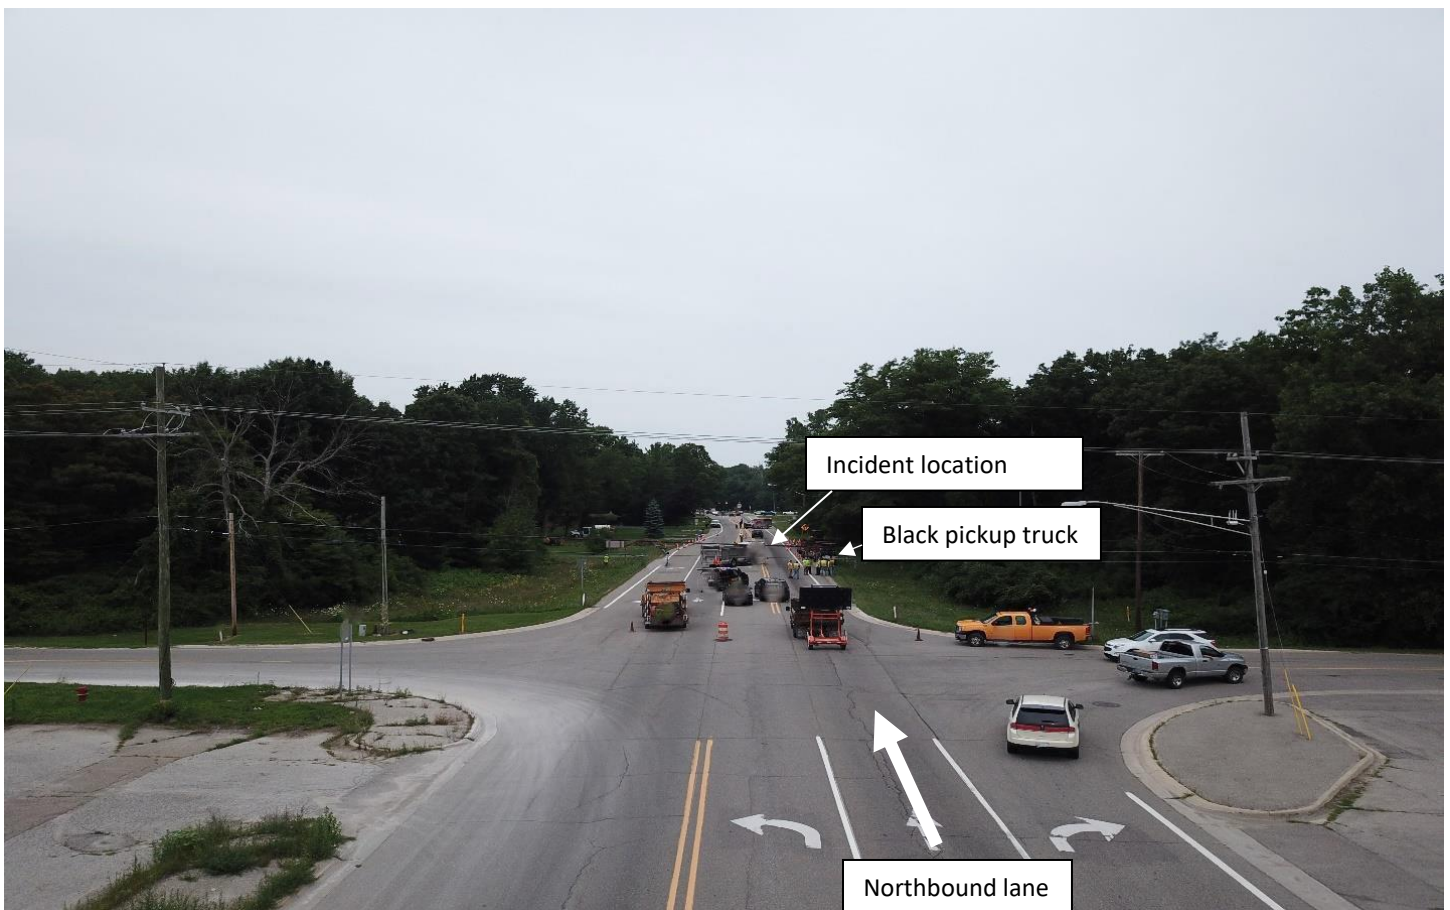
Photo 1. Drone view, south of intersection looking north

The north-south roadway had two through-travel traffic lanes, and as traffic approached the intersection, a middle (center) lane to make a left turn at the intersection and a right turn lane. (See Photos 1 and 2). The incident occurred approximately 1000 feet north of the intersection.

The road was dry and had a posted speed limit of 50 mph. There was no reduction of speed in the work zone.

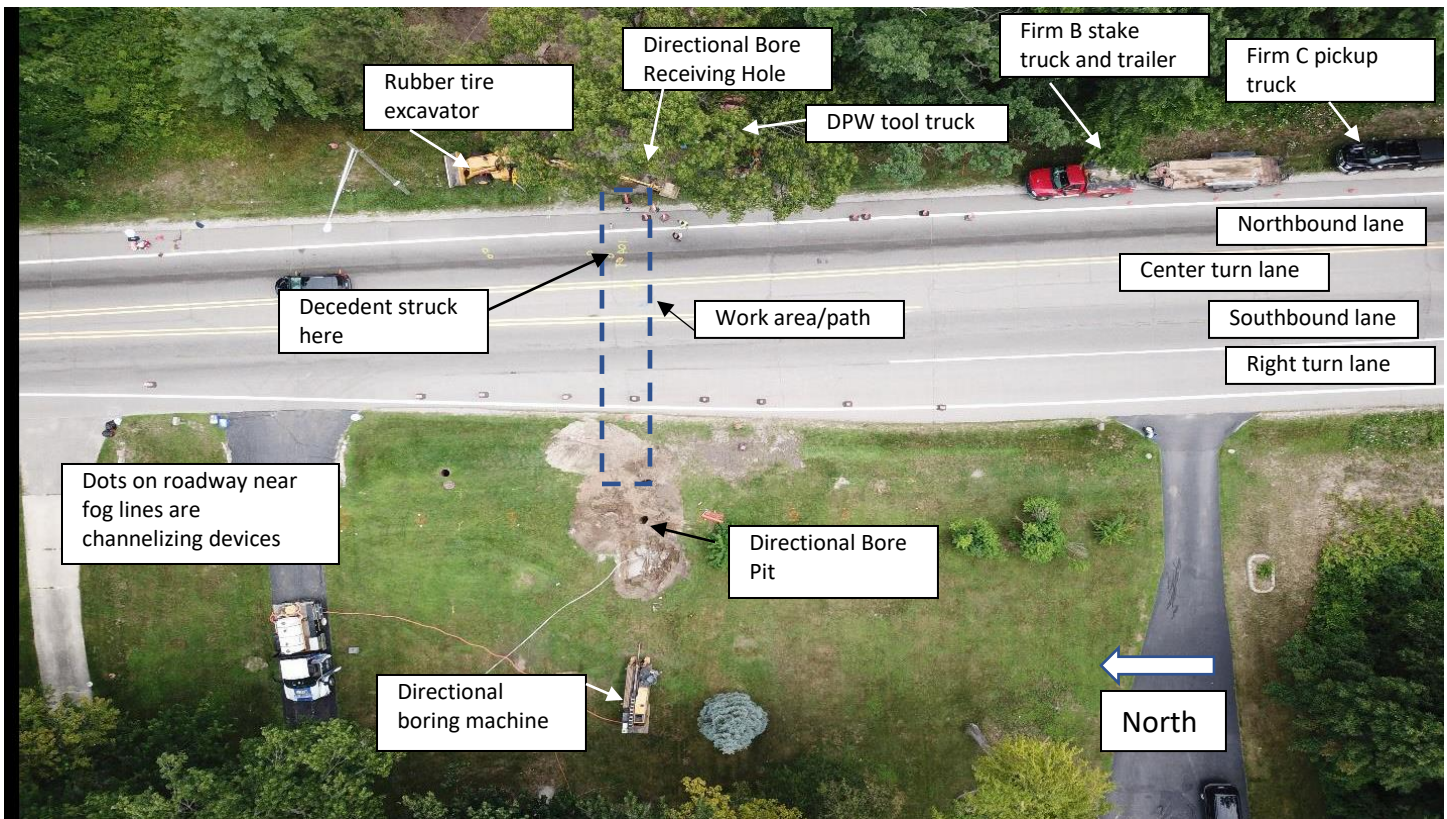
Photo 2 shows the excavation and directional boring equipment, vehicles, channelizing devices and the location of the bore and the decedent at the time he was struck by the oncoming vehicle.

A rubber-tired excavator was used to make two excavations, one on each side of the roadway, so the bore head of the head of the directional boring machine could enter and exit (exit hole is identified on Photo 2 as the receiving hole).

Photo 2. Responding police drone picture, overhead view of incident site.

Firm A personnel had placed the temporary traffic control work zone signage and channelizing devices (traffic cones). The channelizing devices were of different sizes and placed on both the east and west sides of the roadway (Photos 1 and 3). On the east side of the roadway, traffic cones were placed near the rear of the semi-trailer and angled out from the edge of the pavement toward the fog line. Once the cones met the fog line, they were positioned three to four feet west of the fog line in a straight line northbound past the excavation area indicating the shoulder of the roadway was closed. On the west side of the roadway, traffic cones were similarly placed three-to four feet east of the fog line.

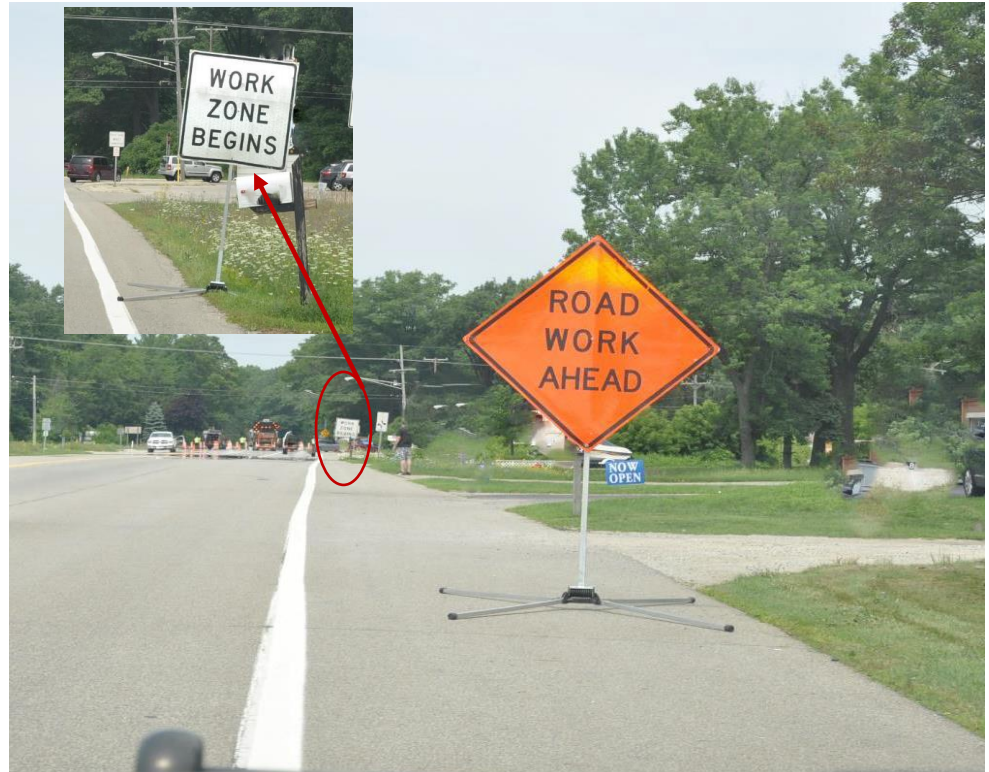
One "Road Work Ahead" sign and one "Work Zone Begins" sign was placed on the east side of the northbound roadway south of the intersection (Photo 4) and one set of signs was placed on the west side of the roadway, north of the incident site for southbound traffic. No "Work Zone Ends" signs were erected. There were no signs within the work area.

Photo 3. Road Work Ahead and Work Zone begins signs placed on northbound roadway, south of intersection

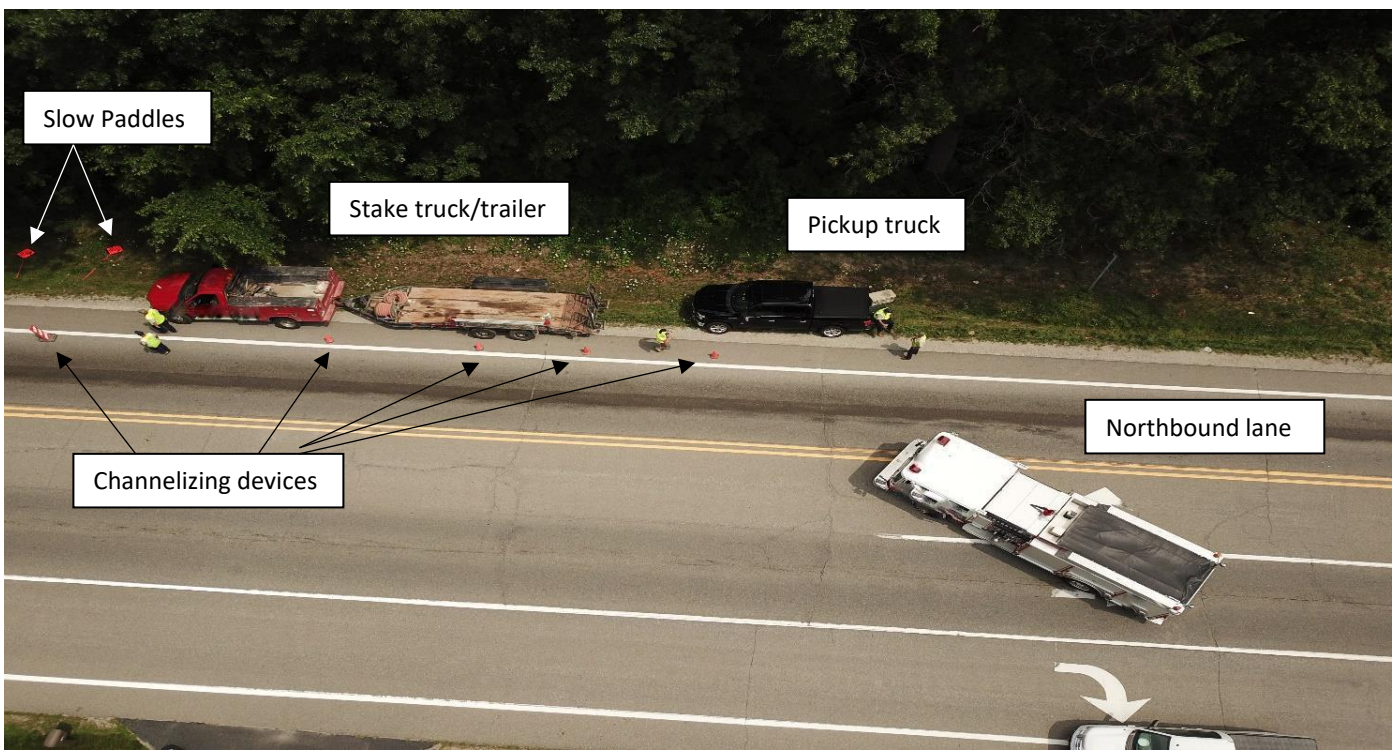
- Near the receiving bore hole were the backhoe and Township DPW’s tool truck, a converted fire engine.
- Firm B’s stake truck with an attached flatbed semi-trailer, parked primarily on the paved shoulder. The amber lights on top of the stake truck were not activated. The truck’s four-way flashers were not activated.
- Firm C’s black pickup was parked primarily on the grass south of Firm B’s truck/trailer unit. The four-way flashers on the pickup were not activated.

Photo 4. Location of construction equipment and channelizing devices

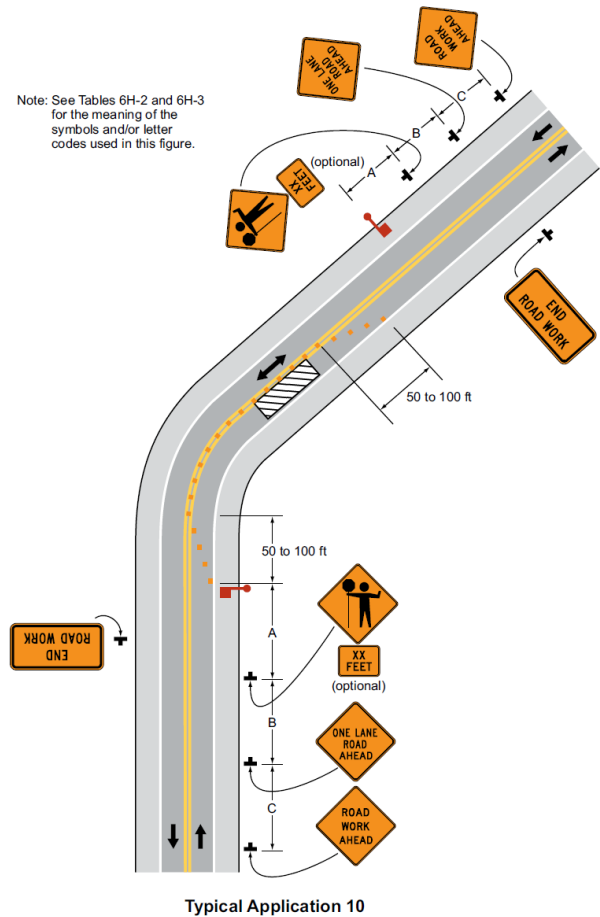
Figure 6H-10. Lane Closure on a Two-Lane Road Using Traffic Regulators (TA-10)

Figure A. *Michigan Manual of Uniform Traffic Devices, Figure 6H-10: Lane Closure on a Two-Lane Road Using Traffic Regulators.*

MIFACE recommends, due to the posted speed limit of 50 mph in the area and the assumed traffic volume (due to the many businesses located just south of the intersection) that the minimum MMUTCD traffic control device plan be TA-10: Lane Closure on Two Lane Road Using Traffic Regulators (see Figure A). Ensuring that traffic is stopped in both directions as the worker walks from one side of the road to the other side ensures the worker will not be struck by a vehicle. All traffic should be stopped when workers are crossing/working in the roadway. Traffic regulators are one method to ensure this.
