**REPORT#:** 2018OR030

## Pipefitter Struck by Pressurized Pipe and Killed

### **Oregon Fatality Assessment and Control Evaluation Program**

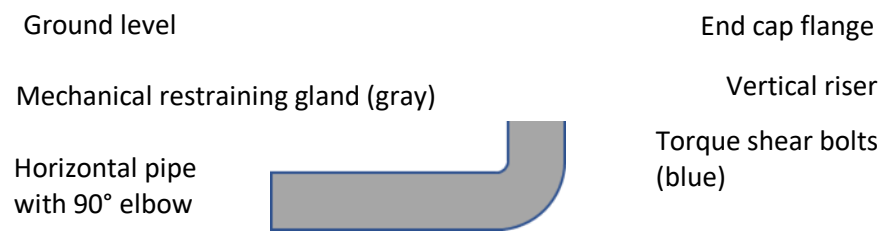
On March 6, 2018 at approximately 11:38am, as part of a three-man crew, a 49-year old Non-Hispanic White male pipefitter was killed while performing a hydrostatic pressure test of a fire suppression system for a data center under construction in Eastern Oregon. The decedent, an employee of a subcontractor, was testing the connection between two fire suppression tank pads when a below-ground connection of a 64-inch long, 12-inch diameter PVC pipe that was under pressure (175-190 PSI) failed. This caused the pipe to thrust upward approximately six to ten inches at high velocity, striking the impact driver the decedent was using to tighten flange bolts on the end cap of the above-ground section of the vertical riser (*see Diagram 1*). The torque shear bolts on the mechanical restraining gland connecting the south vertical riser to the horizontal section had not been tightened at all prior to being backfilled.

**Diagram 1. Schematic of vertical riser connection to horizontal section of pipe, with mechanical restraining gland and torque shear bolts.**

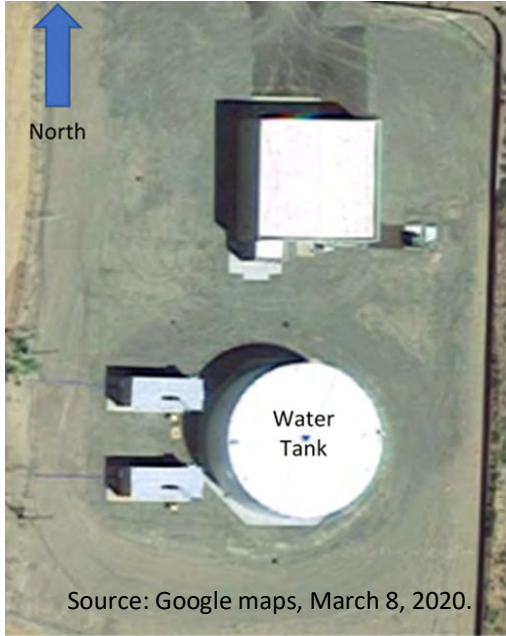
The incident site was near a large data center facility under construction in rural Eastern Oregon. The subcontractor had been hired by the prime contractor to provide excavation; water pipe installation for the facility, as well as construction and testing of both a fire suppression system and a wastewater treatment facility; and concrete work for building walls and equipment pads. Two fire suppression tank pads were connected to a 470,000-gallon water storage tank via 12-inch diameter pipes. The tank pads were also connected to each other via a 12-inch pipe that ran north to south below ground, with 64-inch long vertical risers at each end (see *Photo 1 and Diagram 2*). The vertical risers terminate within the fire suppression tank pads, which are then enclosed.

**Photo 1. Incident scene, aerial view, after construction completed.**

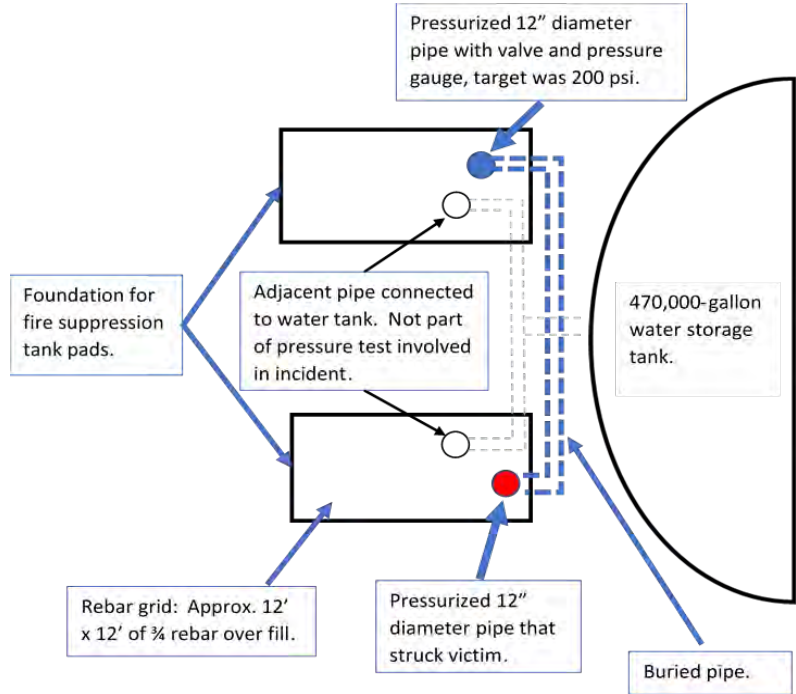
**Diagram 2. Schematic of Incident scene.**

On the morning of March 6, 2018, three subcontractor employees (the excavation/pipe superintendent, and two pipefitters) were performing a hydrostatic pressure test on the connecting pipe between the fire suppression tank pads. The subcontractor had already performed hydrostatic pressure tests on the 12-inch pipes between the water storage tank and the tank pads without a recorded incident.

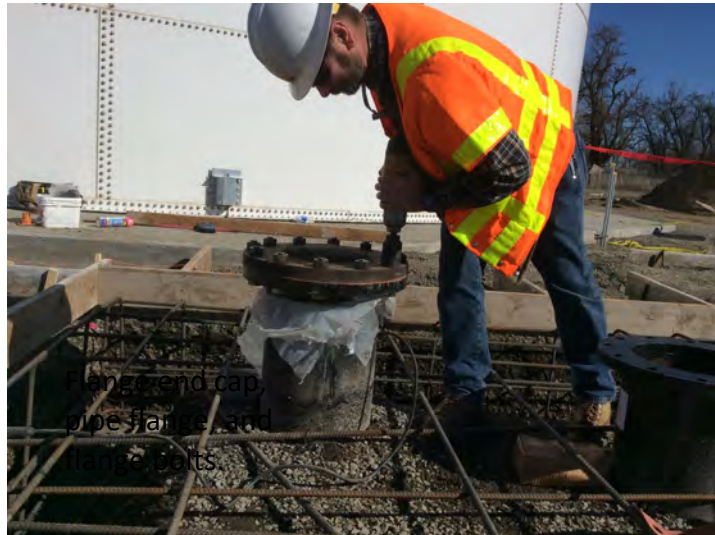
The hydrostatic pressure test on the pipe that ran between the tank pads took place after the pipes had been backfilled and the foundation forms and rebar for the tank pads had been constructed (*see Photo 2*). The vertical risers were backfilled with gravel so that 48 inches of the risers were below grade and 16 inches above grade. In preparation for the hydrostatic pressure test on the morning of March 6, 2018, the north riser was capped with a threaded port to which a hydrostatic pumping unit was installed, and the south riser was capped after the pipe was filled with water and secured with flange bolts (*see Photo 2*).

**Photo 2. Simulation of work performed by victim prior to incident. Note backfill and rebar lattice.**  
*(Photo courtesy of OR-OSHA.)*

During the hydrostatic pressure test, the pressure was approaching the target pressure of 200 PSI, but would not hold, indicating there was a leak. The crew looked for leaks on exposed pipe flanges and observed a small amount of water between the south riser flange and the end cap (*see Photo 2*).

One pipefitter and the excavation/pipe superintendent returned to the hydrostatic pumping unit on the north riser. The other pipefitter (decedent) stayed at the south riser and used an electric impact driver (*see simulation in Photo 2*) to tighten the bolts connecting a pipe flange and end cap. The water pressure in the 12-inch pipe was between 175-190 PSI as the decedent worked his way around the flange and end cap, leaning over it to tighten flange bolts with the impact driver held close to his chest.

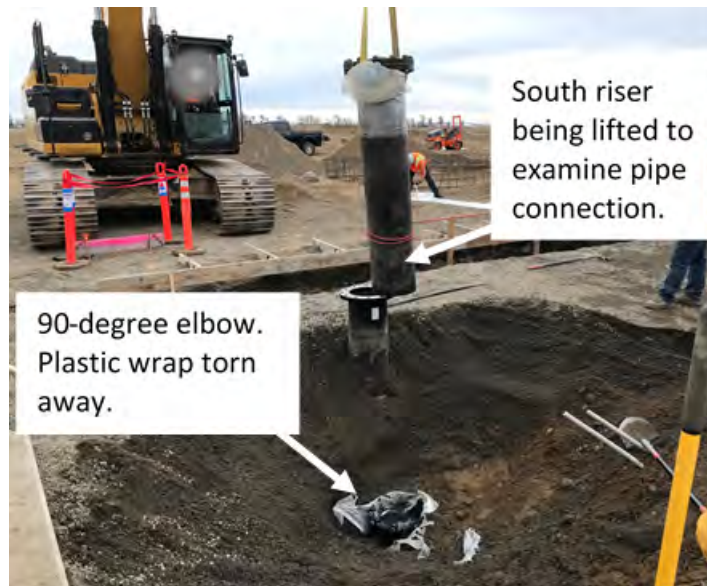
At approximately two feet of depth from top of riser, there was evidence of erosion alongside the riser, indicating a leak. At approximately four feet of depth from top of riser, plastic wrap placed around the connection between the vertical

riser and the 90-degree elbow of the horizontal section of the pipe was visible. The plastic wrap was placed around the riser and connection point by the crew who poured a thrust block, which is a concrete support block below the 90-degree elbow of a horizontal pipe. A thrust block prevents soil compaction below the elbow that could occur from pressure cycling, which could lead to misalignment strain on the pipe connection and subsequent leaks. The plastic wrap protects the connection joint, in case future access is needed for repairs or maintenance.

At approximately six feet of depth from top of riser, the connection joint between the vertical riser and the 90-degree elbow of the horizontal pipe section was visible (*See Photo 3*). The 90-degree elbow had a flange with 12 silver-colored flange bolts connected to the mechanical joint restraining gland, which had 12 blue torque shear bolts to connect and hold the vertical riser to the flange on the elbow of the horizontal pipe.

**Photo 3. Post-incident excavation. South vertical riser to connection point with 90-degree elbow of horizontal pipe section. (Photo courtesy of OR-OSHA)**

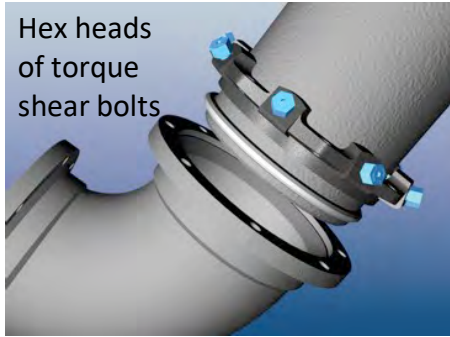
The mechanical joint restraining gland (“gland”) works by being bolted to a pipe flange with flange bolts, then a section of riser pipe is inserted into the gland and torque shear bolts on the gland are tightened, moving inward at an angle so that the torque shear bolts dig into the side of the pipe. The hex-heads of the torque shear bolts are made to break off when the bolts have been sufficiently tightened (*see Images 1-3, EBAA Iron, Inc., 2018*).

**Image 1.** Mechanical joint restraining gland (dark gray, with blue torque shear bolts) fitted onto end of pipe.

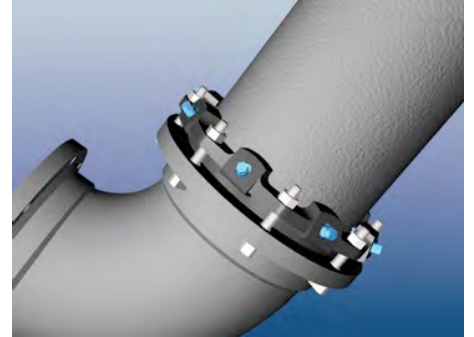
**Image 3.** The hex-heads of the torque shear bolts (blue) are broken off when sufficiently tightened.

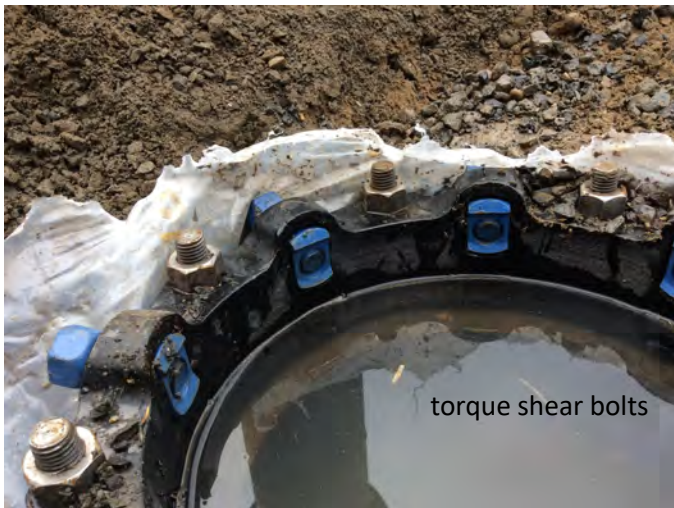
When the plastic wrap was torn away, observers noticed that the hex heads of the torque shear bolts on the gland were intact, indicating that the torque shear bolts had not been tightened sufficiently (see *Photo 4*). When the south vertical riser was removed and inspected, there were no torque shear bolt marks on the pipe, which would have been visible had the torque shear bolts been tightened sufficiently (see *Photo 5*).

**Photo 4.** Flange bolts (silver) and torque shear (blue) on gland. Vertical riser has been removed. Note hex-heads of torque shear bolts are still attached.  
(Photo courtesy of OR-OSHA.)

### ***Recommendation #2: Pipe systems should be pressure-tested and inspected before pipes are backfilled. Use checklists during tasks and inspection process to reduce risk of overlooking critical steps that could endanger workers.***

The State Plumbing Inspector, the Fire Marshall, and the prime contractor's supervisor conducted a visual inspection of the vertical riser connection to the elbow, which was wrapped in plastic. After the inspection, the prime contractor authorized the subcontractor to backfill the area around the pipes. There was no indication a review of the Cite it, Write it checklist or something akin to the subcontractor's hydrostatic testing procedure checklist was reviewed. If those documents had been reviewed during the inspection process, it is likely the untightened torque shear bolts on the south riser would have been discovered and corrected before the pipes were backfilled.

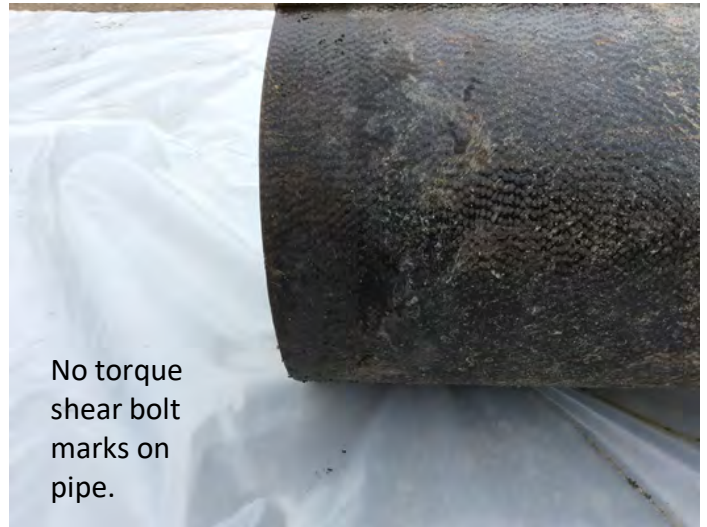
**Photo 5.** Bottom end of south vertical riser. Note there are no torque shear bolt marks on the outside of the pipe, indicating torque shear bolts were not tightened.  
(Photo courtesy of OR-OSHA.)

At approximately 11:38am, the below-ground connection joint of the south riser failed (as discovered during the subsequent investigation), causing the riser to rapidly thrust upwards approximately six to ten inches, striking the impact driver and the decedent in the chest, knocking him backwards and onto the rebar grid surrounding the riser.
