**REPORT#:** 18MA046

**REPORT DATE:** May 14, 2020

## Municipal Crossing Guard Fatally Injured When Struck by a Car – Massachusetts

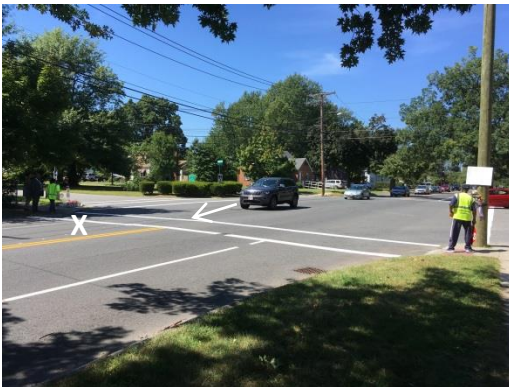
Figure 1 – Incident location. X marks victim location and the arrow indicates direction of travel of the vehicle.

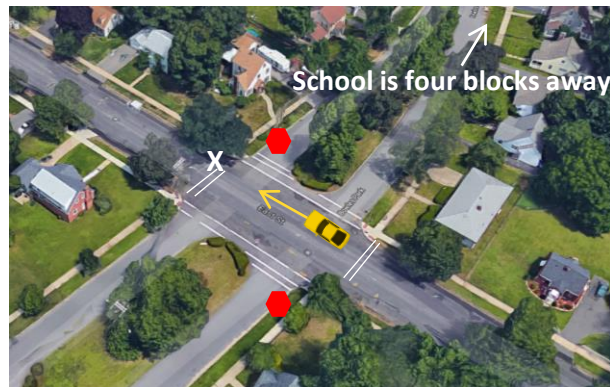
Figure 2 - Aerial view of incident location. X marks victim location and the yellow arrow indicates vehicle travel direction. The red hexagons indicate stop signs for the side streets. The school is located four blocks away.

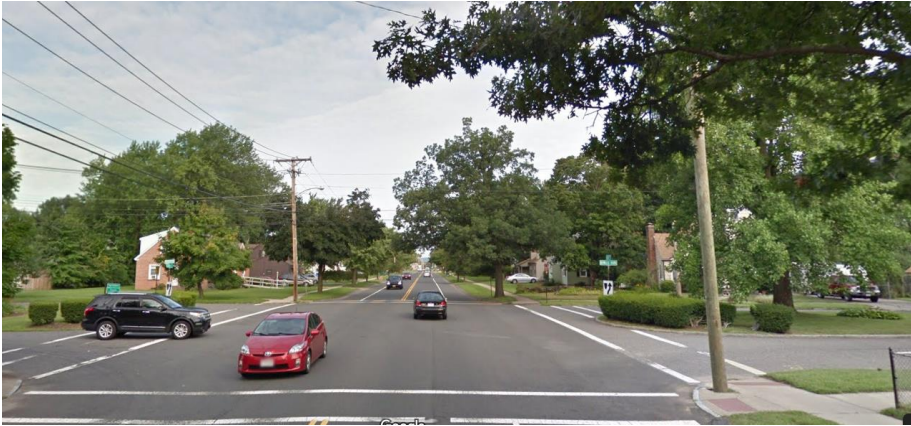
The victim's assigned location was the unsignalized four-way intersection of the island-divided side street and the main roadway (Figure 3 and 4). This intersection was about four blocks from the school. Because the side street had a wide grass median island and the main roadway had wide paved shoulders, this resulted in a large intersection. At the intersection, stop signs were located only for the side street and both the side street and the main roadway had sidewalks separated from the roadway edges by grassy areas. On-street parking was allowed on both the side street and the main roadway. All of the painted crosswalks at the intersection were cracked and fading and in need of being repainted. There was no roadway signage warning motorists of the crosswalks across all four areas of the intersection (Figure 5).

Figure 3 - Incident location. X marks victim location and the arrow indicates vehicle travel direction.

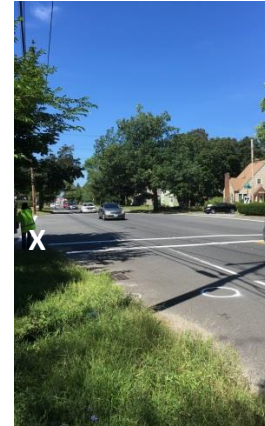
Figure 4 - Incident location. X marks victim's assigned location.

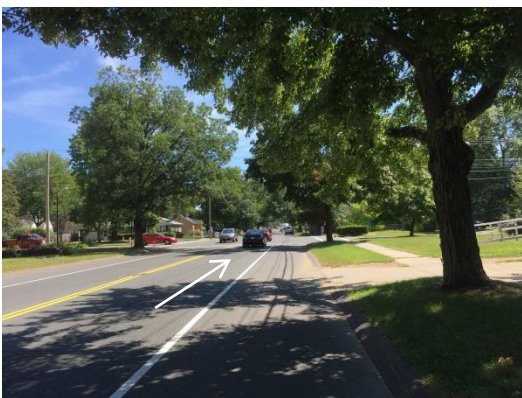
Figure 5 – Roadway leading up to the intersection. Note that there is no signage warning motorists of the crosswalk ahead.

In this case, prior to the incident, no traffic control signage was present at the crosswalk locations. The least effective crosswalk roadway markings, which are two white parallel lines with no center lines, were being used and these markings were faded and cracked. Although at the time of the incident there were no cars parked on the roadway edge, on-street parallel parking was allowed within 20 feet of the crosswalk and on both sides of the roadway. This is prohibited by the MUTCD, Part 3 Figure 3B-21. Cars parked within 20 feet of a crosswalk could possibly contribute to a motorists' decreased visibility of pedestrians in the crosswalks.

In order to make the crosswalk location safe for crossing guards, students, and other pedestrians using the crosswalk, and to make the area more visible to motorists, municipalities should ensure that permanent MUTCD compliant, fluorescent yellow-green signage are installed prior to and at all crosswalk locations and that painted crosswalks are highly visible and in good condition. Municipalities should also routinely review crosswalk signage for compliance with the MUTCD and routinely evaluate crosswalk roadway markings to ensure they are not faded and are in good condition.

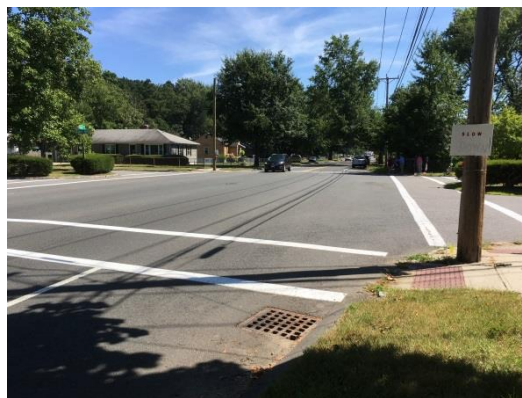
Figure 6 – Incident location. X marks victim location and the arrow indicates vehicle travel direction.
