REPORT#: 17MI128

REPORT DATE: 8/5/19

Construction Foreman/Carpenter Dies from Complications From Fall From Roof

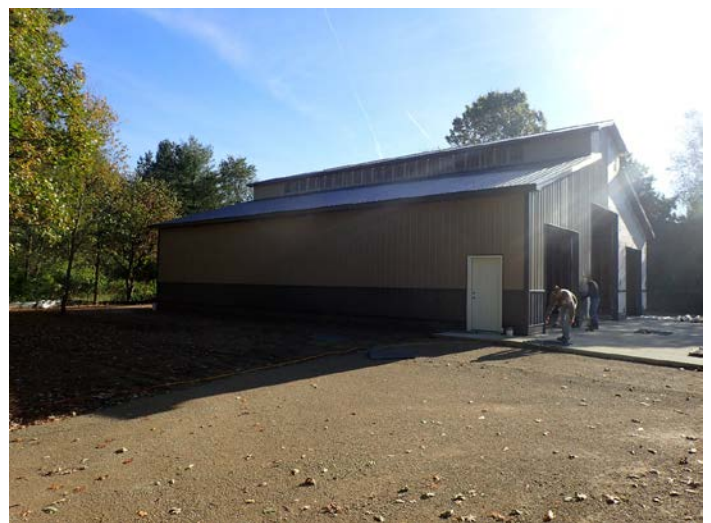
Photo 1. Pole barn under construction
