REPORT#: 15MI110

REPORT DATE: 1/16/19

Construction Laborer Working in Highway Work Zone Struck by Van

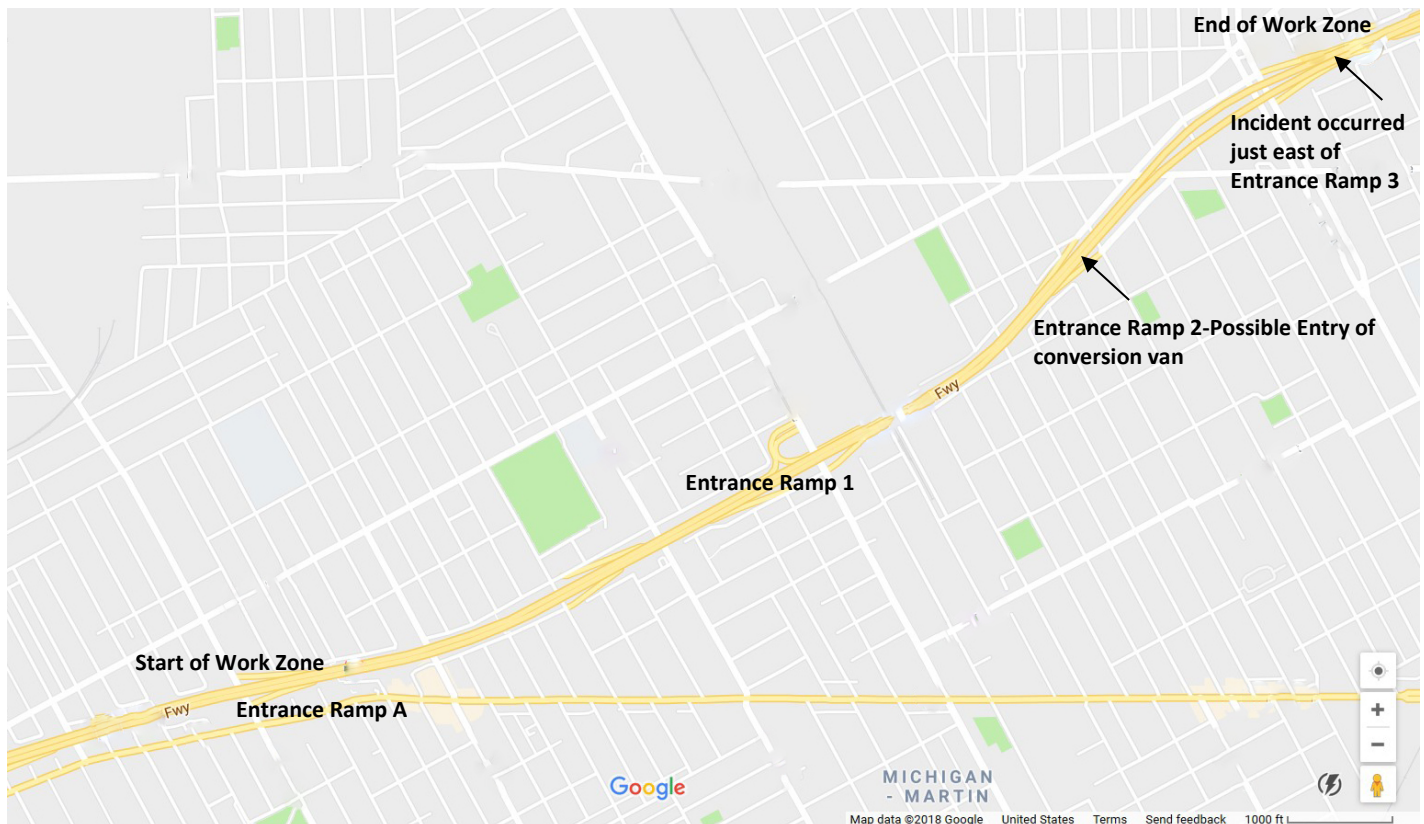
In the direction in which the work crew was working, there were four expressway entrance ramps within the 2-mile long work zone (See Figure 1). The responding police accident investigator stated to the MIOSHA compliance officer that both ramps #1 and #2 had barricades erected; the accident investigator had to drive around the barricades at ramp #2. Sight lines to the entrance ramp #2 were unobstructed (Photo 1). After entering the expressway, the roadway curved (Photo 2).

The crew consisted of lead truck (“over truck”) with 4 workers. The “over truck” was located approximately 65 feet east of the second crew (decedent and his coworker) with a kettle truck. The “over truck” workers used high pressure air to clean out roadway cracks and seams to prepare the cracks/seams for sealing. The decedent and his coworker followed with the kettle truck and used a pressurized wand to inject a molten asphalt based material into the now open and clean seams/cracks. At the time of the incident, the over truck was working just east of the foot of the entrance ramp #3e (See Figure 1)

Figure 1. Google Map view, with identifying street names removed, of the incident site

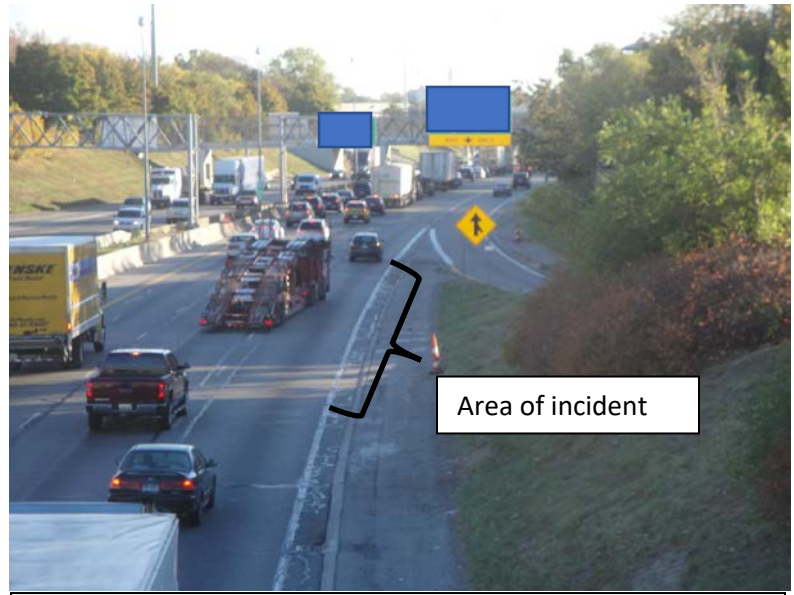
The decedent and his coworker were wearing Class 3 high visibility vests; scene pictures show the vests had substantial amounts of sealing material on them. The workers were on break and waiting for the “over truck” crew to move ahead. The decedent’s coworker was positioned at the rear of the truck on the driver’s side checking the temperature of the crack sealing material. He saw the decedent walking toward him from the right shoulder of the roadway (Photo 3).

Photo 3. Overview of Incident site. View of expressway just east of entrance ramp #3.

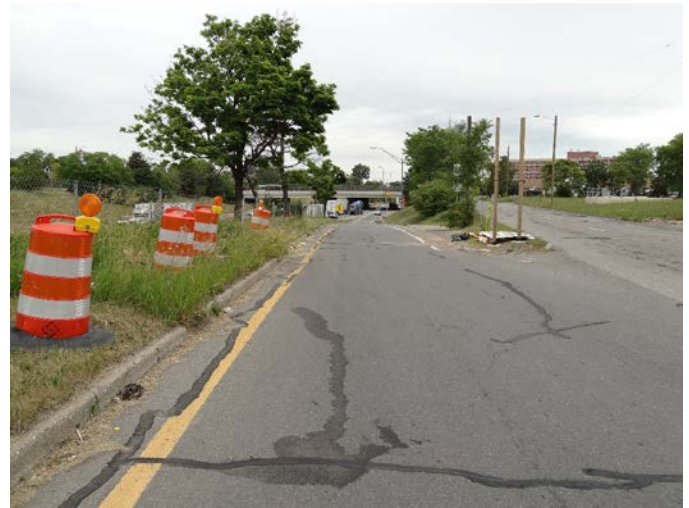
Photo 5. Construction materials at entrance ramp #2
