REPORT#: 15MI104

Caretaker of a Farm Held in Trust Died Due to a Tractor Overturn to the Rear While Moving Downed Tree

Michigan Fatality Assessment and Control Evaluation (FACE) Program

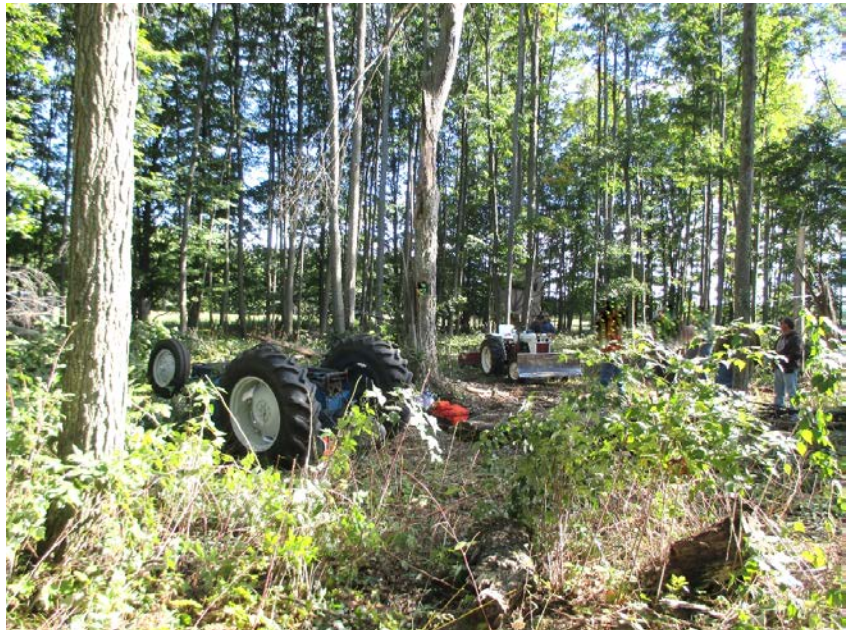
Photo 1. Overview of incident scene

The decedent was working with his family member. The decedent was operating a Ford 3000 tractor while the family member was operating a 1970s-1980s SATOH BISON S-650G equipped with a blade in both front and back (See Photo 1 depicting incident scene) to push the smaller tree tops toward the grass pasture/edge of the woods.

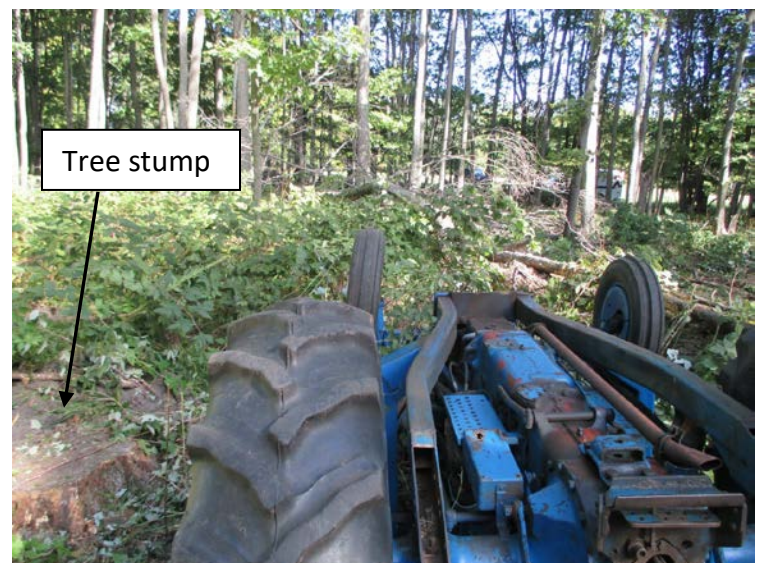
The tree stumps were not cut down to ground level (Photo 2). The woods had uneven terrain and there was a slight incline. There was understory plant material covering the ground and the stumps. The ground was dry.

Photo 2. Stump by tractor wheels

In the path of the tractor, near the front passenger side wheel was a tree stump partially hidden by undergrowth.

Recommendation #3: Evaluate the terrain prior to beginning an operation with a tractor and ensure the working area is clear of obstructions and/or mark hazards for visibility.

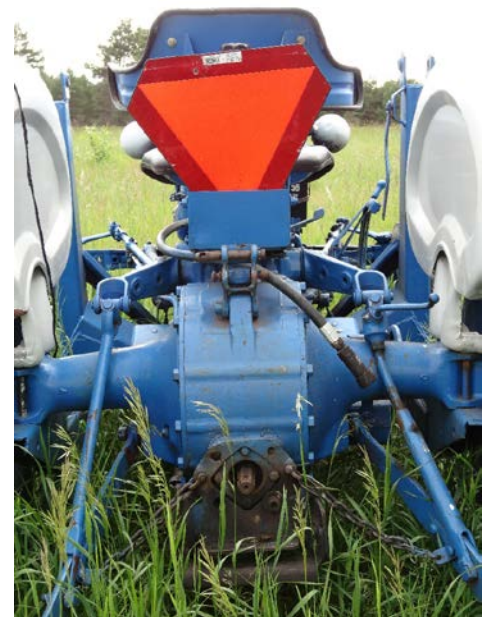
The decedent was using a refurbished two-wheel drive, 1960s-era Ford 3000 tractor. The tractor did not have a rollover protection structure/seatbelt, a PTO master shield and stub shield, or a drawbar (Photo 3).

The tractor had an improperly displayed, non-permanently affixed slow moving vehicle (SMV) sign on the rear of the tractor; the SMV sign was wedged in an upside-down position in a metal compartment behind the tractor seat. Police photographs taken at the incident scene (Photo 5) show the SMV in the same position as in Photo 3 taken by the MIFACE researcher. It is unknown if the decedent drove the tractor on a public roadway. The family member did not know if the tractor had mechanical issues, such as the condition of the clutch or brakes. No maintenance records were made available to the MIFACE researchers.

Photo 3. Placement of SMV sign behind tractor seat and no drawbar

Recommendation #5: Ensure all tractor guards and safety features are correctly installed.

Discussion: Although not a factor in this incident, the decedent placed himself at risk when he operated the tractor without the PTO master shield and stub shield. Tractor operators should ensure that PTO shields are intact before use. Additionally, although unknown if the tractor was driven on a public roadway, the installation/configuration of the SMV sign did not comply with transportation signage requirements. Tractor owners should ensure that SMV signs are properly installed on equipment driven on a public roadway.

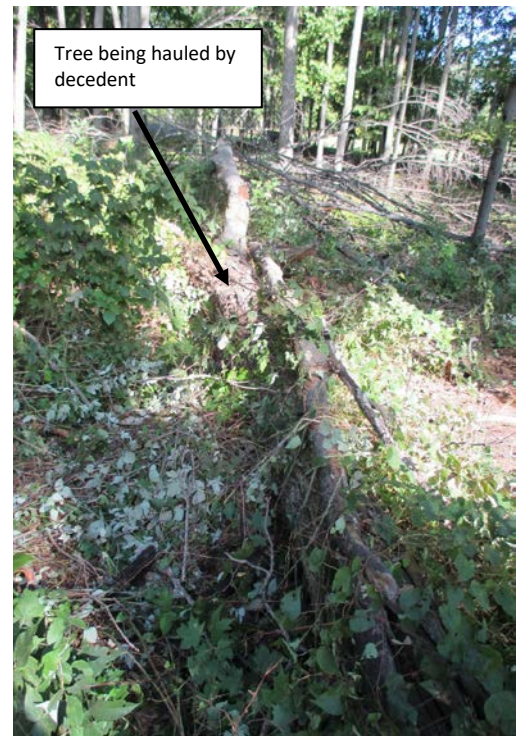
After lunch, the decedent and his family member drove the equipment to the area where the logging had previously taken place. After the logging activity had taken place, another tree had fallen, and the decedent wanted to haul the approximately 16-inch diameter, 90-foot long tree (Photos 4, 6) out of the woods prior to removing the tree tops. The decedent wrapped a chain around the trunk of the tree and around the 3-point top link pin at seat height, located approximately 33 inches above the ground.

Photo 4. Overview of tree and chain placement on tree

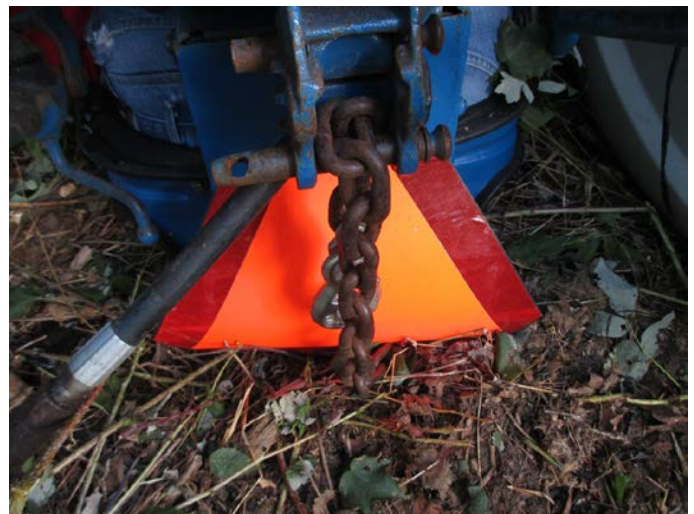
Photo 5. Location of chain on tractor and SMV sign placement/orientation at time of incident

The decedent hitched high, near seat height, which increased the angle of pull, the leverage of the tree being pulled, and the pressure of the rear tires against the ground. When loads are attached to a tractor at any point other than its designed location (drawbar or other hitch points recommended by the tractor manufacturer), the design of the tractor for pulling loads is defeated.

Recommendation #2: Ensure proper hitching techniques are utilized when using the tractor to pull loads.

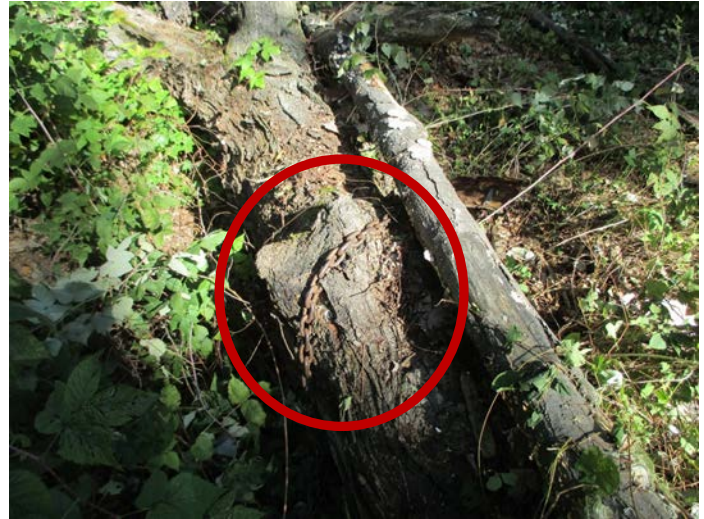
Photo 6. Location of chain on tree

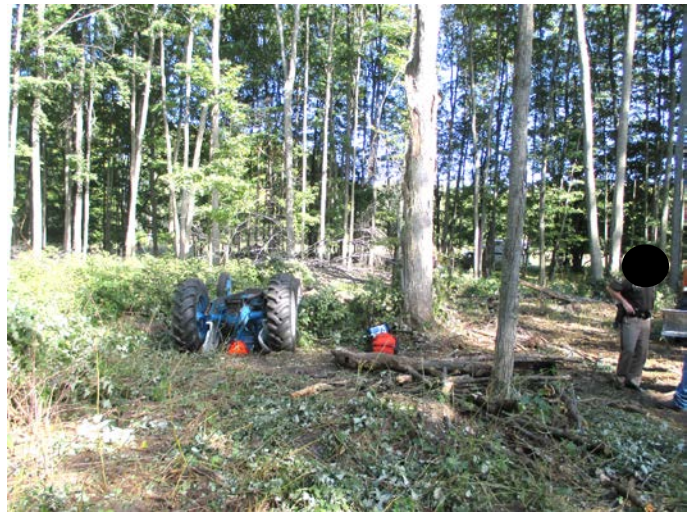
Discussion: In the area of the woods where the decedent was working there was uneven terrain, a slight incline, and undergrowth which may have obscured ground hazards. It is unknown to what extent the decedent evaluated the work area for hazards. Police photographs (Photos 1,7) taken at the scene show he did not mark the location of the stump or clear out the area prior to hauling the large tree. MIFACE recommends that prior to operation of equipment that the work area is inspected, and hazards are identified, marked, or, to the extent possible, remediated.

Photo 7. View of incident area, undergrowth, obstructions in path of tractor movement
