# MIFACE Investigation Report #11MI059

## Subject: Hispanic Farm Laborer Struck by 550-gallon Water Tank When Wood Support Structure Collapsed

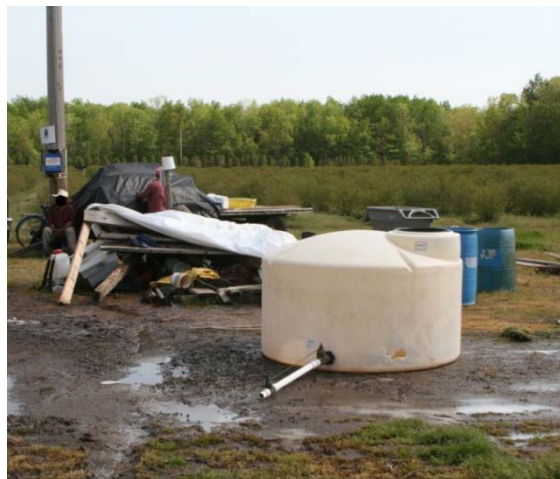
Figure 1. Overview of incident scene after moving the tank from the decedent

created and protected a storage area under the upper platform/tank. The nails used for the structure's assembly were standard non-galvanized nails. The decedent did not sink the corner posts in the ground or use cross-bracing.

The sequence of events was unwitnessed. The owner and the responding sheriff department hypothesized that the decedent was retrieving some items within the storage area under the tank when the structure collapsed. One corner post was broken. The post either broke, causing the structure to collapse and the water tank to fall, or the post broke during the water tank's fall. The tank fell toward the open side that allowed access to the stored material. When the structure collapsed, the crash was

- Outdoor rigid frame structures/platforms constructed with outdoor-rated, pressure-treated lumber should have the appropriate lumber strength, bracing, and fasteners to withstand at least two times the weight of the supporting mass.

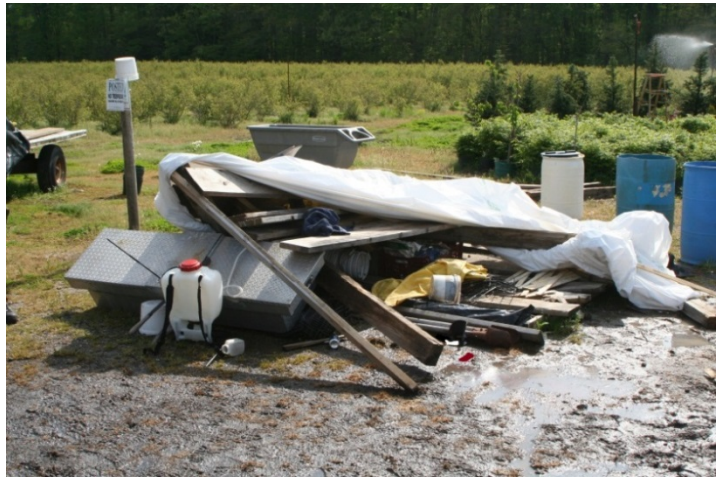
Figure 2. Overview of incident scene

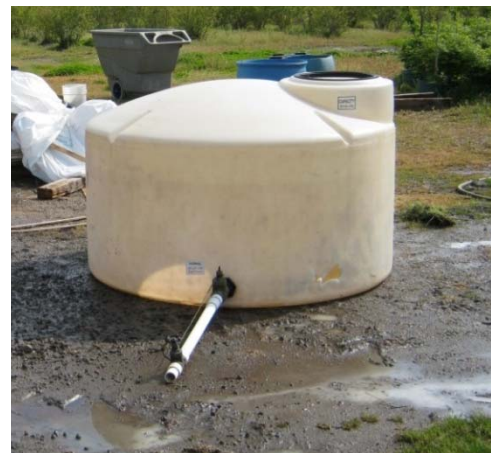
Figure 3. Water tank with hole in side

While emergency response was summoned, the farm owner used a shovel to poke a hole in the water tank to drain the water so he could move the tank from the decedent (Figure 3).

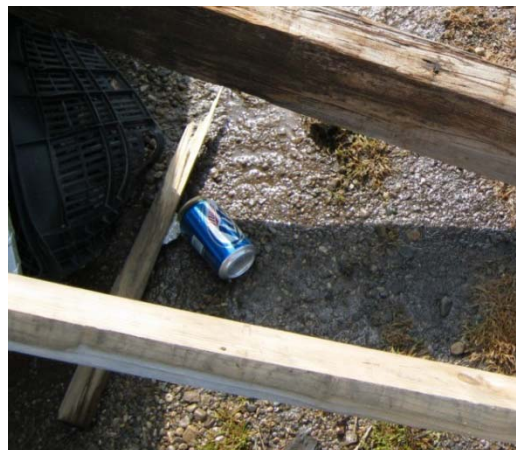
The police pictures taken at the scene show a beer can next to the collapsed structure (Figure 4). It is unknown if the can was empty and had been there for a period of time or if it was a can from which the decedent had been drinking.

Figure 4. Beer can found at scene

The employer did not have an alcohol and drug-free workplace program. Even small operations with few employees should consider designing and implementing an appropriate alcohol- and drug-free workplace program that matches the needs of their organization.
