REPORT#: 17MI098

REPORT DATE: 10/22/19

Farm Owner Drowned in Ditch When Tractor Overturned to Side and Pinned Him

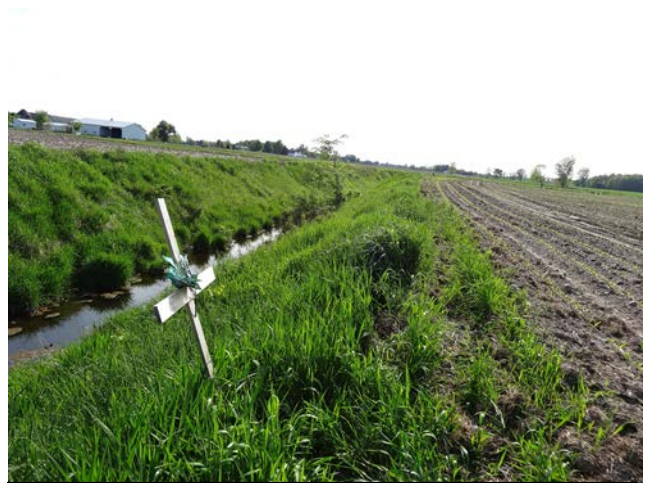
Photo 1. View of field looking west. Cross placed at site of incident.

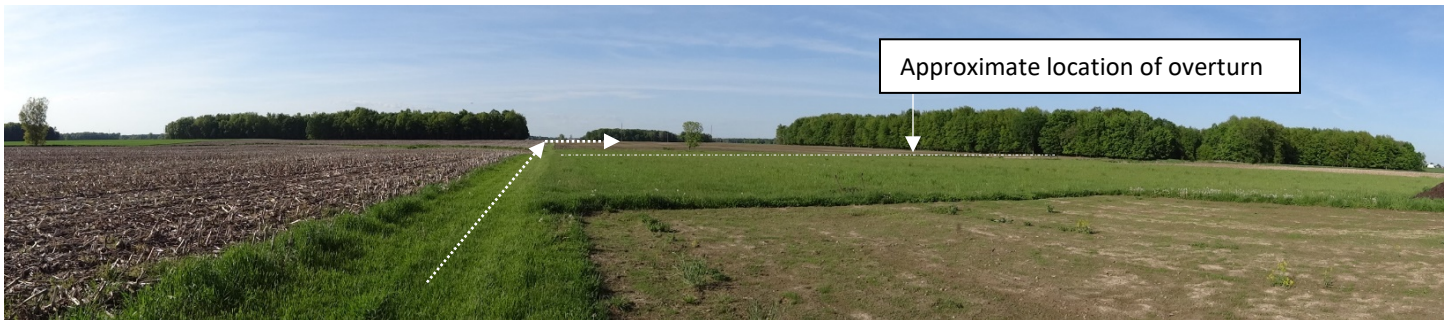
His residential property included his home, a large lawn, several outbuildings, a barn, and a large garden (Photo 2). The incident occurred in the field north of his residence. There was a ditch with steep banks separating the residence lawn and the hay field. Responding police estimated the depth of the ditch as 10 feet. The base of the ditch was filled with

Photo 2. Overview of backyard/field configuration. Dotted arrows show path of decedent. Dashed line shows location of ditch.

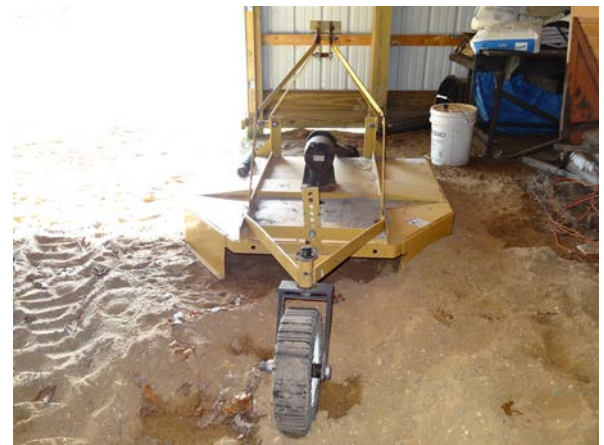
The John Deere 2320 tractor involved in the incident was purchased in 2009-2010. The tractor was purchased equipped with 42-inch long front forks and a roll over protection structure (ROPS). For reasons unknown, the decedent removed the ROPS. When mowing, the decedent attached a PTO-powered brush hog to the rear of the tractor (Photo 3).

Photo 3. Brush hog used on day of incident

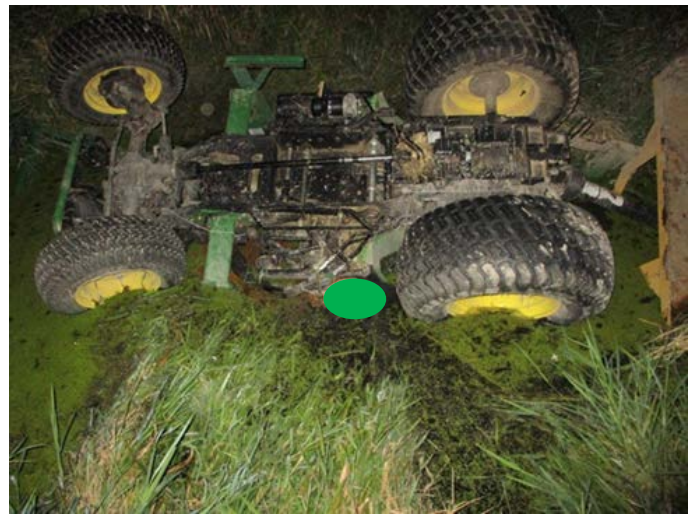
At approximately 9:15 p.m., the family member drove along the edge of the field and spotted something "green" in the ditch, which was the decedent's tractor upside down and submerged in the water-filled ditch (Photo 4). The family member called the decedent's spouse and then called 911 after finding the decedent trapped in the water, under the tractor. All family members were at the scene when the emergency responders arrived.

Photo 4. Overturned tractor in the ditch. Green oval is location of decedent under the tractor.

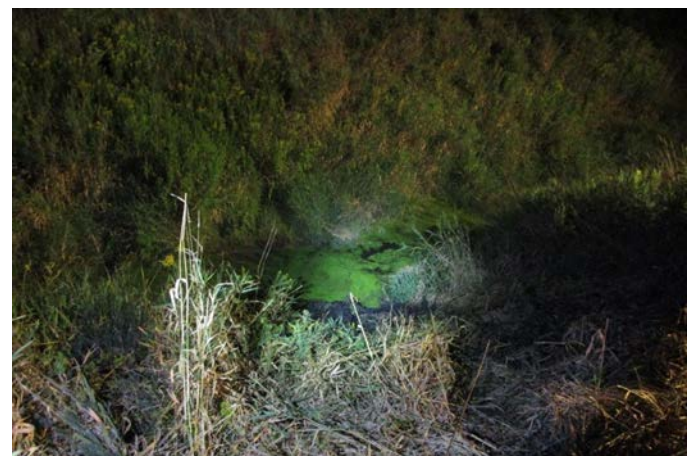
It appeared that the decedent had been driving eastbound adjacent to the bank mowing the weeds. Police noted that the incident site had an area that clearly showed where the vegetation had been knocked down at the bank of the drainage ditch at the incident scene (Photo 5).

Photo 5. Incident scene showing ditch bank and water level.

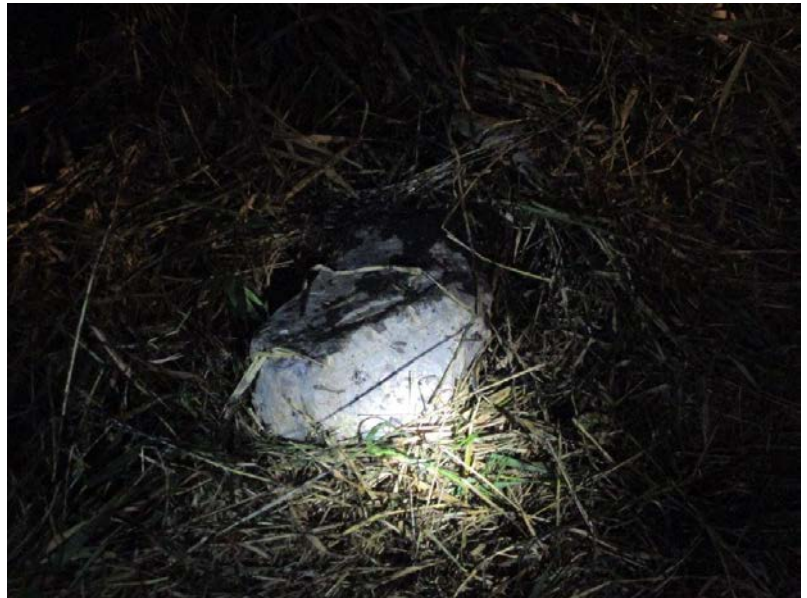
The incident was unwitnessed, and the exact sequence of events is unknown. Several hypotheses were developed based on potential scenarios: 1) The tractor struck concrete debris obscured by tall and/or lush grass (Photo 6). The impact either bounced the tractor or turned the steering toward the ditch leading to a slide down the slope enhanced by the tractor's "turf tires." Near the bottom the tires caught beginning an overturn that ejected the operator into the water. Due in part to the removed/disabled upper ROPS section the tractor completely flipped, landing on top of the operator and pinned the operator in a submerged condition; 2) the passenger side tractor wheel(s) were too close to the edge and the bank sheared, causing the tractor to slide down

Photo 6. Concrete block at ditch edge that may have been a factor in this incident

Where operations are to occur where there is a likelihood of obstructions hidden by plant growth operators should consider a worksite survey to determine if obstructions are present.

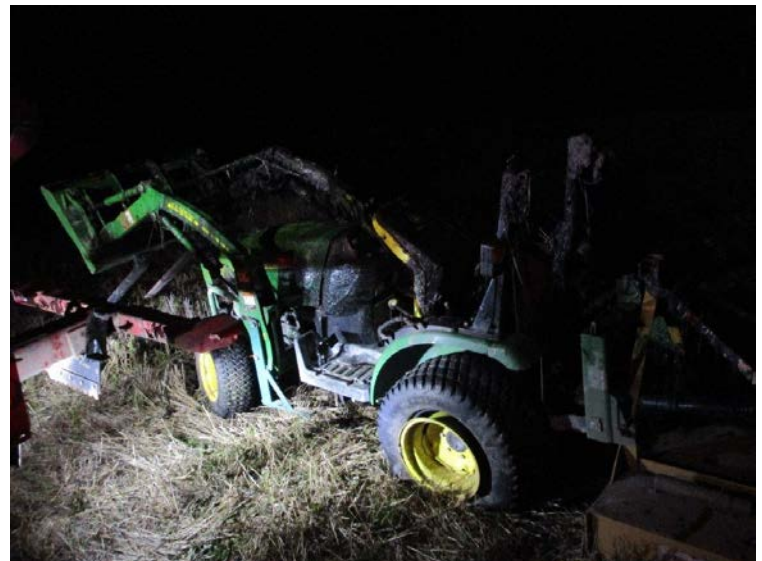
A towing company with the assistance of emergency responder removed the tractor and the decedent's body from the ditch. After the tractor was removed from the ditch, police found that the driver's side rear tire was flat.

When the tractor was removed from the ditch, the tractor bucket was elevated (Photo 7). It is unknown if the decedent had been operating the tractor with the bucket elevated or if this was caused when the tractor rolled into the ditch. Post mortem examination found evidence that he may have been, at one point during the rollover, under one of the rear tractor tires.

Photo 7. Condition of tractor after being removed from ditch. Note elevated bucket and flat driver's side rear tire.

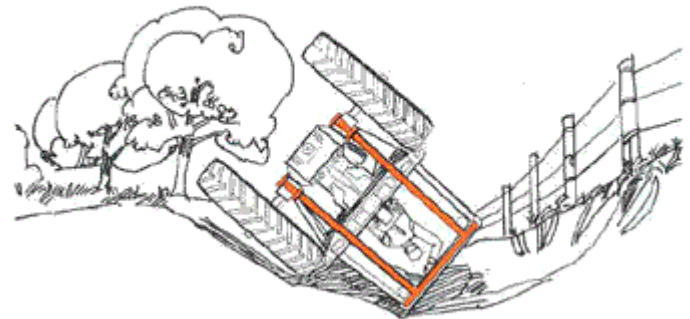
Discussion: Although the farm was on flat terrain, a rollover hazard existed at the confluence of the ditch edge and field. Rollover protective structures (ROPS), when used in combination with a seatbelt, are 98 percent effective in preventing death and serious injury in the event of a tractor overturn. The tractor had originally been equipped with a factory-installed rollover protection structure, but the ROPS was removed by the decedent. If the ROPS and seatbelt were used as intended, the decedent might have been able to exit the tractor seat after the tractor came to rest at the base of the ditch because the ROPS may have provided enough clearance between the tractor seat and the base of the ditch.

Figure 1. ROPS protecting operator in tractor overturn to side

Recommendation #1: Tractor owners should ensure their tractors have a manufacturer-approved, certified, tractor specific rollover protection structure (ROPS) and seatbelts installed.

To maintain the operator safety, tractor operators should ensure that all tractors are equipped with a tractor-specific ROPS and seatbelt certified/approved by the manufacturer. To maintain the zone of protection provided by the ROPS, the seatbelt must be used. Operators should assure any unit where the ROPS has been removed for authorized operations is only used for those operations. Older tractors manufactured prior to 1976 do not come equipped with a ROPS. To assist farmers in finding a ROPS for these older tractors, the University of Kentucky Extension program developed the Kentucky ROPS Guide, which can be used by any US or Canadian farmer to locate retrofit ROPS for older tractors or even “gray market” tractors (i.e., non-U.S. made tractors imported without manufacturer authorization). The guide is available online at <http://www.ca.uky.edu/rops>.

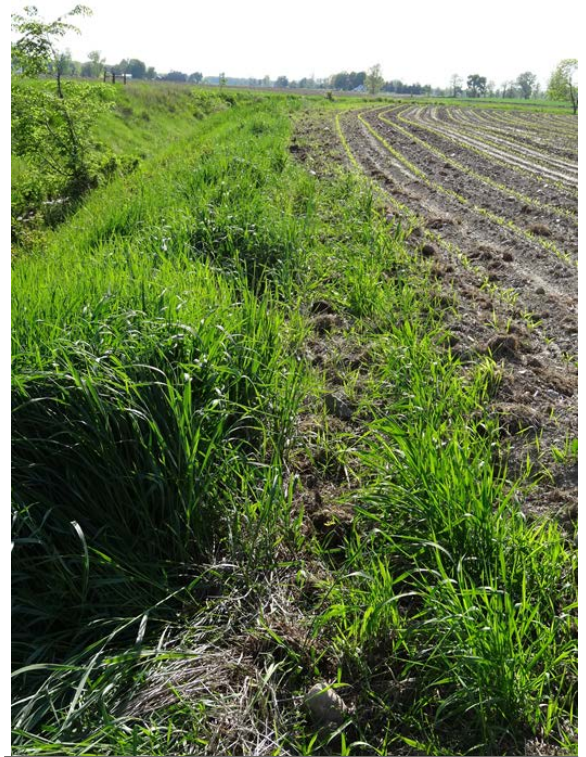
Discussion: The outside row of soybeans was planted approximately two- to three- feet from the edge of the ditch edge. This limited distance between the edge of the field and the ditch narrowed the traveling room the decedent had to avoid injury to the crop. A planting boundary should be established so that the outside planting row does not impinge on an access area to other fields/areas. The grass boundary from the edge of the ditch should be at least equal to the depth of the ditch. A good rule of thumb is to stay back from the edge of the ditch as far away from the bank as the ditch is deep. The weight of the tractor could cave the bank in if too close to the shear line.

Photo 8. Looking west, field edge. Photo taken from location decedent’s tractor overturned.

Recommendation #2: Conduct a field survey to identify hazards, including hidden obstructions and establishing crop-planting limits/boundaries to maintain farm machine access.
