REPORT#: 17MI136

Farm Laborer Pinned by Tree Branch Against His Tractor Seat

Michigan Fatality Assessment and Control Evaluation (FACE) Program

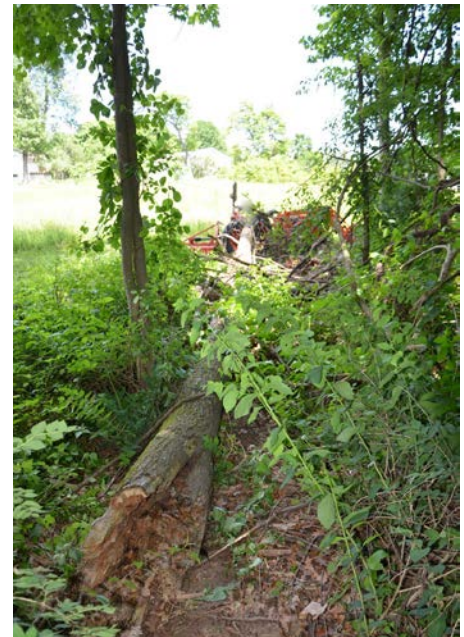
In summer 2017, an 80-year-old male farm hand died when a tree branch from the downed tree being moved by his tractor's loader bucket struck him (Photo 1). The decedent drove the Kubota MX5000 tractor equipped with a brush hog and a Kubota LA852 loader in the front to a 10-acre field to mow it; the now unused crop field was being maintained for future sale. He arrived at the site mid-morning, mowed for a while, ate lunch with a property owner adjacent to the property being mowed, and then resumed the task. The incident occurred near a tree line while he was mowing the perimeter of the property. A tree had broken near the base of the trunk and had fallen from the tree line into the field in the mowing path. The tree had several branches that formed a "Y". The incident occurred while the decedent, seated in the tractor seat, attempted to use the loader as a bulldozer to move/push the tree to the side and out of the field. Per the police report, it appeared the decedent had made several attempts to move the tree; there were marks on the hydraulic arms of the loader as well as paint transfer to the tree consistent with the hydraulic arm dimensions. On the decedent's last attempt, it appeared the tree "rolled" up and over the bucket and a branch struck and pinned him in the tractor seat.

Photo 1. Downed tree being moved by decedent using a loader bucket. View from within tree line.

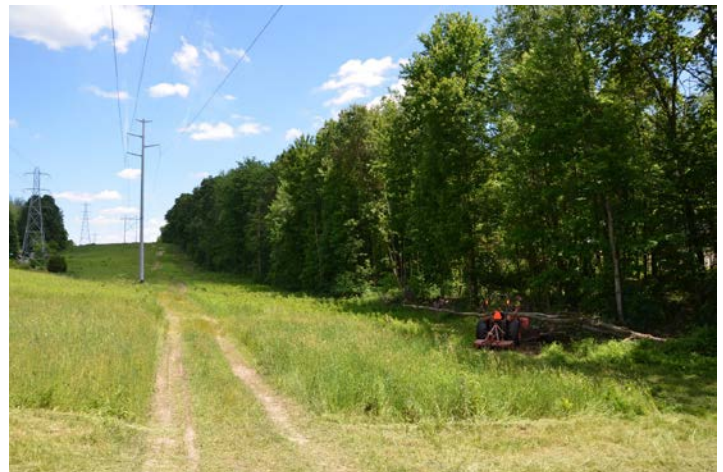
The incident scene was a 10-acre unused former crop field located approximately 4.5 miles from the farm. The field was positioned under power lines, had residential homes on one side and a tree line on the other side. The field sloped slightly downward from the residential side to the tree line (Photo 2).

Photo 2. Topography of field. Power lines, slope and tree line. Location of decedent's tractor near tree line.

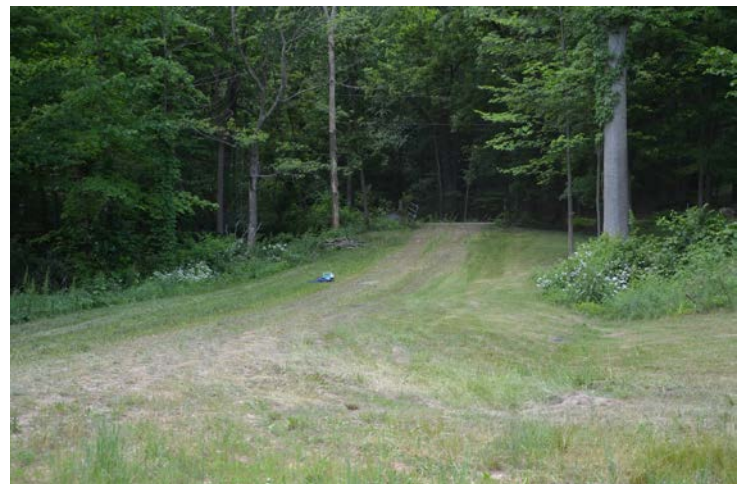
The field was accessed by gated entrance from a public roadway (Photo 3). The decedent drove the Kubota MX5000 tractor with a foldable rollover protection structure (ROPS) in the protective position. The tractor was equipped with a slow moving vehicle sign, vehicle marking/lights and seatbelt in place. The tractor had a brush hog (mower deck) at the rear and a Kubota LA852 loader in the front.

Photo 3. Gated entrance to field from road. Also shows area that had been mowed.

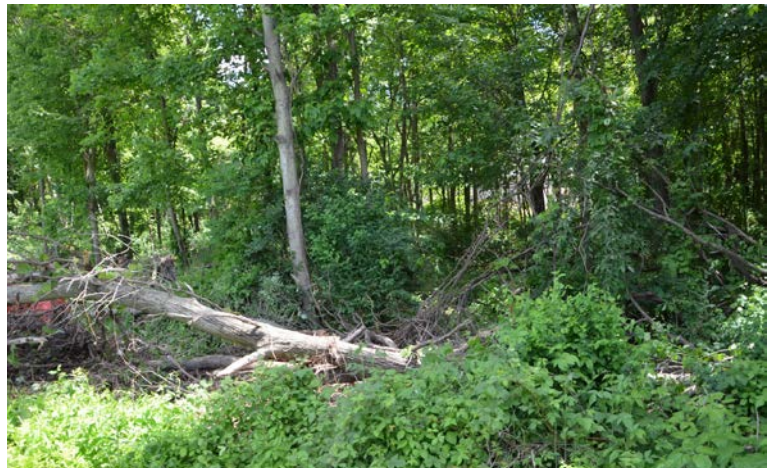
Photo 4. Downed tree location and position near tree line.

The decedent began to mow the second half of the parcel, starting at the perimeter. He had made at least one mowing pass around the field perimeter. While mowing near the tree line, he encountered the 25-30-foot long tree that had fallen into the field (Photo 4). The 2-foot diameter tree trunk had broken approximately 3-4 feet above the ground. The main branches of the tree, which were approximately 14 inches in diameter, formed a “Y” shape (Photo 5). The tree had fallen between other trees in the tree line.

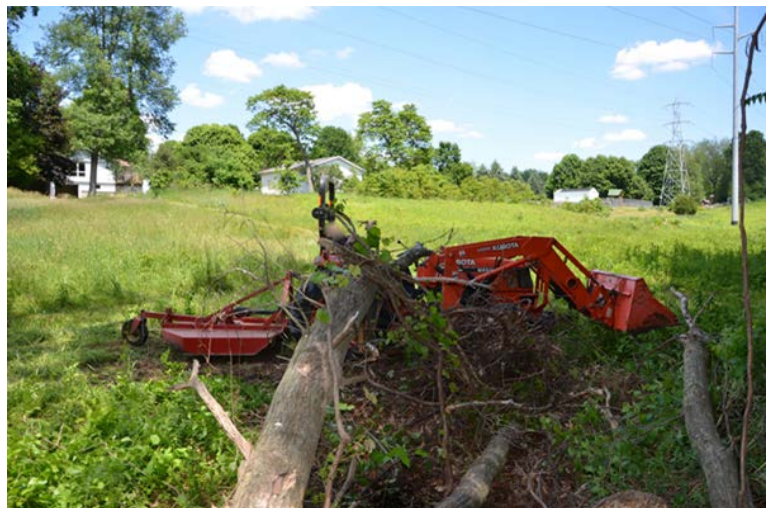
Photo 5. Downed tree location and position near tree line. Note the branches forming a “Y” shape, one on the ground and the other laying across the tractor.

Photographs 5-9 showed that the decedent made multiple attempts to push the tree, using the tractor/loader bucket as a bulldozer. He positioned the tractor nearly perpendicular to the mowing path. There were distinct marks along one of the tree's upper limbs as where it appeared he had pushed it and caused a gouge within the bark at a distance consistent with that of his bucket and the line made within the bark was also consistent with the thickness of the side of his bucket. Farther down the branch towards what would have been the top of the branch, another set of marks had orange paint

- Hypothesis #3: The multiple attempts to push the tree out of the way may have been stopped by the small branch coming into contact with a stump and/or entanglement in wild grape vines (See soil disruption in Photo 5). The height of the bucket (we believe the loader level was not changed) suggested the decedent lifted while pushing the larger branch. The small branch may have been stopped by the stump in addition to the wild grape vines. The compressive force, as evidenced by the side bucket cuts on the large branch, was being applied at the angled part of the bucket. Friction no longer could withstand the compressed “Y” force and the large branch “released” to its natural position. The location of the resting point of the branch was consistent with an arc from the branch crotch rather than a full-length tree movement. The limb forcefully came over the bucket, hit the tilt arms low, slid up the arms and by that time there was enough release at the stump to allow some clockwise rotation (looking from the tree’s stump) allowing it to clear the loader arms, then rotating counter clockwise to its natural position. Also, the deformation of both fenders suggested a downward force rather than a lateral force.

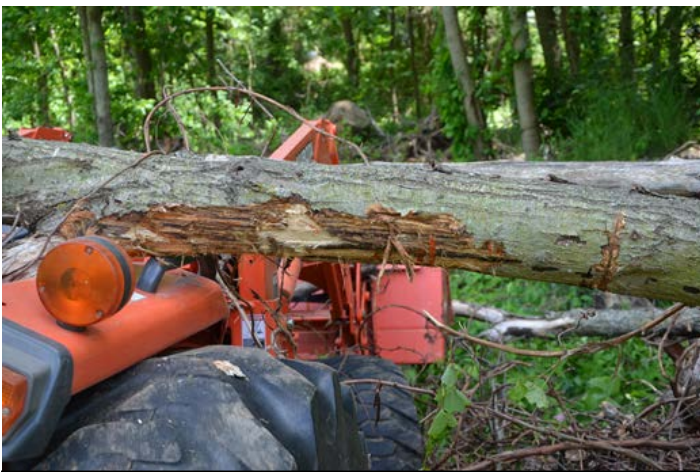
Photo 6. Marks on tree caused by loader bucket and hydraulic arms from multiple attempts to push tree

transfer that was consistent with the color of his tractor (Photo 6 and Photo 7). There were marks on the hydraulic arms of the tractor as well as where the hydraulics met the hydraulic cylinder (Photo 8 and Photo 9). Orange paint was visible on the tree and transferred in a width consistent with that of the hydraulic arms of the tractor.

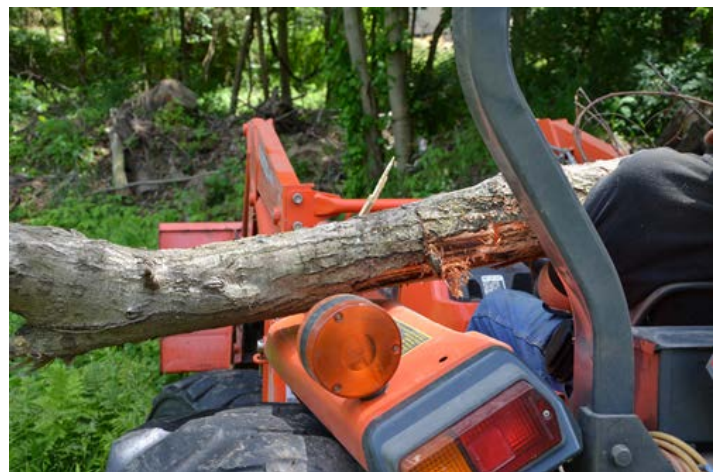
Photo 7. Marks on tree caused by loader bucket and hydraulic arms from multiple attempts to push tree

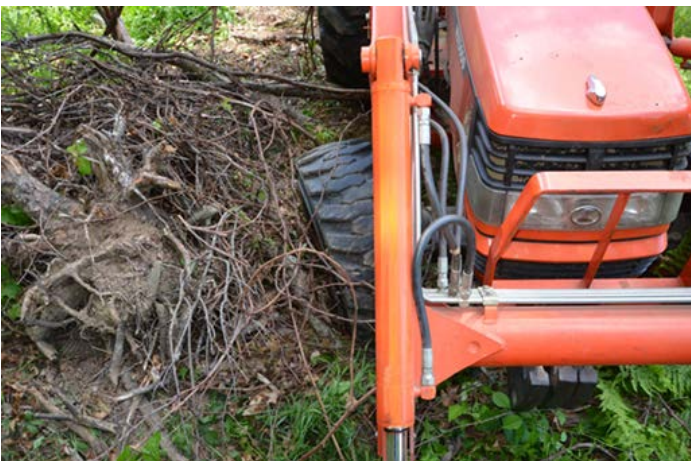
Photo 8. Paint transfer marks on hydraulic arm caused by tree

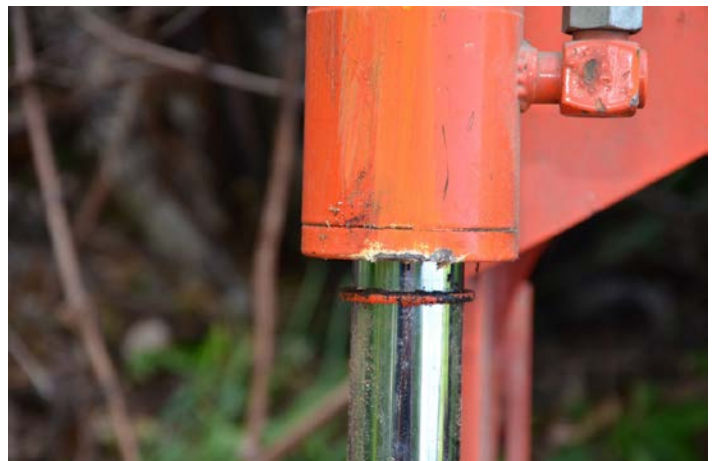
Photo 9. Marks on hydraulic arm/cylinder caused by tree
