FATALITY INVESTIGATION REPORT

Rubber equipment operator died after his head was caught between bars of operating machinery

REPORT#: 2018-29-1

REPORT DATE: June 2019

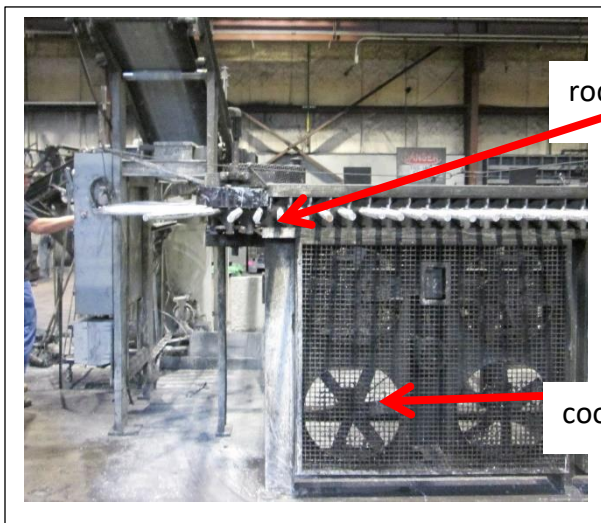
On August 23, 2018, a 23-year-old rubber cutter was killed when he attempted to retrieve a rubber strip on the cooling line (Festoon, see photos 1 and 2) that had passed the point where it should have been fed onto a conveyor. He raised his head between two horizontal bars, and as the line began to move, it forced his head against the electrical panel support. OR-FACE received notification of the incident from Oregon OSHA (OR-OSHA). This investigation report is based on OR-FACE site visit with an OR-OSHA investigator, review of OR-OSHA investigation documents, follow-up discussions with the OR-OSHA investigator, and best practices research.

Photo 1. Unguarded festoon (cooling line) (Photo courtesy of OR-OSHA).

There were other similar festoons on site. None were safeguarded to prevent entry into danger zones or contact with rotating bars/rods. Employees were allowed to reach into the machine to make minor alterations while operating.

- **Recommendation #1: Safeguard machinery to protect machine operators and others who work in the area from hazards. The safeguard should prevent employees from having any part of their body in the danger zone during the machine operating cycle.**

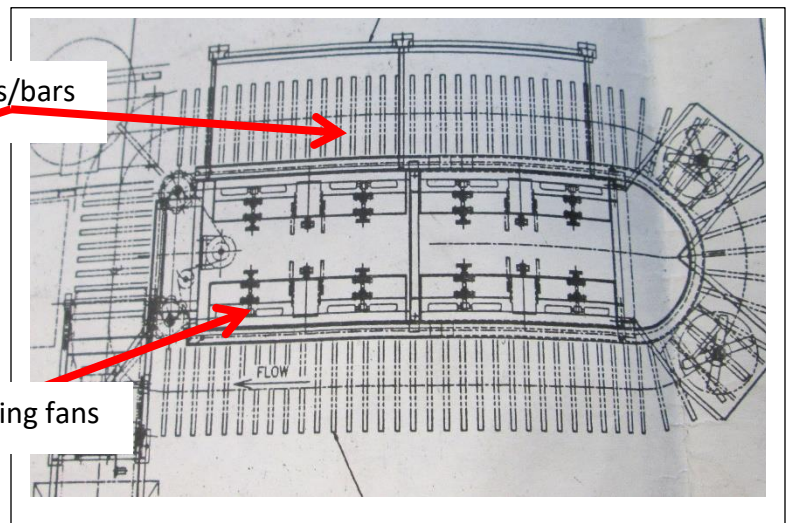
Photo 2: Schematic of festoon (cooling line) (Photo courtesy of OR-OSHA).

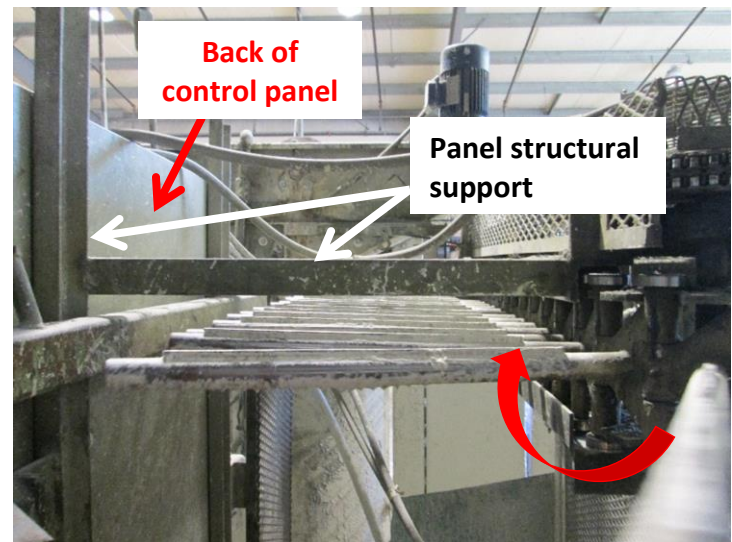
There were no witnesses to the incident (the decedent was not within visual sight of the Rubber Lacer, who was at the other end of the festoon), and no one observed the worker entering the unguarded festoon area. It is speculated that the lead strip had passed the point where it would normally be fed to the conveyor and had made its way around the corner, where the worker likely entered the festoon. As the bars rotate around the corner of its elliptical path, the bars separate (see Photos 2 and 3) at the outside end. It appeared that the worker raised his head between two bars, and when the equipment began to rotate, his neck was caught between the bars, forcing his head against the control panel support.

Photo 3. Festoon corner section; note the distance between two bars (Photo courtesy of OR-OSHA).

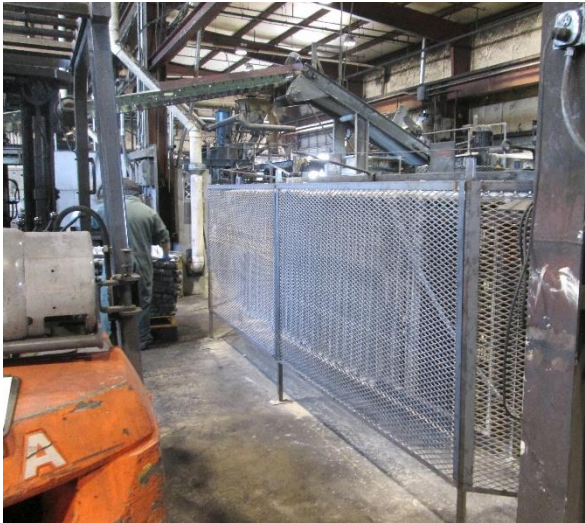
Photo 4. Installed guard at festoon line
(Photo courtesy of OR-OSHA).

One of the festoons is situated near the locker room and employees walked passed rotating rods several times daily. According to the employer investigation report, unguarded festoons are common throughout the rubber industry. It is unknown if festoon manufacturers recommended guards/barriers or notified buyers of potential entanglement hazards. After the incident, the employer halted production until physical guards were installed (see Photos 4 and 5).

OSHA's publication, "Basics of Machine Guarding" (see references), states that equipment safeguards must be secure such that workers cannot easily remove or tamper with the safeguard. The physical barriers (see Photos 4 and 5) installed by the employer after the incident appeared to be secure and fixed. However, such barriers should not create interference. If the guard impedes the worker from completing his task efficiently and comfortably the guard will likely be overridden or disregarded. It was not determined in the investigation how often the rubber strip required redirection from the festoon line to the off-loading conveyor. When doing so, the safeguard must prevent hands, arms, and any other part of a worker's body from making contact with hazardous moving parts. A tool to reach over the guards to capture and direct the strip may be a consideration. However, this action should not create new hazards.

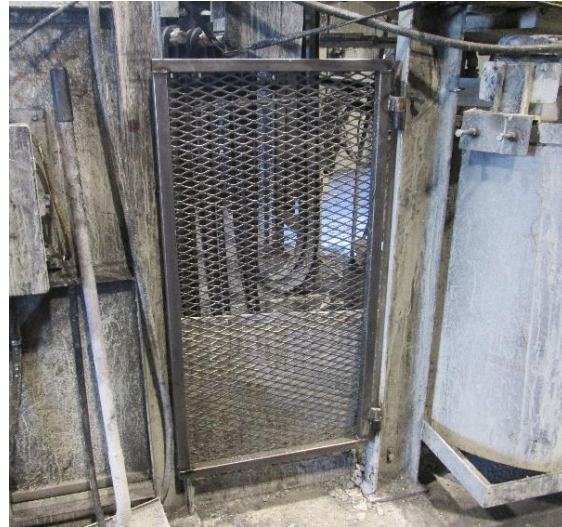
Photo 5. Installed guard with serpentine rubber strip visible (Photo courtesy of OR-OSHA).
