## FATALITY INVESTIGATION REPORT

<b>DATE:</b> March 30, 2018	<b>REPORT#:</b> 2018-08-1	<b>REPORT DATE:</b> September 2019

<b>TIME:</b> 2:30 p.m.	<b>SUMMARY</b> On March 30, 2018, a 36-year-old male skid-steer (track loader) operator was caught between the cab and lift arm. Nearby security video captured the event. Installation of helical piers, foundation support anchors, had been completed. The operator was attempting to disconnect the employer fabricated helical hydraulic head attachment from the last installed helical pier. He was controlling the skid-steer while standing in front of the cab in between the lift arms front frame rail cross member. A hydraulic hose that had been wrapped around the right control lever of the skid-steer pulled the control lever forward and when the operator pulled the safety bar down, the right lever was engaged causing the lift arms to lower, crushing the operator. The operator was pronounced dead at the scene. (Full report begins on p. 3)

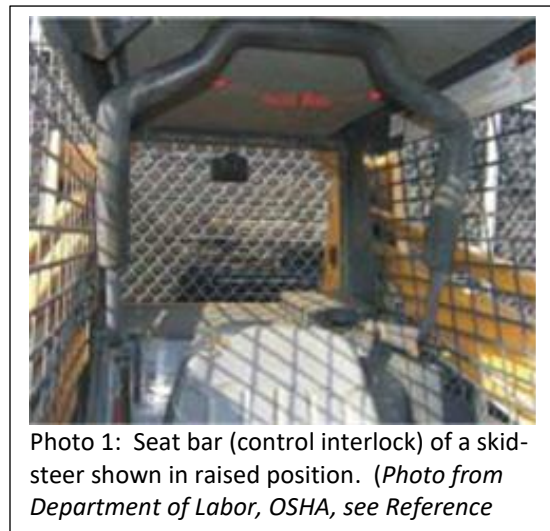
A hydraulic hose connected to the head attachment had been wrapped around the right control lever and pulled the control lever towards the front of the skid-steer (see Photo 3). When the operator pulled the safety bar (also known as seat bar-see photo 1) down it engaged the functions of the equipment and the right control lever caused the lift arms to lower, crushing the operator.

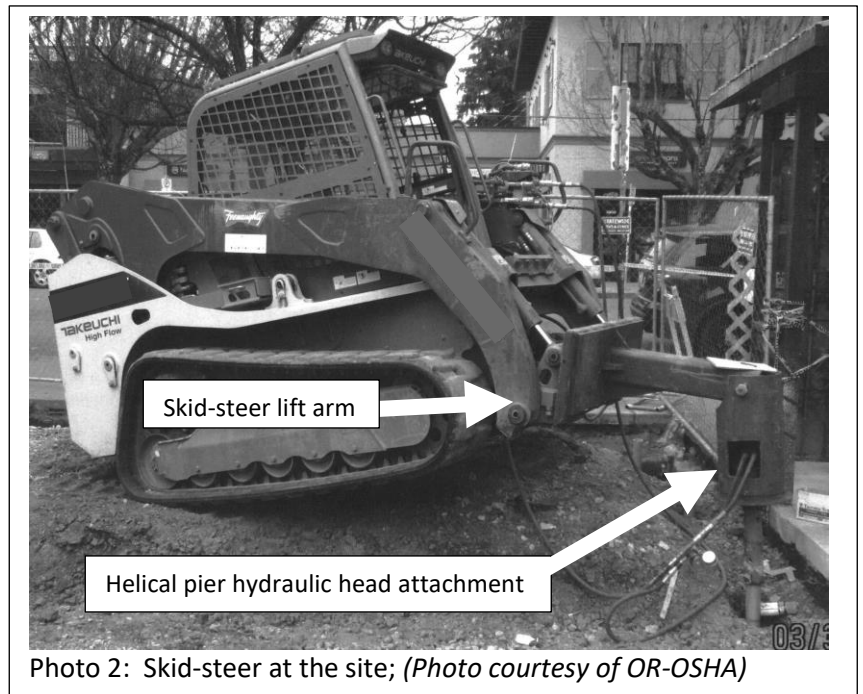
Video surveillance camera at a nearby business recorded the event. The operator stepped outside of the cab, left it running while attempting to release the pressure from the pin connecting the skid-steer's helical head attachment (which drives the helical pier to appropriate depth) to the installed helical pier. He positioned himself in front of the cab and in between the lift arms front frame rail cross member.

Photo 2: Skid-steer at the site; (Photo courtesy of OR-OSHA)
