MIFACE Investigation Report #10MI122

Subject: Farmer Pinned Under Driver's Side Front Tire of a Front-end Loader

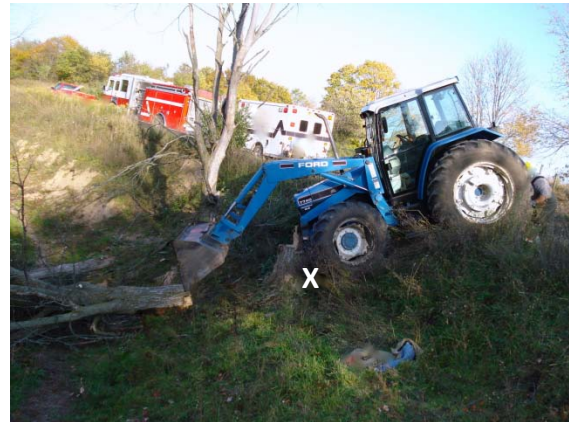
Figure 1. Position of decedent and tractor after tractor moved forward and down the embankment.

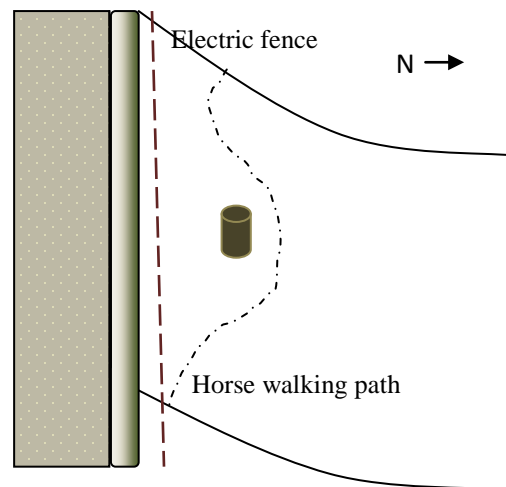
Drawing 1. Incident Scene

The north side of the driveway had a steep drop off which then leveled out to the horse pasture. The packed sand driveway had an area approximately 5 feet wide between the edge of the driveway and the beginning of the slope down to the pasture. The driveway had a two- to four-inch area of soft sand between the packed sand area and the grass at the leading edge of the slope. The 24-inch diameter dead tree involved in the incident was located on the slope approximately seven feet from the driveway's edge.

An electric fence (red dashed line) was installed along the length of the driveway and was positioned between the driveway and the incident dead tree. A walking path had been created by the horses on this sloped area that was several feet below the electric fence and followed the path of the driveway and then veered north of the dead tree. His wife indicated that he had previously expressed concern that this tree would fall and injure the horses.

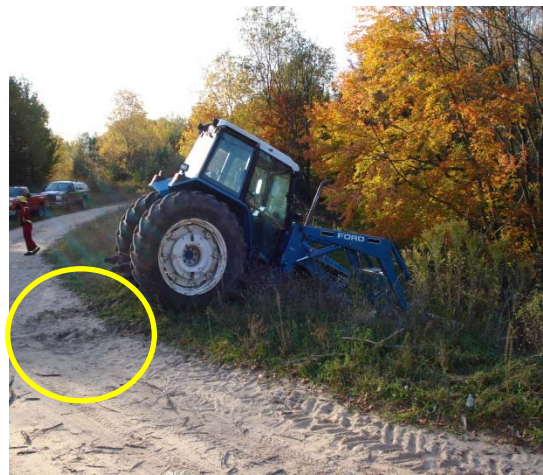
The decedent was facing the stump with his back to the tractor working under the raised bucket. It appears that when the decedent completed his cuts on the tree and the tree fell, the tractor rolled or fell forward over the edge of the driveway's drop off (Figure 2). The tractor tire marks are located within the yellow circle on Figure 2. The decedent, still holding the chain saw in his right hand, did not have enough time to react. The rolling/falling tractor was stopped by the stump of the tree the decedent had just cut, causing him to be pinned under the driver's side tractor tire. The medical examiner report indicated that there were skid marks from the back tires on the sandy driveway (See Figure 2).

Figure 2. Driveway configuration and tractor position after moving forward when tree fell.

The use of the tractor equipped with a loader bucket was not designed nor intended for use as an assist for applying pressure to assist in a tree felling activity, and thus was a misapplication of tractor use. It is unknown how much "push" or force was placed upon the tree by the tractor and bucket. If the force was substantial, stored kinetic energy was released when the tree fell, which could have forced the tractor over the edge of the driveway.

When agricultural equipment is positioned on or near an incline, the equipment may move/roll down the slope, creating a hazard for downhill workers. If equipped, the operator should lower the tractor bucket to the ground, lock the brakes together and set the brake lock or, if equipped the park lock, and turn the engine off. If the equipment must be left running, then the park brake should be set with the transmission in neutral.

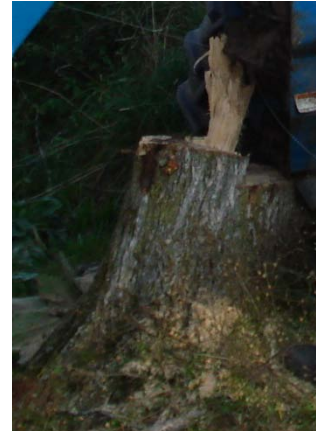
Remove the tractor from this task and the work activity was tree felling. Although experience can be a great teacher and a necessary element in skill development, misguided experience can foster poor technique and enhance bad habits. The decedent had experience, but his work practices, such as lack of wearing appropriate personal protective equipment (gloves only), and his felling technique (notch, backcut and hinge wood) did not adhere to consensus or MIOSHA standards for tree removal.

Figure 3. Locations of cuts made on tree stump

Figure 3 shows the tree stump of the tree felled by the decedent. It appears that the decedent made the undercut on the tree on the side of the tree facing the road and the back cut on the tree on the side of the tree facing the pasture.

MIFACE measured both the undercut and the back cut made by the decedent on the 24" diameter tree. The undercut (See Illustration 1 from the MIOSHA Tree Cutting Standard). The MIOSHA General Industry Safety and Health Standard, Part 53, Tree Trimming and Removal Standard rules state:

- Farmers should use proper directional felling techniques (notch and back cut) with chain saws and wear appropriate personal protective equipment to prevent injury.

A proper notch (undercut) and back cut directs the tree's fall and the hinge wood (holding wood) keeps the tree under control and in its directed fall path. If appropriate felling techniques had been utilized, the need for the tractor/bucket would not have been necessary, and this tragedy could have been avoided.

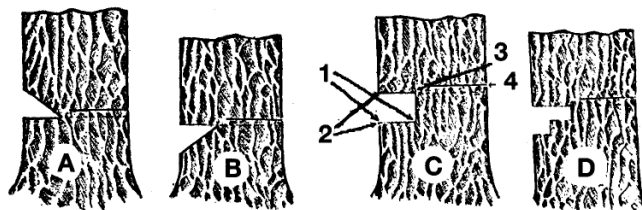
Illustration 1. Figure 1 of MIOSHA General Industry Standard Part 53 showing approved undercuts

- An undercut shall be large enough, about 1/3 the diameter, to safely guide the tree and reduce the possibility of the tree splitting.
- A back cut shall leave sufficient hinge wood (the distance between notch and back cut) to guide the tree's fall in the desired direction and to hold the tree to the stump during most of its fall. A back cut shall be about 2 inches (50.8 mm) above the undercut and as level as possible.
