REPORT#: 18KY054 REPORT DATE: 1-16-2019

Teen Roofer Electrocuted when Ladder Contacts High Voltage Power Line

Fatality Assessment and Control Evaluation (FACE) Program

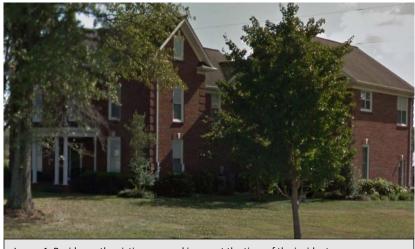
Image 1. Residence the victim was working on at the time of the incident. Photo property of KY FACE.

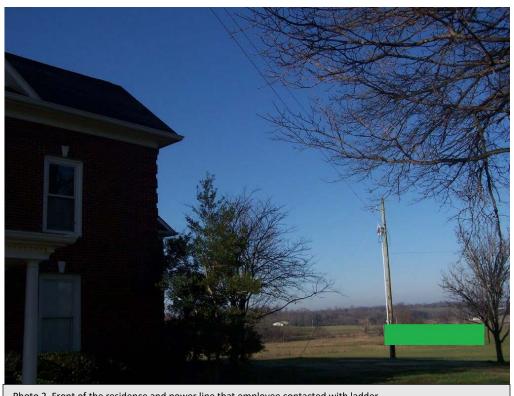
At approximately 12:00 pm, the victim gathered a model D1828-2EQ Werner aluminum extension ladder and moved to the front of the house to begin work there while the other three men moved on to the side of the house. At the front of the house, there were two 4 feet x 4 feet boxwood bushes planted 3 feet from the home's exterior wall at the point where the victim was attempting to access the roof. There were no witnesses, but it is believed that because of the bushes, the victim was having trouble accessing the roof. With the ladder still fully extended, the victim attempted to move it closer by lifting the ladder and walking between the bushes to find a suitable base. The ladder became unstable, causing the victim to lose his balance falling backwards. As the victim and ladder were falling, the ladder fell into a top phase power line carrying 7.2 kilovolts (7,200 volts). Because the victim was still in contact with the highly conductive aluminum ladder when it struck the power line, electricity was able to travel through the metal and into the young worker. He was immediately electrocuted.

Photo 2. Front of the residence and power line that employee contacted with ladder. Photo property of KY FACE Program.

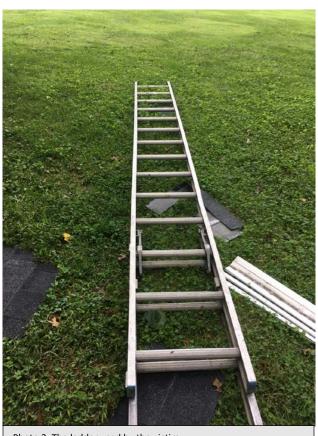
Photo 3. The ladder used by the victim. Photo property of KY FACE.

Discussion: At the time of the incident, the victim was using an aluminum ladder to access the roof. Aluminum has an electrical resistivity (ρ (Ω^{\bullet} m)) – the measure of how strongly a material opposes the flow of electric current – of 2.82×10^{-8} at 20° C. Inversely, aluminum has an electrical conductivity (σ (S/m)) – the measure of how well a material conducts an electrical current – of 3.5×10^{7} at 20° C. Because of its extremely low resistivity and extremely high conductivity, aluminum is one of the best electrical conducting metals, behind only silver, copper, annealed copper, and gold⁶. As the ladder contacted the overhead power line, 7,200 volts and 16 amperes (amps) travelled through ladder, into the victim, and exited his body via the stomach and each foot's fifth (pinky) toe. At values as low as 100 milliamps (.1 amps), death can occur⁷. Due to the high amount of amperes that entered the victim's body, cardiac arrest occurred instantly.

Discussion: The victim was moving a model D1828-2EQ Werner aluminum extension ladder that weighed approximately 56 pounds. When collapsed, the ladder was 14 feet tall and had a maximum open extended length of 25 feet. At the time of the incident, the victim, who measured 5'10" tall and weighed 165 pounds,

was moving the ladder, which was extended to the maximum length of 25 feet. As the ladder became unstable and began to fall, the victim may have been unable to support the ladder's top-heavy design while standing on uneven terrain, which allowed it to contact the power line.

In order to prevent similar incidents, the employer should consider using a non-conductive ladder, such as those made of a fiberglass-reinforced polymer, when working around live power lines. Due to its low electrical conductivity and high resistance to corrosion, these ladders would make a safe and practical choice when working outdoors around electricity. However, employers should ensure that these fiberglass ladders are maintained properly as required by 29 CFR 1926.1053. Unmaintained ladders may accumulate excess dirt or moisture that can conduct electricity in the event it encounters a high voltage line.

In instances where an extension ladder needs to be relocated, employees should lower the extended portion of the ladder until it is appropriately collapsed, carefully lay the ladder down, and transport it horizontally while grasping the ladder's middle section with both hands in order to safety manage its weight. Once the ladder is placed in the necessary area, ensure the base is secure and re-extend the ladder to the appropriate height. Had the ladder been lowered and transported horizontally, the high voltage line could have been avoided.

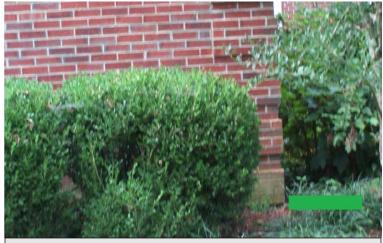
Photo 4. The box wood bush the victim was attempting to work around. Photo property of KY FACE.
