REPORT#: 18KY007 REPORT DATE: 11-5-18

Police Officer Drives into Flood Waters and Drowns

Fatality Assessment and Control Evaluation (FACE) Program

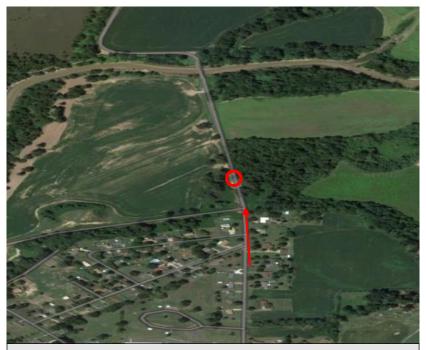
Photo 1. Aerial photo of the scene with creek at normal levels. Arrow indicates direction of travel; circle indicates where the vehicle entered the water. Photo courtesy of Google

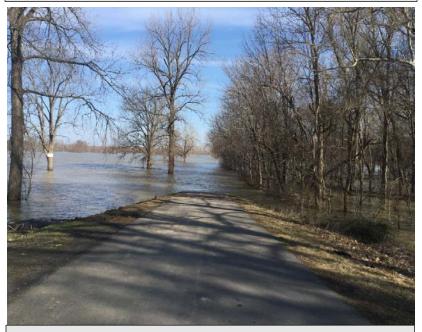
Photo 2. Scene where the victim and his vehicle entered the water. $\label{eq:Photo property} \text{Photo property of KY FACE}.$

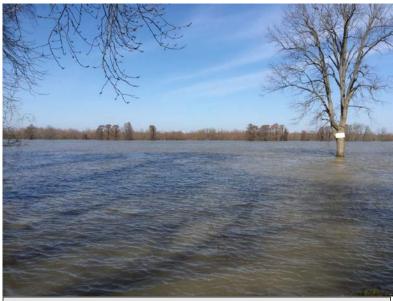
Photo 3. The flooded field from which the victim and his vehicle were retrieved. Search and rescue divers located both approximately 150 yards northwest of the marked tree. Photo property of KY FACE.
