**REPORT#: 15MI117**

**REPORT DATE: 10/23/18**

## Construction Laborer Died in a Trench Wall Collapse

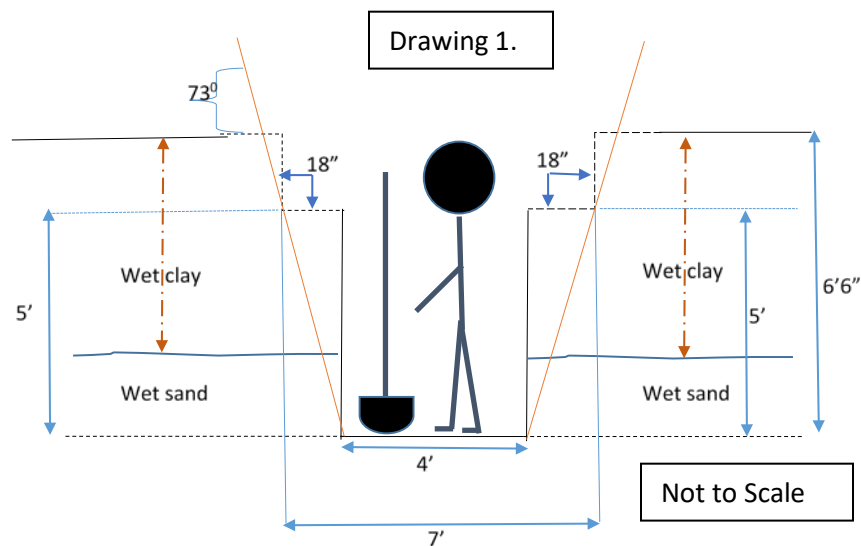
Due to the length of the trench, its measurements varied in depth (5- to 7-feet), base width (30 inches to 4½ feet), and top width (7- to 12-feet). The bench height was also variable (no heights mentioned in reviewed documents).

The trench in the incident area was approximately 7 feet wide at its top, 6½ feet deep, and 4 feet wide at its base. An 18-inch bench was cut approximately 18 inches below the top of the trench and 5 feet from the base. The trench had a 1½-foot seam of wet sand at its base, and then another 5 feet of wet clay. (See Drawing 1).

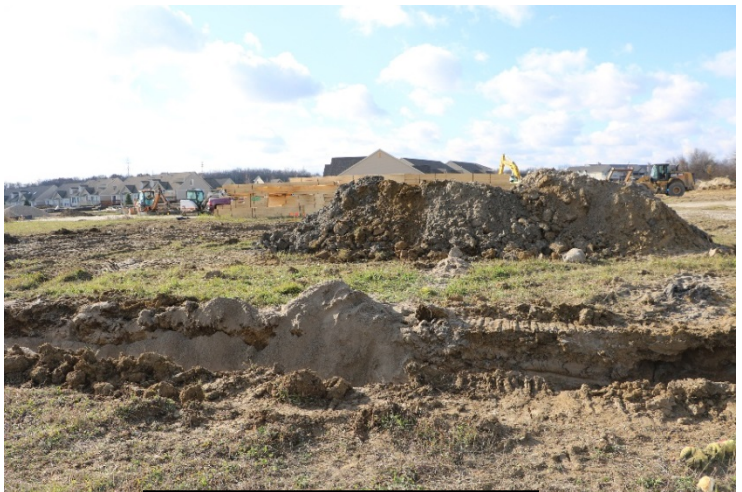
Figure 1. Placement of spoils

Coworker 2 was using a Kawasaki excavator with a 3-foot wide bucket. He placed the spoils on the side of the trench that collapsed. The spoils were placed more than 2 feet away from the trench wall as required by MIOSHA standard Part 9. (See Figure 1).

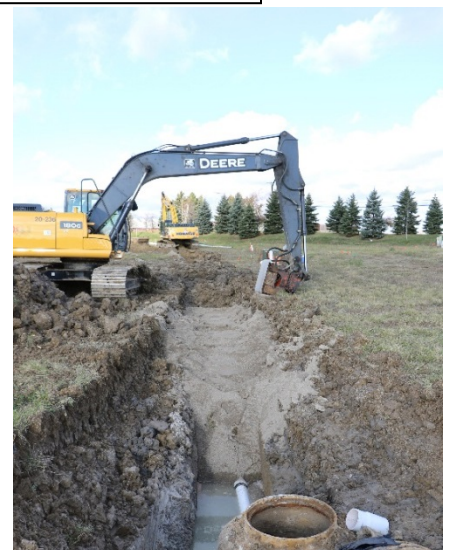
Figure 2. Water location in trench

Earlier that morning the excavator operator noticed more water at the west end of the trench and asked the decedent if he wanted the trench box that was onsite. The decedent stated no. (See Figure 2).

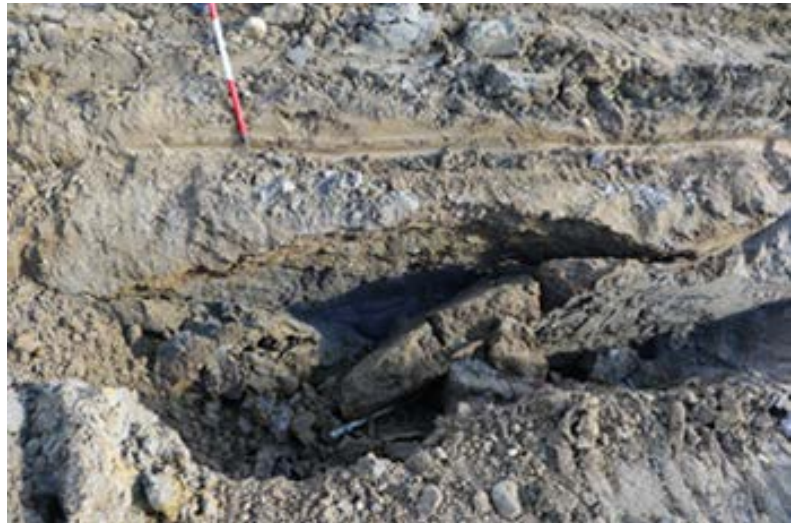
*Figure 3. Trench wall collapse*

When the foreman finished the placement of the survey stakes, he walked the site to check out progress. He came to the incident trench area where the decedent and Coworker 1 were working. The foreman looked over and noticed the south wall starting to give way and yelled for the decedent and Coworker 1 to get out of the trench. Both workers began to run east toward the ramp. Coworker 1 was able to safely exit the trench. The south clay/dirt wall collapsed, striking the decedent on his right side, burying him from the waist down side and pinning him against the north trench wall (See Figure 3). The decedent's shovel was pushed into the decedent's right side but never penetrated. The force of the south wall collapse caused the decedent to strike the north wall also causing part of the north wall to also collapse, although the bench was still intact.

The MIOSHA compliance officer investigating the fatality utilized a penetrometer to determine the consistency/hardness of the soil from the spoils pile. Readings found predominately sand and read 0.0 T.S.P. and clay clumps at 3.0 T.S.P. Based on trench measurements provided by one of the top management employees, the MIOSHA compliance officer calculated angle of repose of the trench walls at 73 degrees. Based on the soil characteristics, the trench walls should have been 34 degrees.

Employees engaged in pipe installation activities in an excavation that had been benching on each side where the step back of the benches did not extend to the angle of repose as required by table 1, exposing the employees to a cave-in of the excavation, resulting in a fatality. The excavation, as observed by employees and others on site, was 6'-4" deep, 7' wide at the top, 4' wide at the bottom, and 25' long. The north and south sides of the excavation each had a 5' high bench that stepped back 18", achieving an angle of repose of 73 degrees. The soil was a wet sand at the bottom 18" of the excavation, with the remainder being a wet clay.

Employees engaged in pipe installation activities in a benched excavation where the height of the lower bench on each side was greater than the width of the trench measured at the bottom, exposing employees to a cave-in that resulted in a fatality.

***Recommendation #1: Employers should ensure that employees working in excavations are protected from cave-in by an appropriate protective system, such as trench boxes, shields, benching and/or appropriate sloping of trench sides designed in accordance with MIOSHA Construction Safety Standard, Part 9, Excavation, Trenching, and Shoring. To ensure this is done correctly, a qualified person must inspect and approve the excavation, adjacent areas, and supporting systems on an ongoing basis.***
