## Occupational Fatality Report

### Foreman of a Highway Line Painting Crew Killed When a Car Enters the Work Zone – Massachusetts

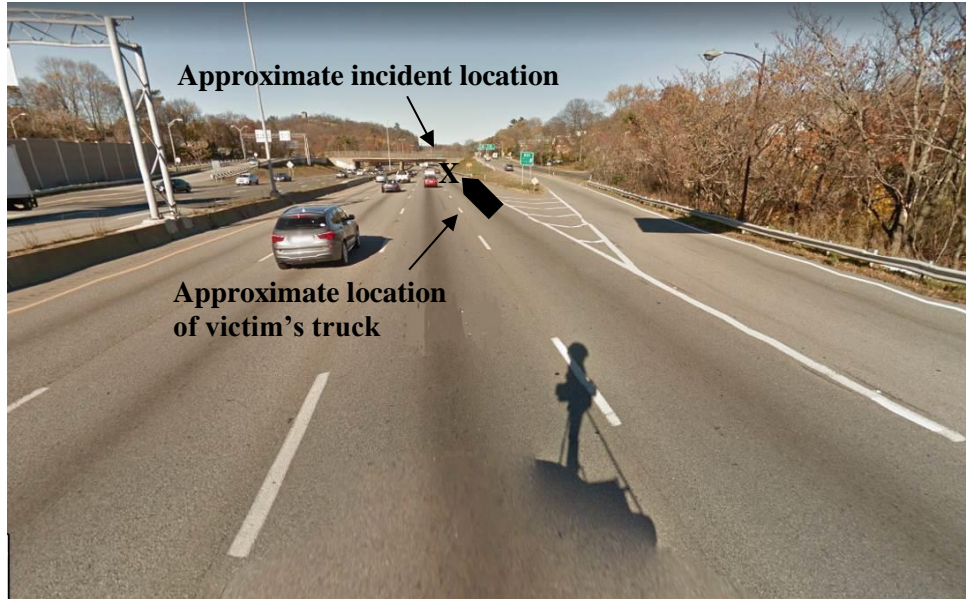
**Figure 1b – Incident location aerial view**
