## Fatality Investigation Report

OR 2014-42-1

### Forestry worker in vehicle killed from timber falling activity

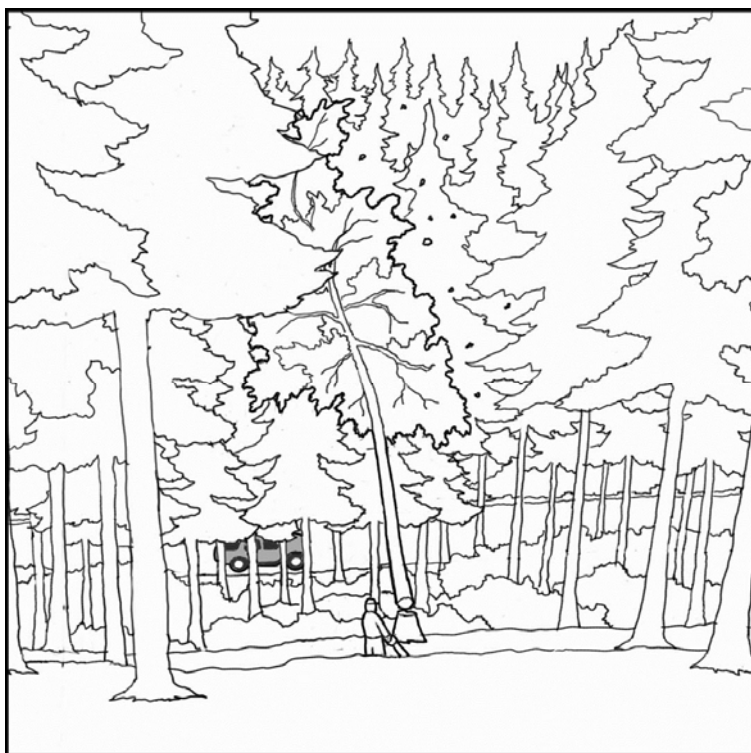
**A schematic of the incident.** The tree/limb density is reduced in the illustration to reveal the vehicle. At the actual site, tree/limb density was greater and the view of the road more obscured.

toward the timber falling activity. There were no warning signs or flaggers present in advance of the active falling area. The faller working at the northwest end cut a tree that fell downslope and into the road, 135 degrees from its intended lay. He went down to clear the tree from the road and discovered a vehicle had been struck by the tree and come to rest further down the road. He discovered the log quality specialist severely injured in her vehicle and called 911. First responders arrived within about 30 minutes but pronounced the log quality specialist dead at the scene.

- **Employers responsible for active logging operations should assure that entry into hazardous logging areas is controlled, including correct placement of flagging, road closures, and adequate and proper signage and warnings.**

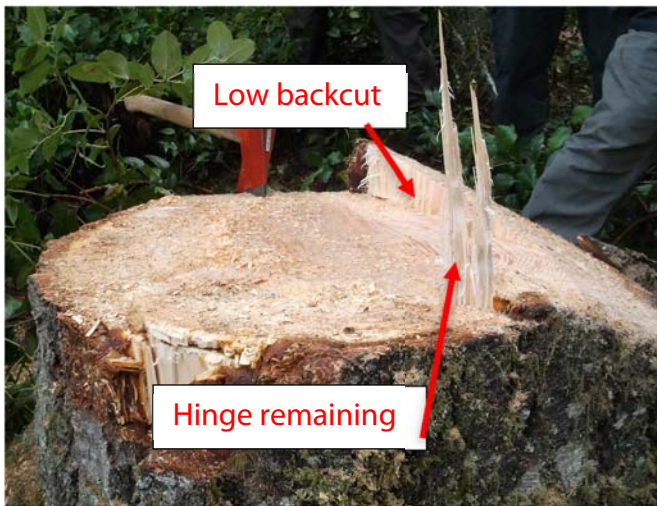
was over 140 feet tall), with a diameter of 36 inches. The OR-OSHA report indicated the distance from the tree stump to the center of the road was approximately 145 feet. The ground below the stump sloped downward toward the road at an approximate 30% grade. The intended lay of the tree was parallel to the road. However, the tree fell 135 degrees away from the intended lay of the tree into the road. The OR-OSHA report noted that in their examination of the tree stump, several unsafe cutting practices were apparent (shown in adjacent photo): sufficient

holding wood was not maintained<sup>2</sup>; low backcuts<sup>3</sup>; and improper cleaning of the face cut. The holding wood on the uphill side of the tree was nearly completely sawn off and only a small 2-inch x 2-1/2-inch hinge remained on the downhill side of the stump. These conditions would

make it more difficult to fall the tree in the intended direction, as its natural lean was toward the road. As the work was being performed the faller used three wedges in an attempt to fall the tree in its intended direction.

- **Employers should assess tree fallers' skills for felling and bucking logs, and require that novice or inadequately performing workers are directly supervised by a qualified person until the faller demonstrates the ability to safely perform these tasks independently.**

- The faller’s employer stated that he had confidence in the faller’s abilities and that if he had identified unsafe cutting practices he would have corrected them. However, during OR-OSHA’s investigation deficiencies in safe cutting practices by this faller were observed, with improper cuts found in several trees that were surveyed at this site in addition to the tree that struck the log quality specialist’s vehicle. It is important, therefore, for logging employers to regularly evaluate their fallers’ work practices, correct any unsafe cutting practices observed, and ensure that all fallers have the necessary skills to perform the task at hand before they are allowed to work independently (OAR 437-007-0800(10)).
