Occupational Fatality Report

Laborer Fatally Injured After Falling from a Home Under Construction – Massachusetts

Release Date: April 11, 2017
Investigation: # 16-MA-001-01

Massachusetts Department of Public Health
Occupational Health Surveillance Program

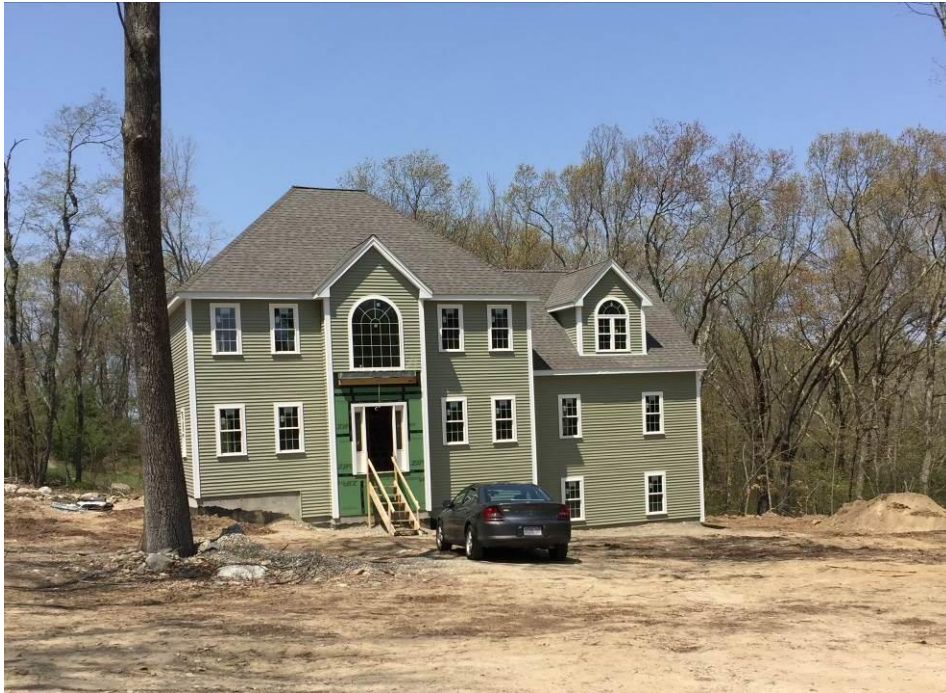
The incident occurred at a construction site of a single family house that was being built (Figure 1). The building location was within a rural residential area of a town. The colonial style house was two stories with a high-pitch hip roof. There was also an attached garage with living space above. The back part of the house, where the incident occurred, was also two stories high. The land around the house was covered with a few inches of snow. Under the snow was dirt and rocks as the lot had not been landscaped. The day of the incident, framing of the house was continuing. The first floor of the house was framed out and the second story was in progress. At the time of the incident, the workers were installing the ceiling joists for the second floor. The house's rafters were not yet installed.

It appears that while the victim was starting to come down from the second floor rear wall top plate, he lost his balance and fell outside of the house, approximately 24 feet to the frozen ground below. The victim sustained head and neck injuries when he landed on the ground. When the foreman found the victim, he immediately placed a call for emergency medical services (EMS). EMS along with local and state police arrived within minutes. The victim was then med-flighted to a regional trauma center where he was in the intensive care unit and was pronounced dead the next day.

Figure 1 – The house being constructed at the time of the incident

Recommendation #1: Employers should provide fall protection for all employees exposed to fall hazards of six feet or more.

Because this job was new construction of a house, a guardrail system may have been a good choice for fall protection.^{3,4} The guardrail system could have been installed early in the project and stayed in place for most of the construction process and moved as needed.

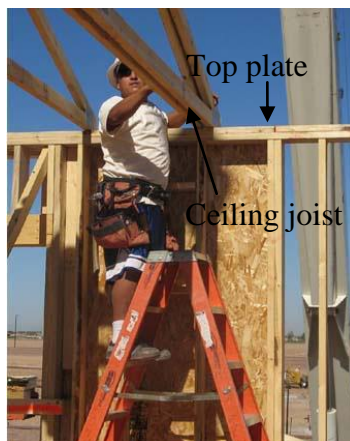
A standard step ladder was set up on the second floor and the victim had climbed this step ladder to access a section of the top plate (Figure 2). The step ladder was positioned on the second floor along the rear wall of the house. The step ladder was a six foot, type 1A duty rating with a 300 pound load capacity limit. Also, a pneumatic nail gun was being used to secure the ceiling joists into place. At the time of the incident, the nail gun was placed up on a previously installed

At this point, the victim climbed the step ladder that was next to the back exterior studded second story wall and then climbed onto the top plate of this back exterior studded wall of the house. A top plate is a structural load-bearing member on top of a stud wall on which joists rest to support an additional floor or to form a ceiling. The height of the top plate to the interior second story floor was seven feet and seven inches and the height of the top plate to the ground below on the exterior side of the house was 24 feet. Since the incident was not witnessed there is some conflicting information about what exactly occurred after the victim climbed onto the top plate. The conflicting information is that once on the top plate, the victim either started to adjust and install the 2x8 inch ceiling joists, or the victim had climbed onto the top plate solely to retrieve the nail gun that was previously placed on one of the ceiling joists.

Figure 2 – Example of a construction worker setting a ceiling joist (connected to a roof rafter) on a top plate
